# **Report**

## **Town of Dedham, MA**

### **2012 Inflow Investigation**

February 2013

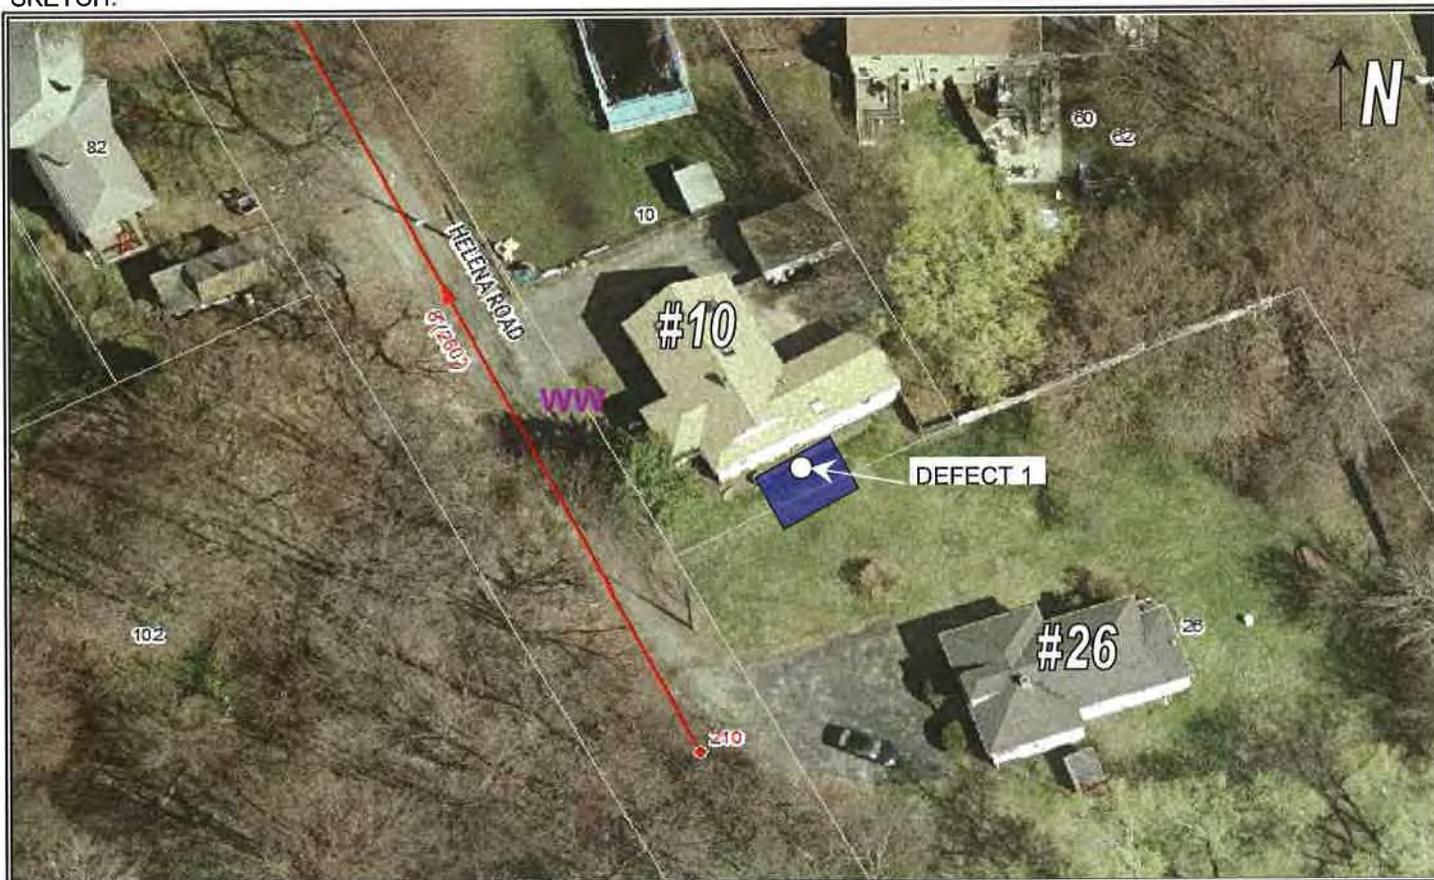
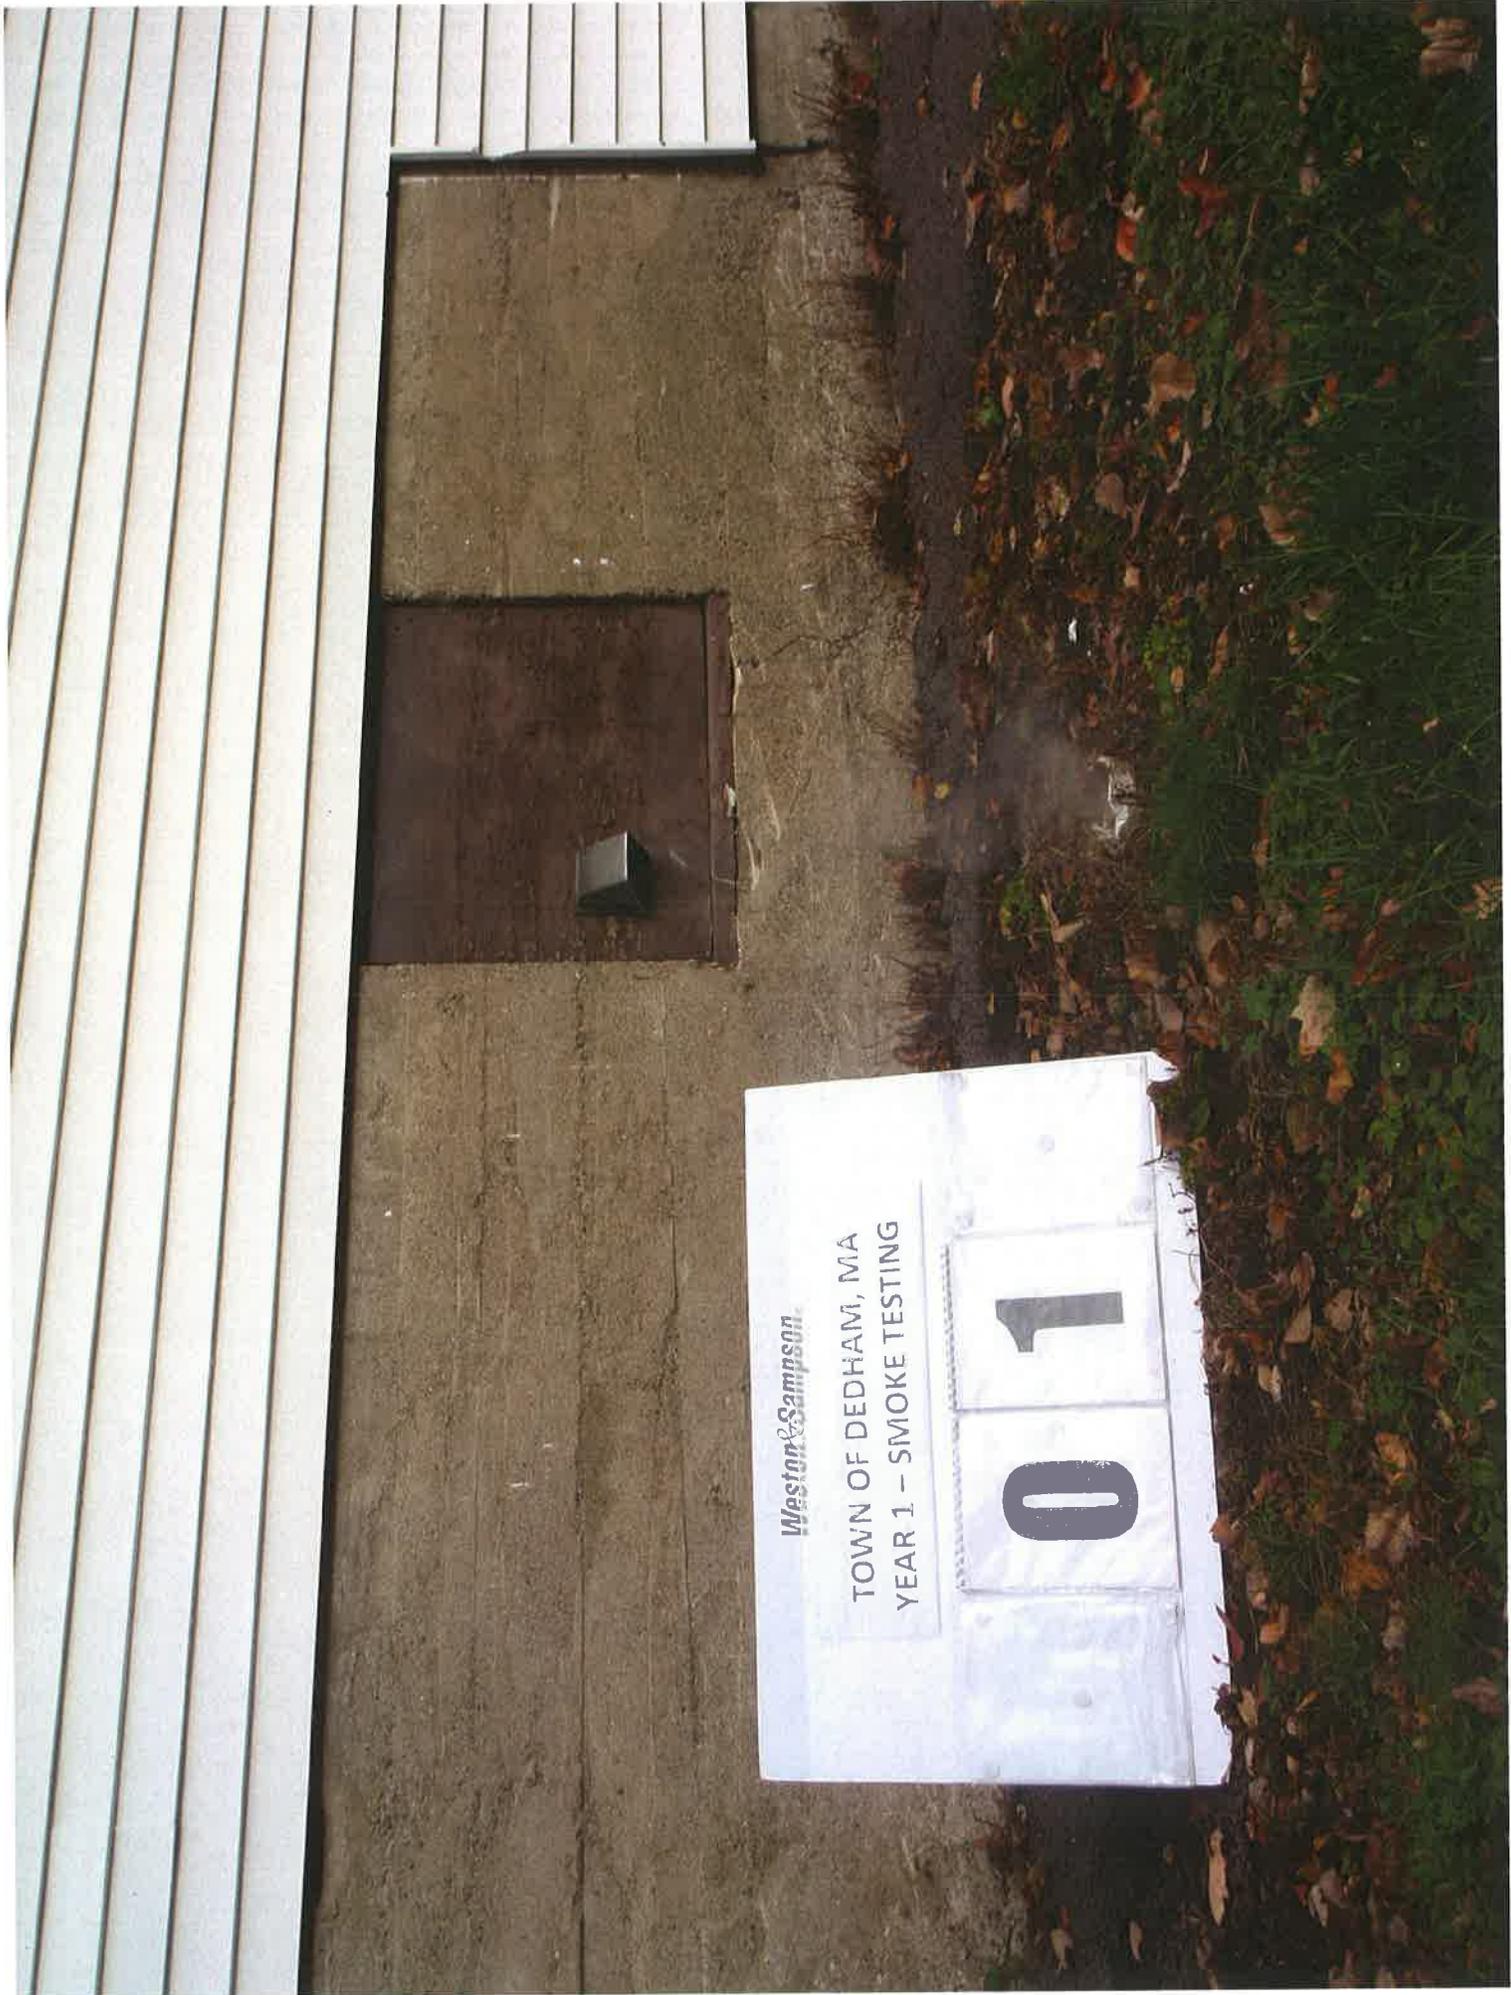
DEFECT: 1 thru 1

DEFECT	DESCRIPTION	Drainage Area (ft <sup>2</sup> )	Surface Type	Severity			Picture No.(s)
				Major	Mod	Minor	
1	Open Cleanout (at grade)	225	Grass / Asphalt			x	28

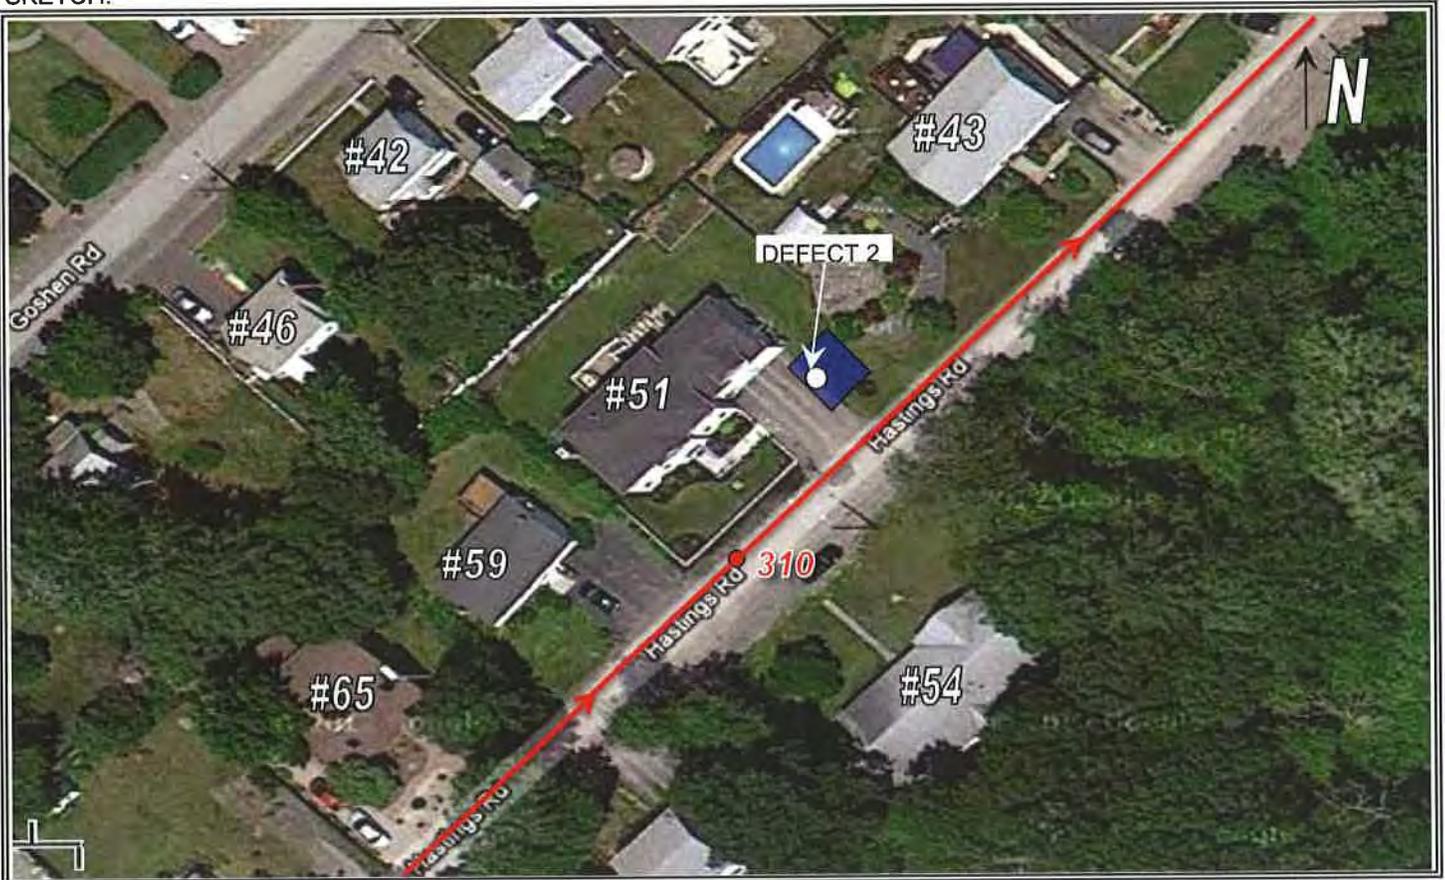
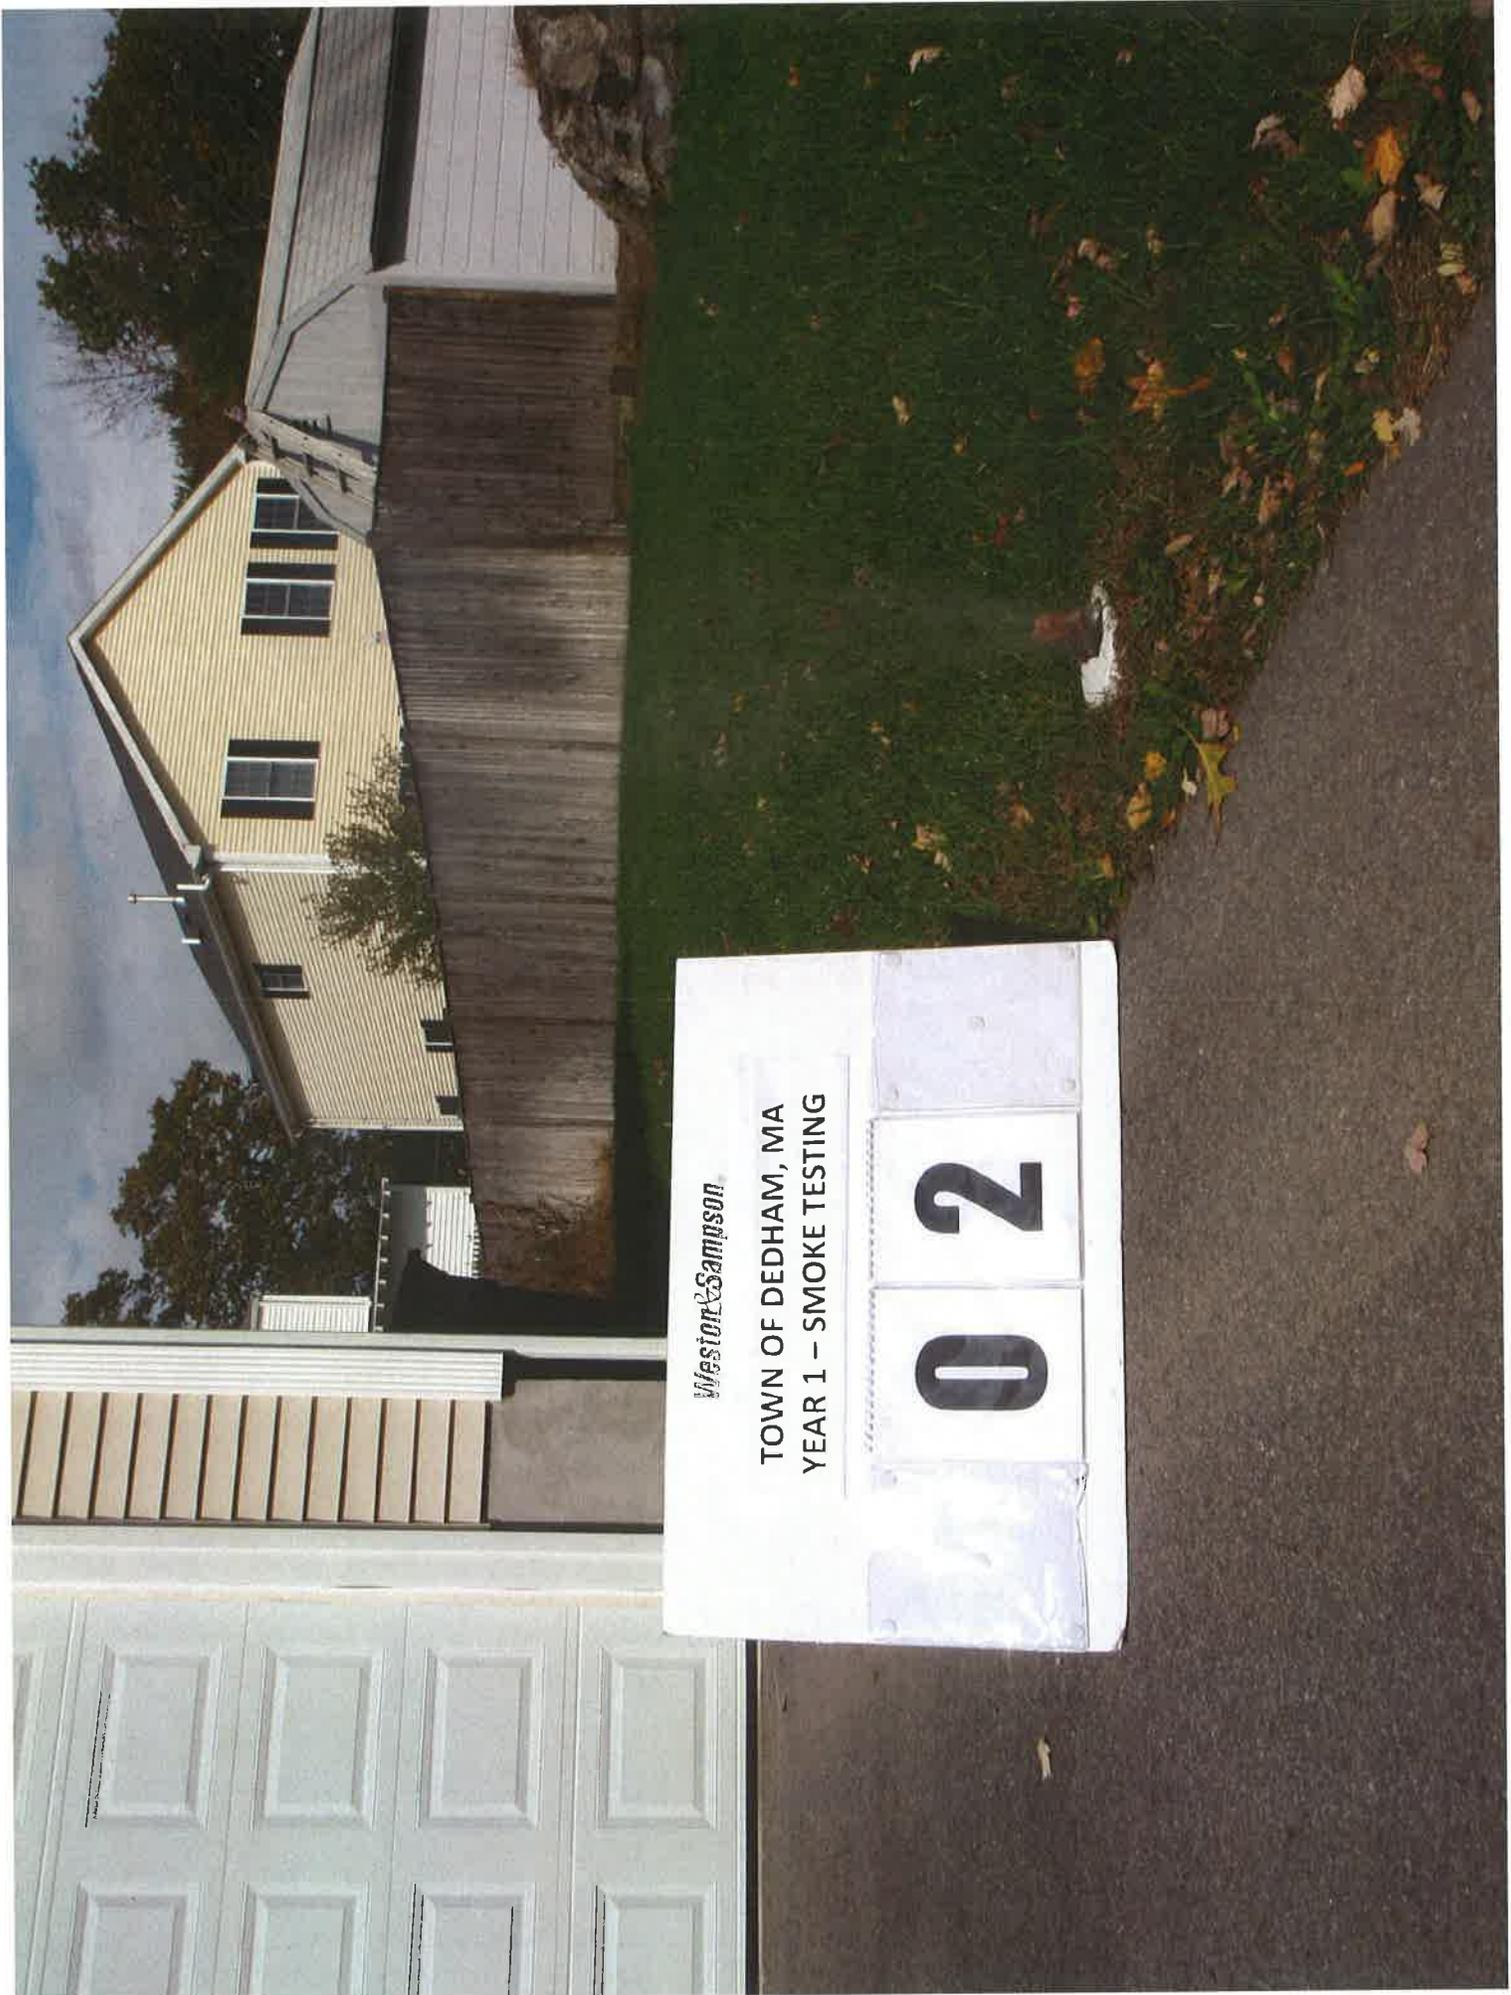
DEFECT: 2 thru 2

DEFECT	DESCRIPTION	Drainage Area (ft <sup>2</sup> )	Surface Type	Severity			Picture No.(s)
				Major	Mod	Minor	
2	Open Cleanout (at grade)	400	Grass			x	32

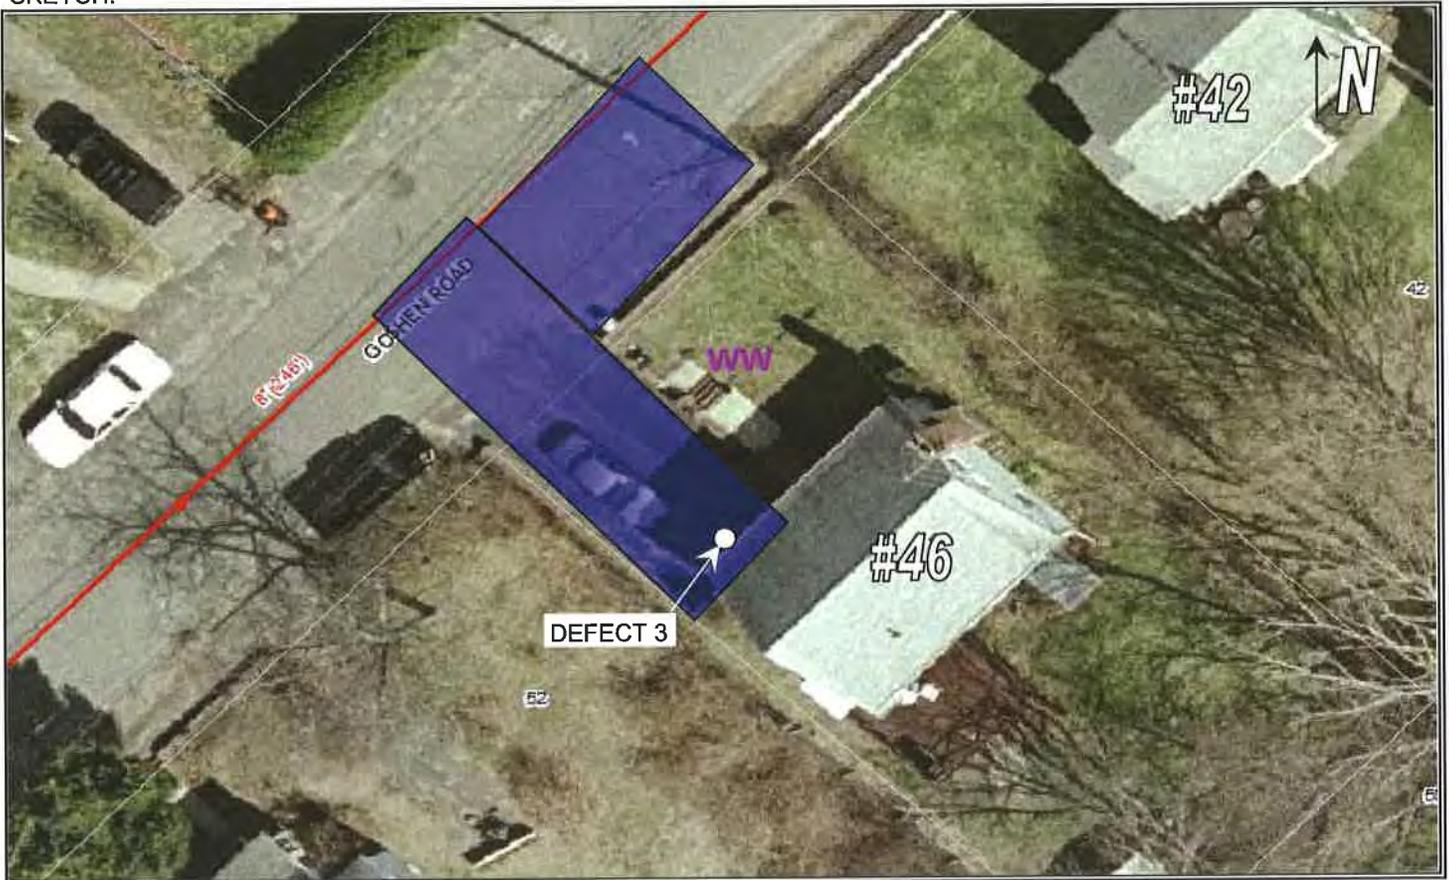
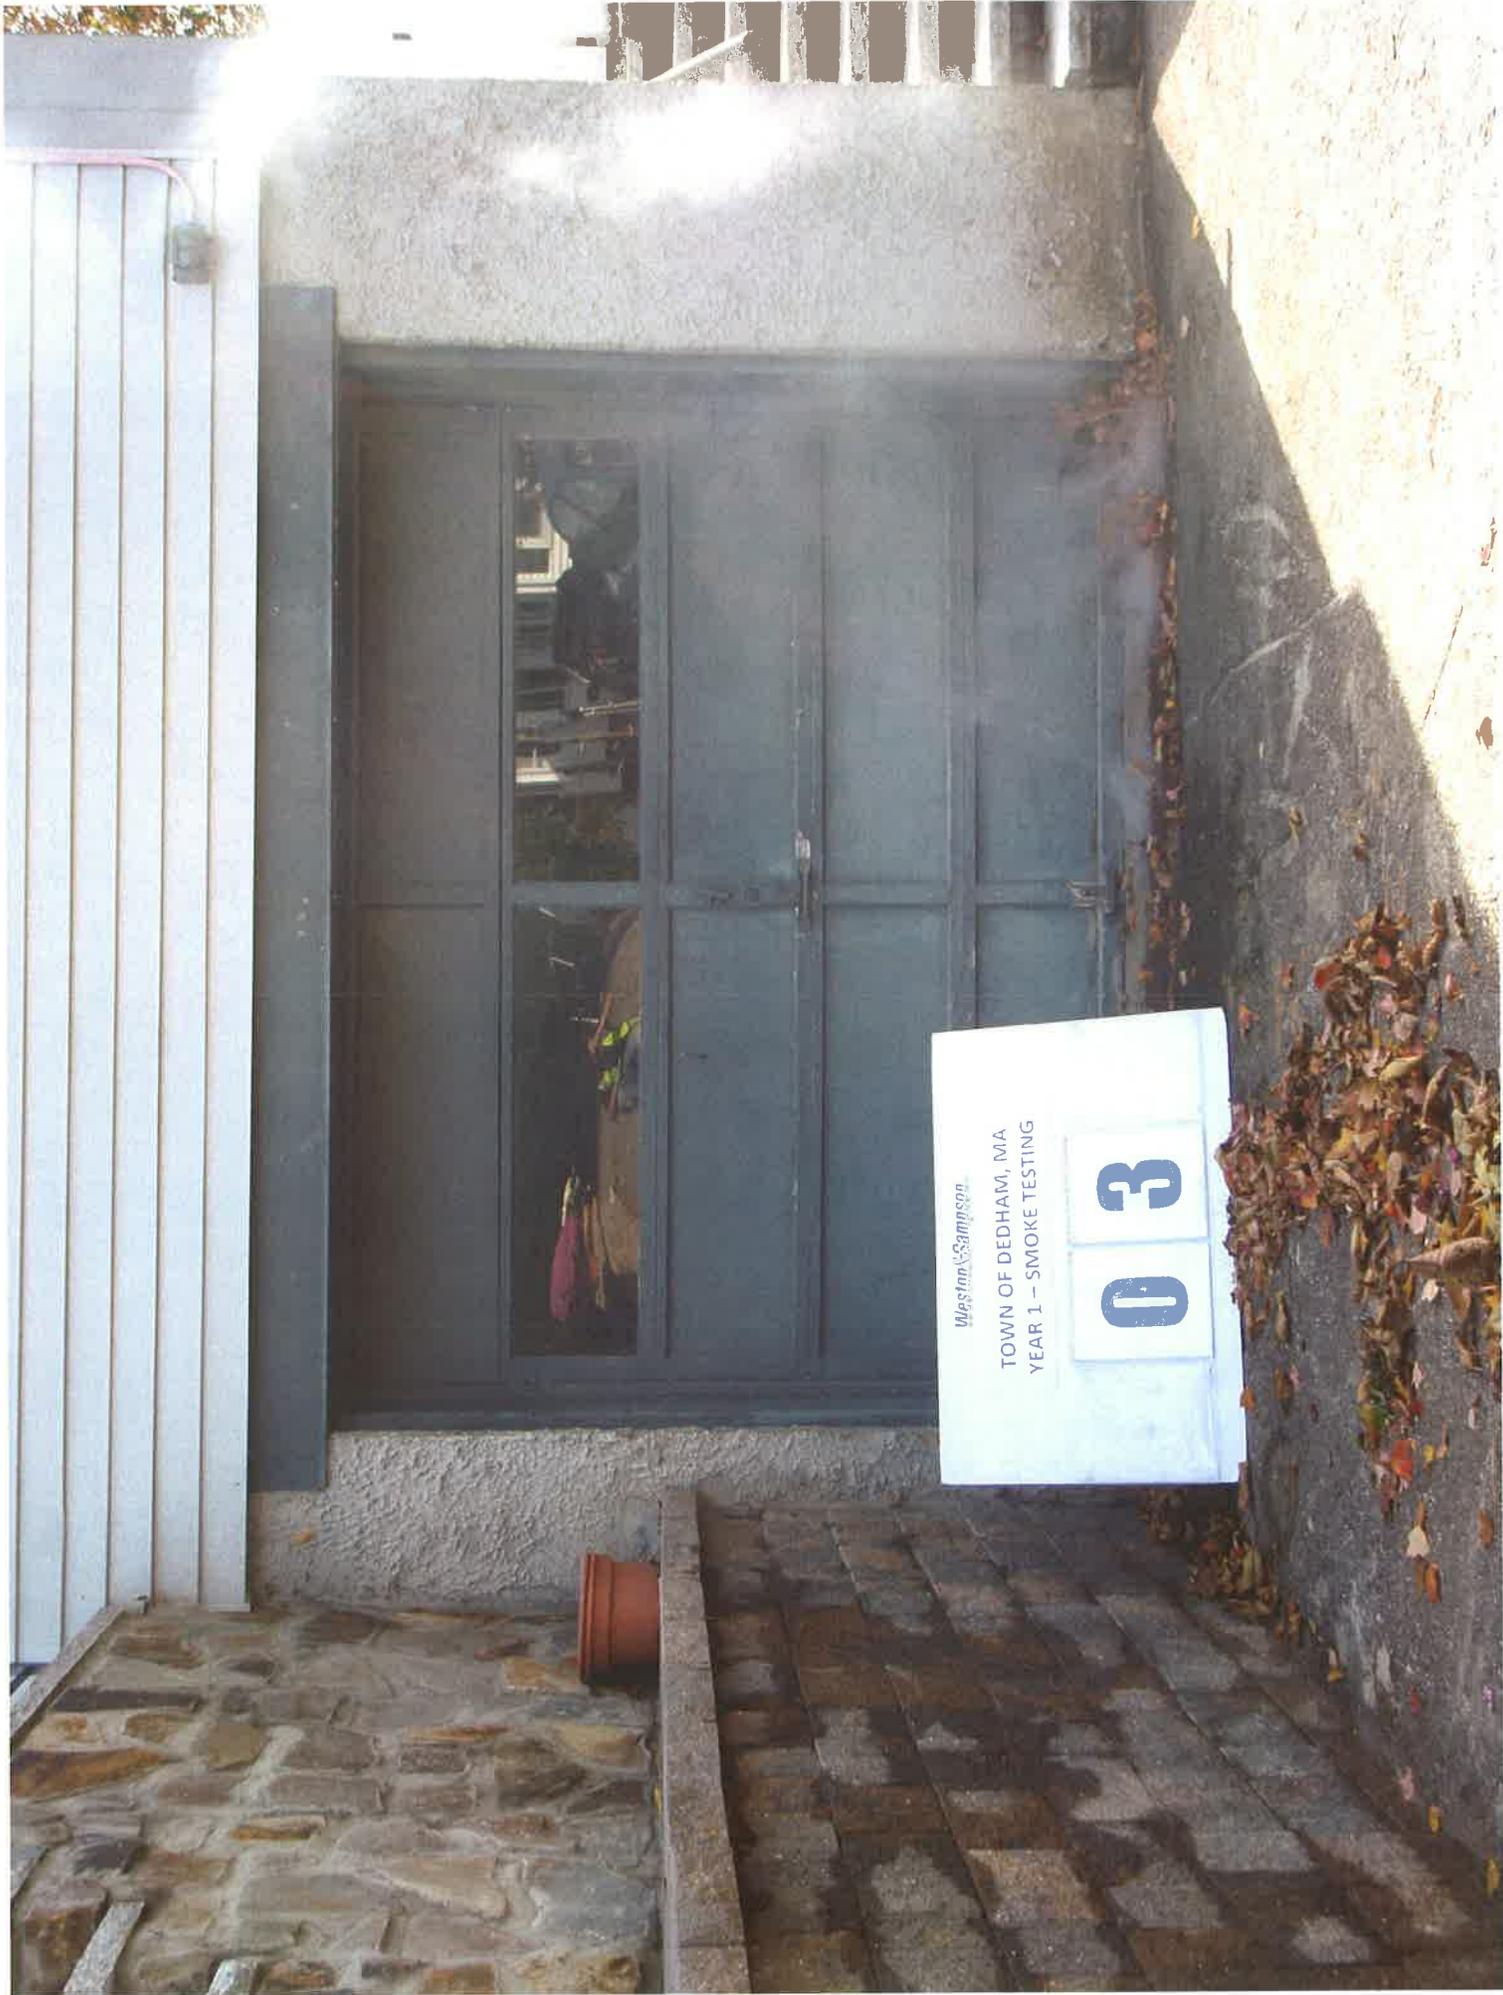
DEFECT: 3 thru 3

DEFECT	DESCRIPTION	Drainage Area (ft <sup>2</sup> )	Surface Type	Severity			Picture No.(s)
				Major	Mod	Minor	
3	Driveway Drain (moderate smoke)	1,501	Asphalt	x			33-35

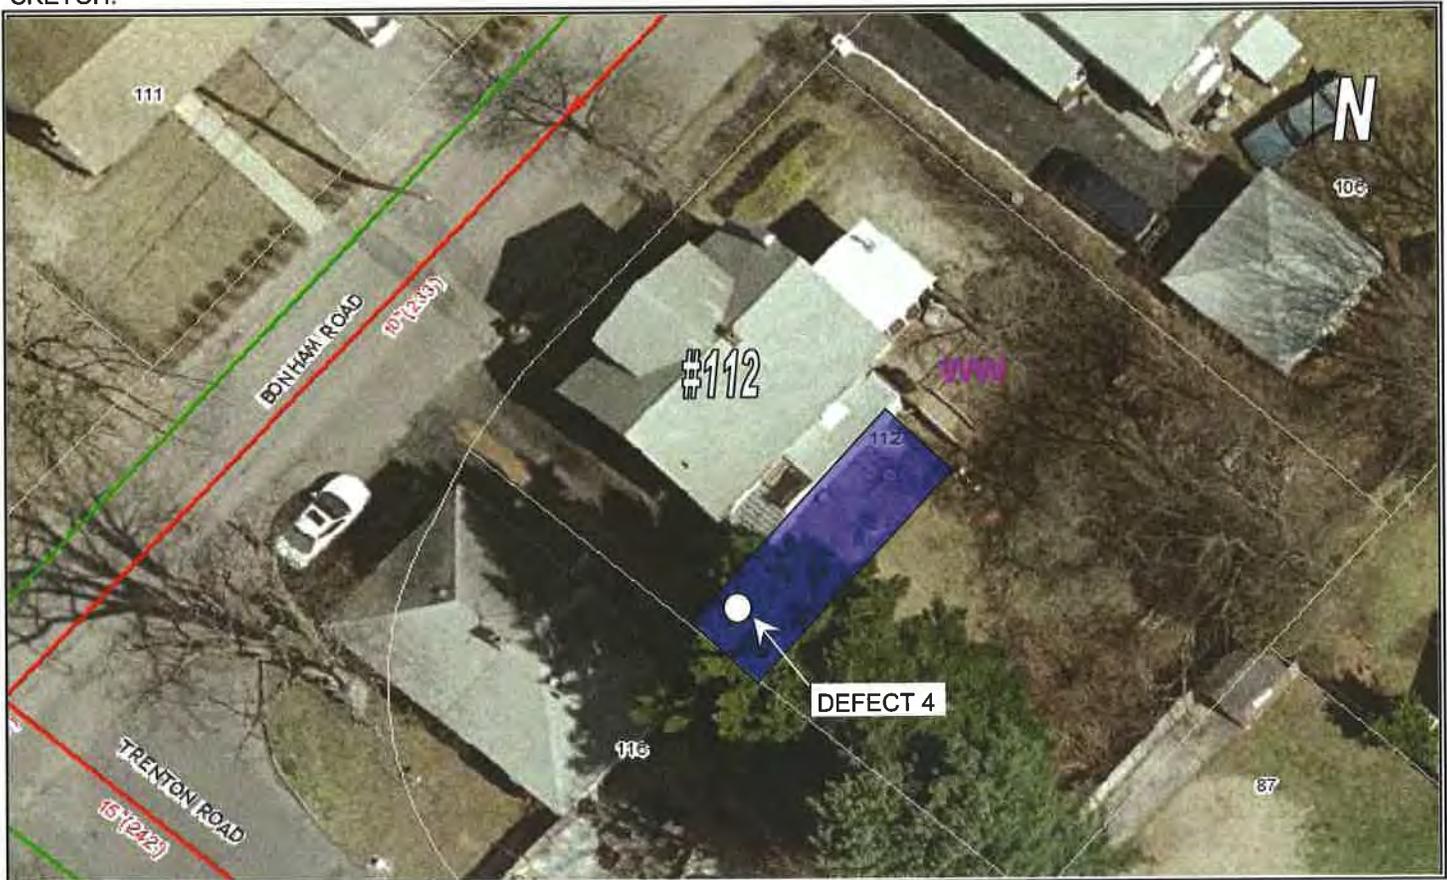
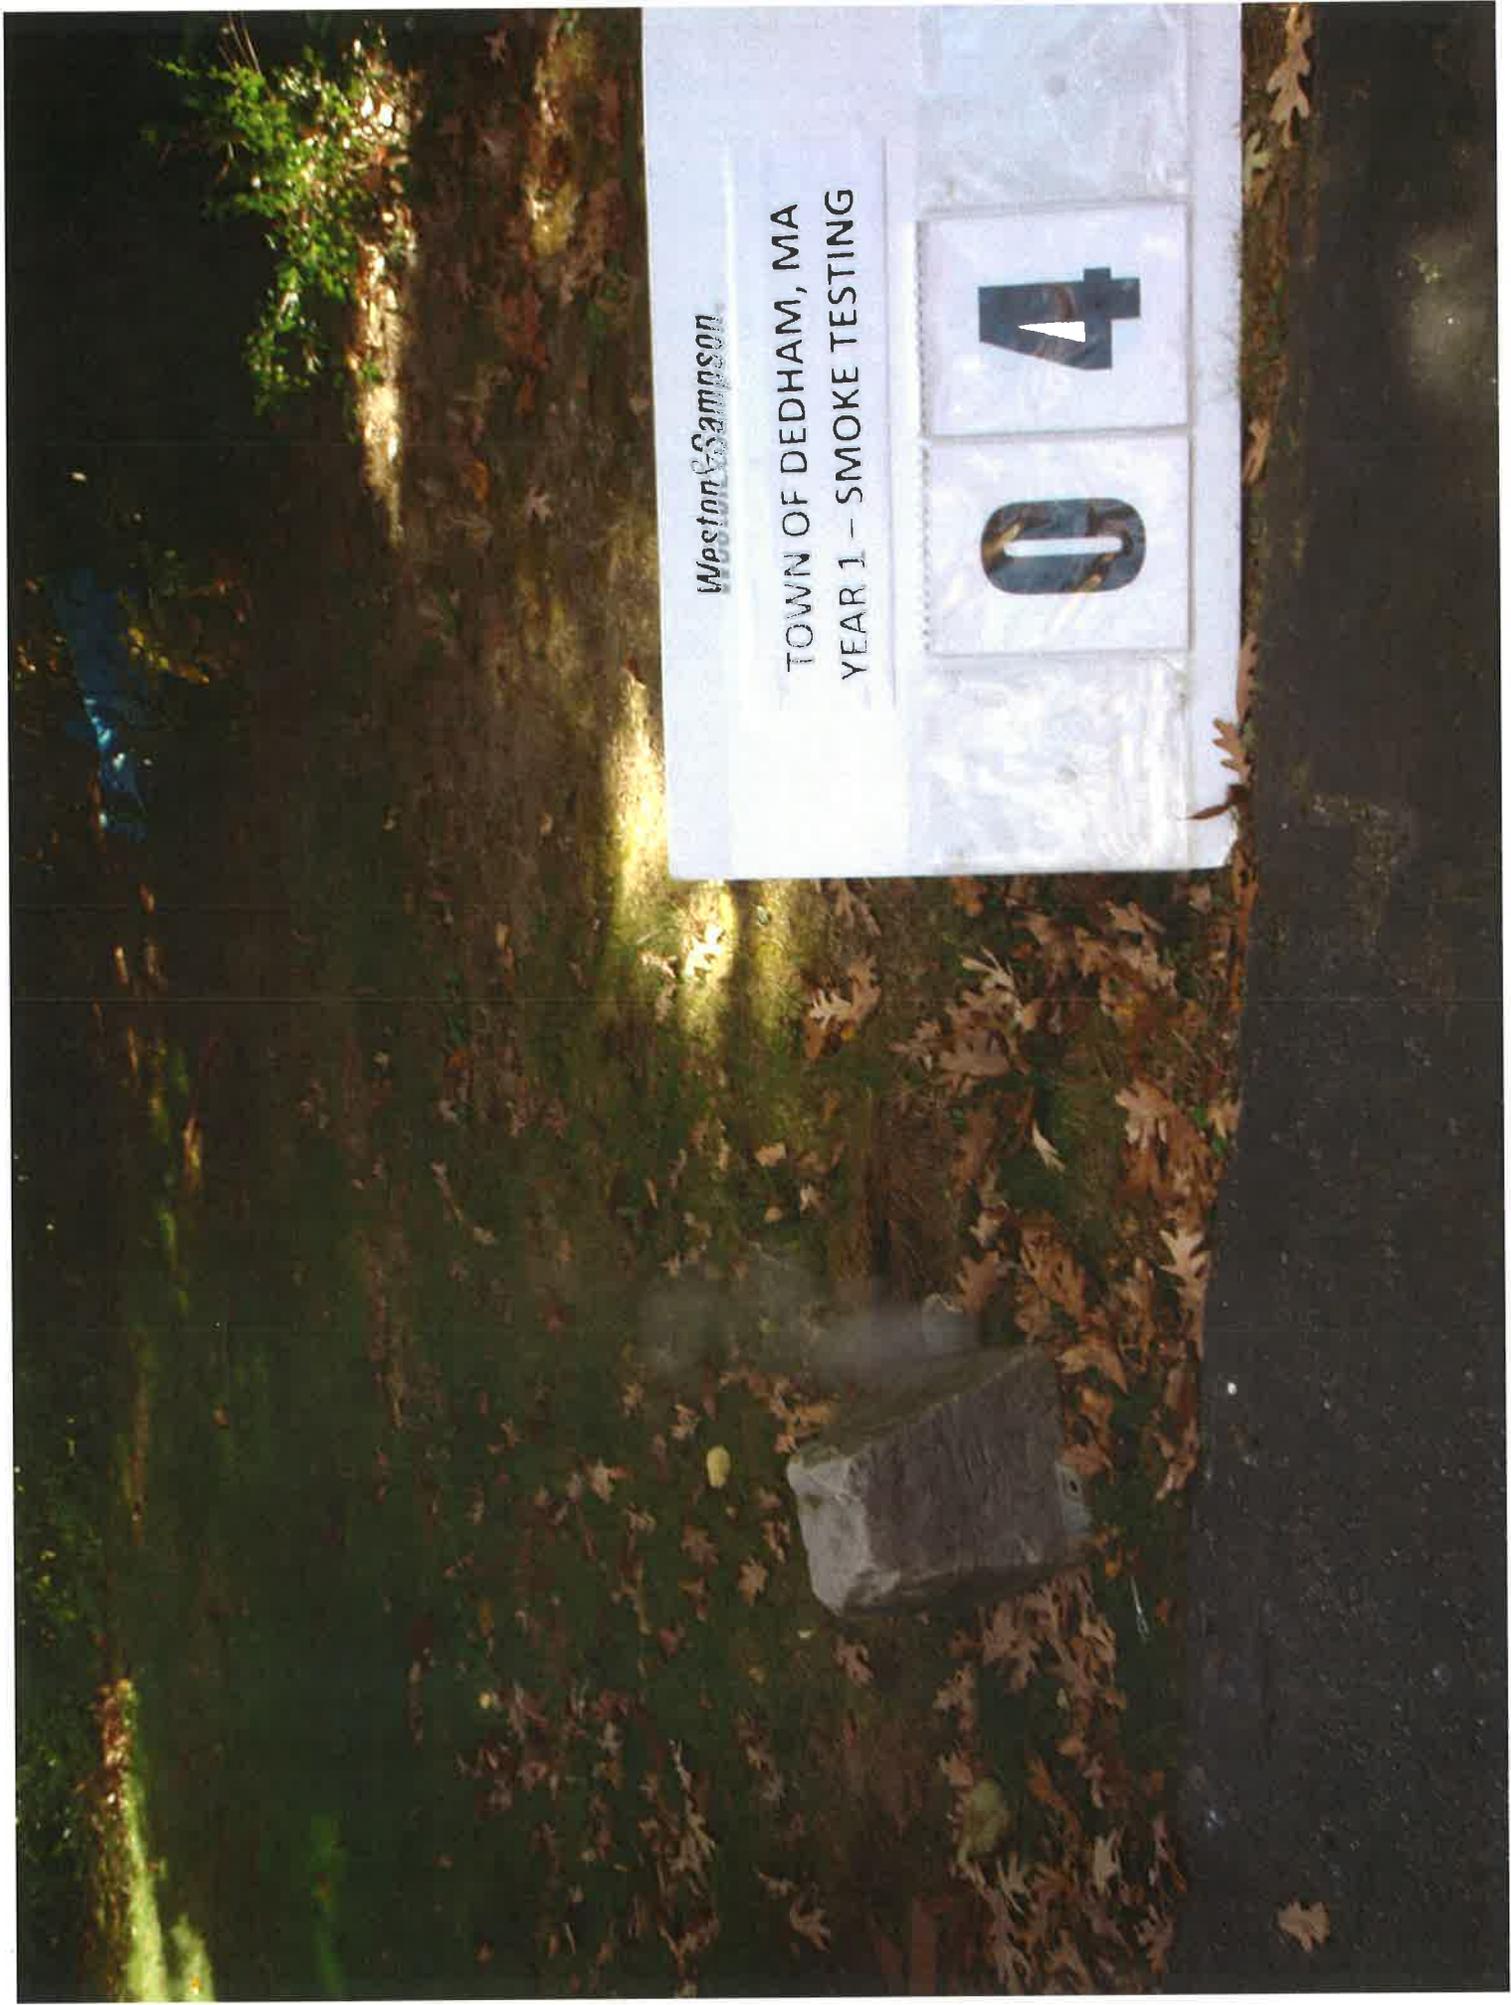
DEFECT: 4 thru 4

DEFECT	DESCRIPTION	Drainage Area (ft <sup>2</sup> )	Surface Type	Severity			Picture No.(s)
				Major	Mod	Minor	
4	Open Cleanout (plastic rock cover) (at grade)	300	Grass			x	37 - 39
