# **Report**

## **Town of Dedham, MA**

### **2012 Inflow Investigation**

February 2013

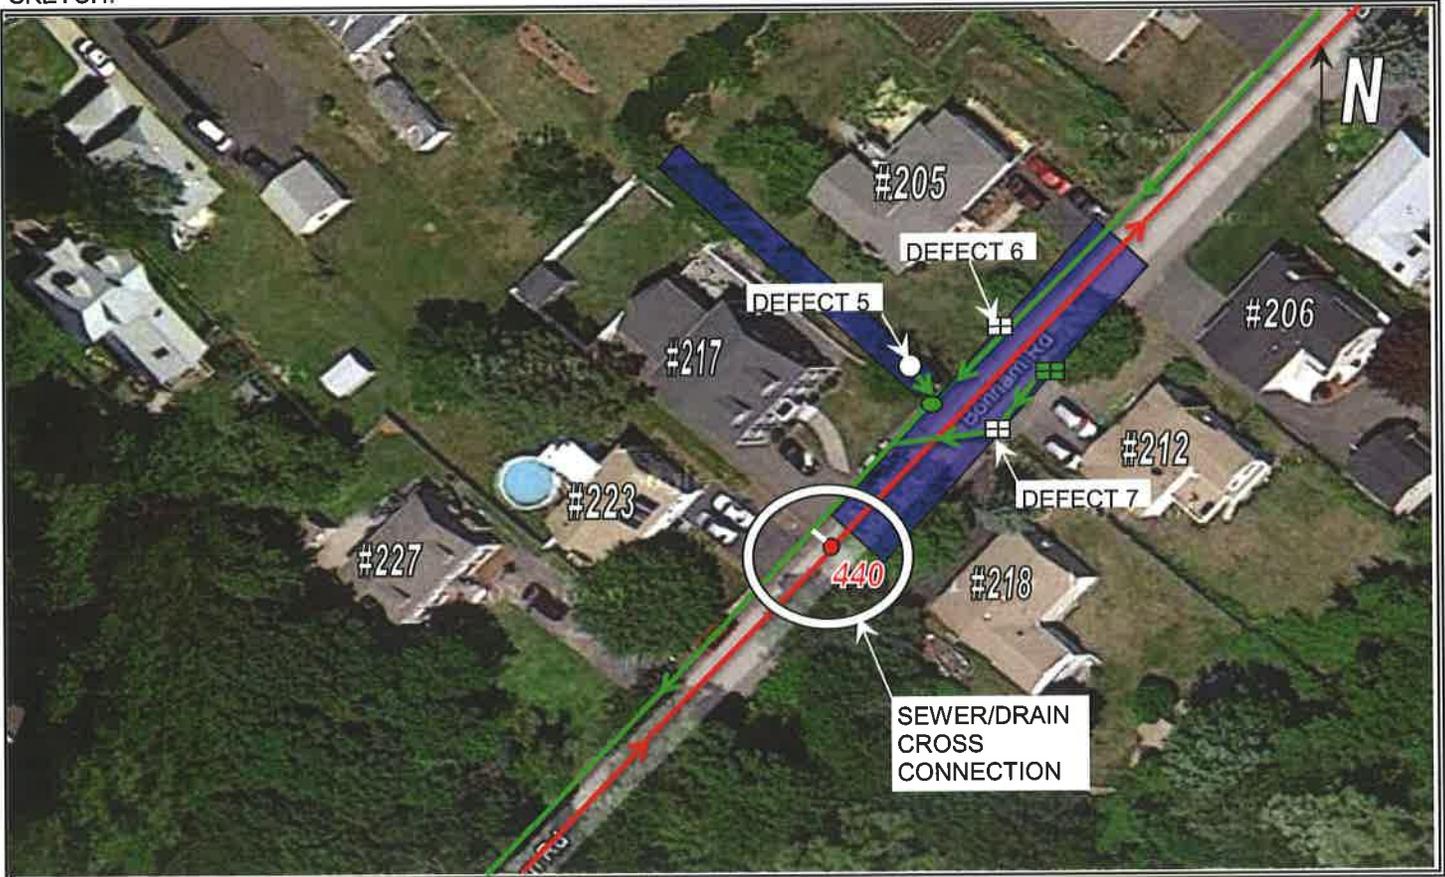
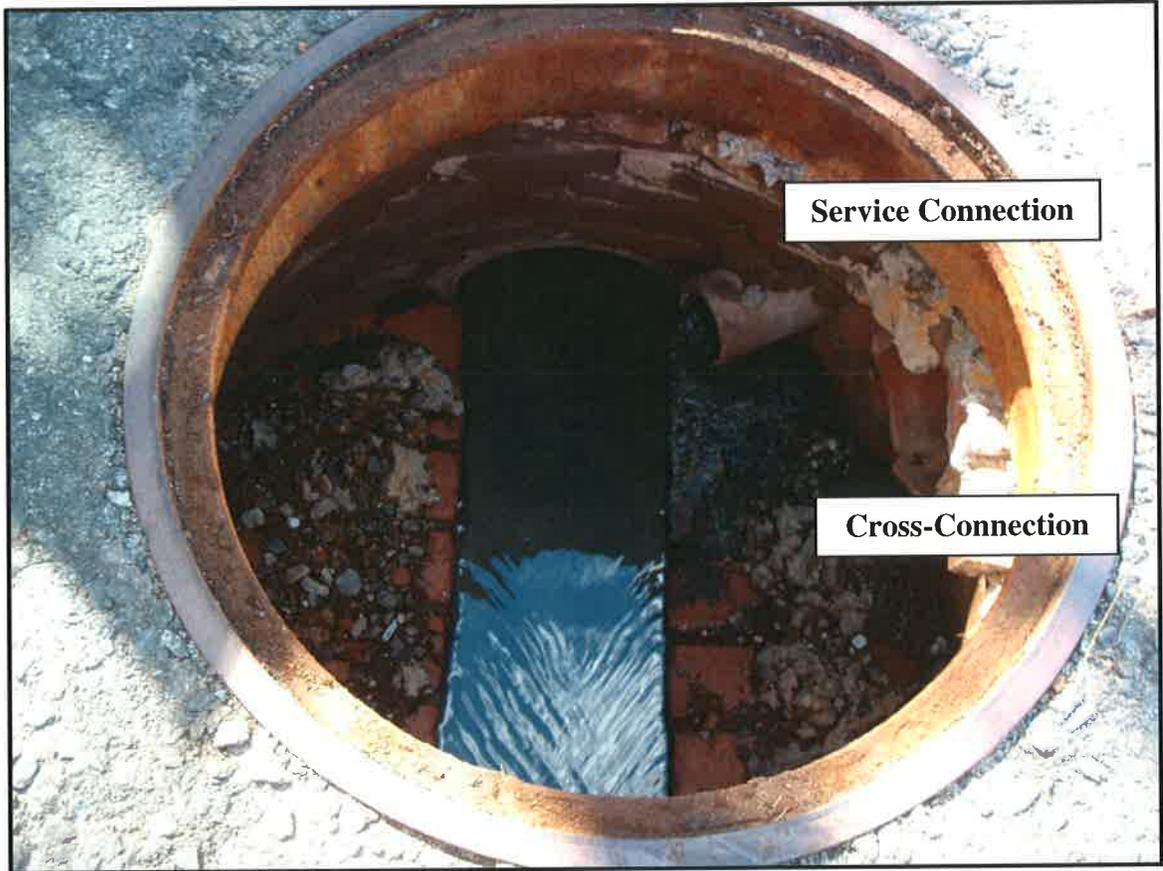
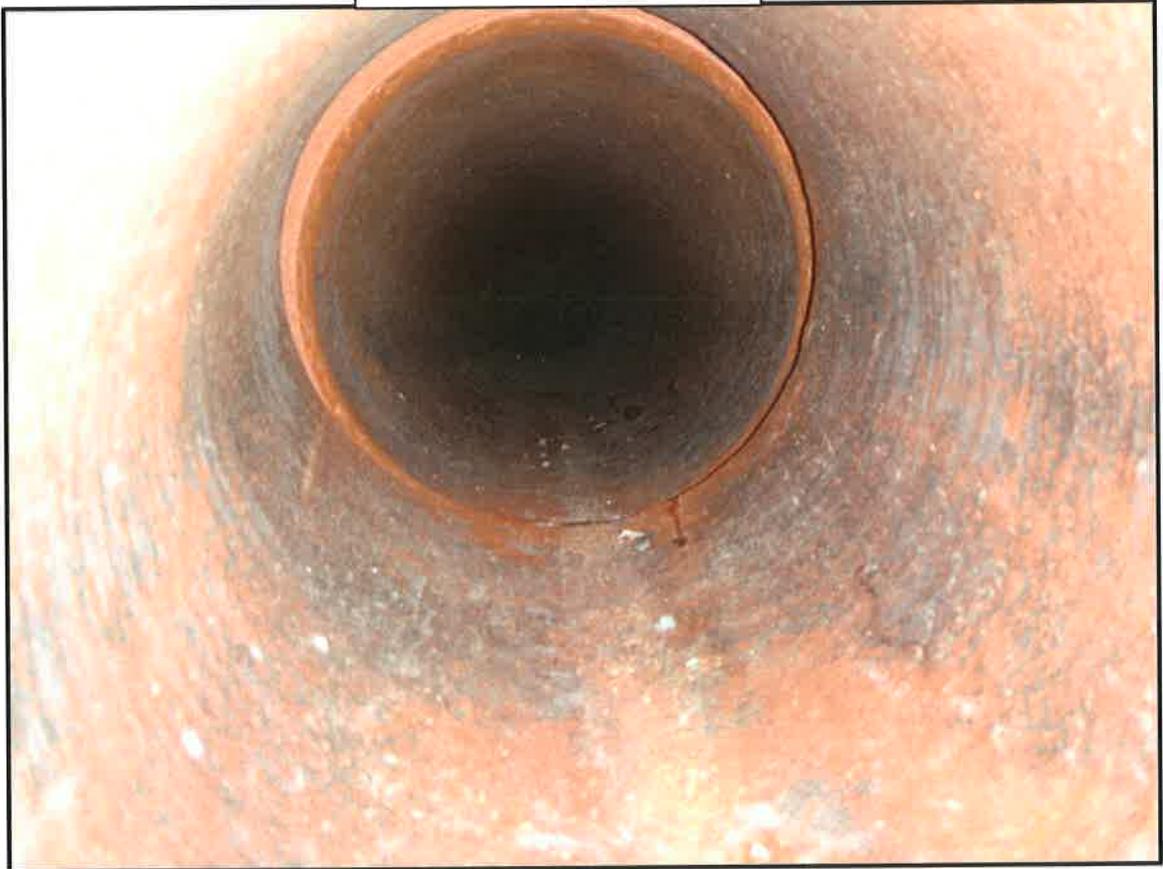
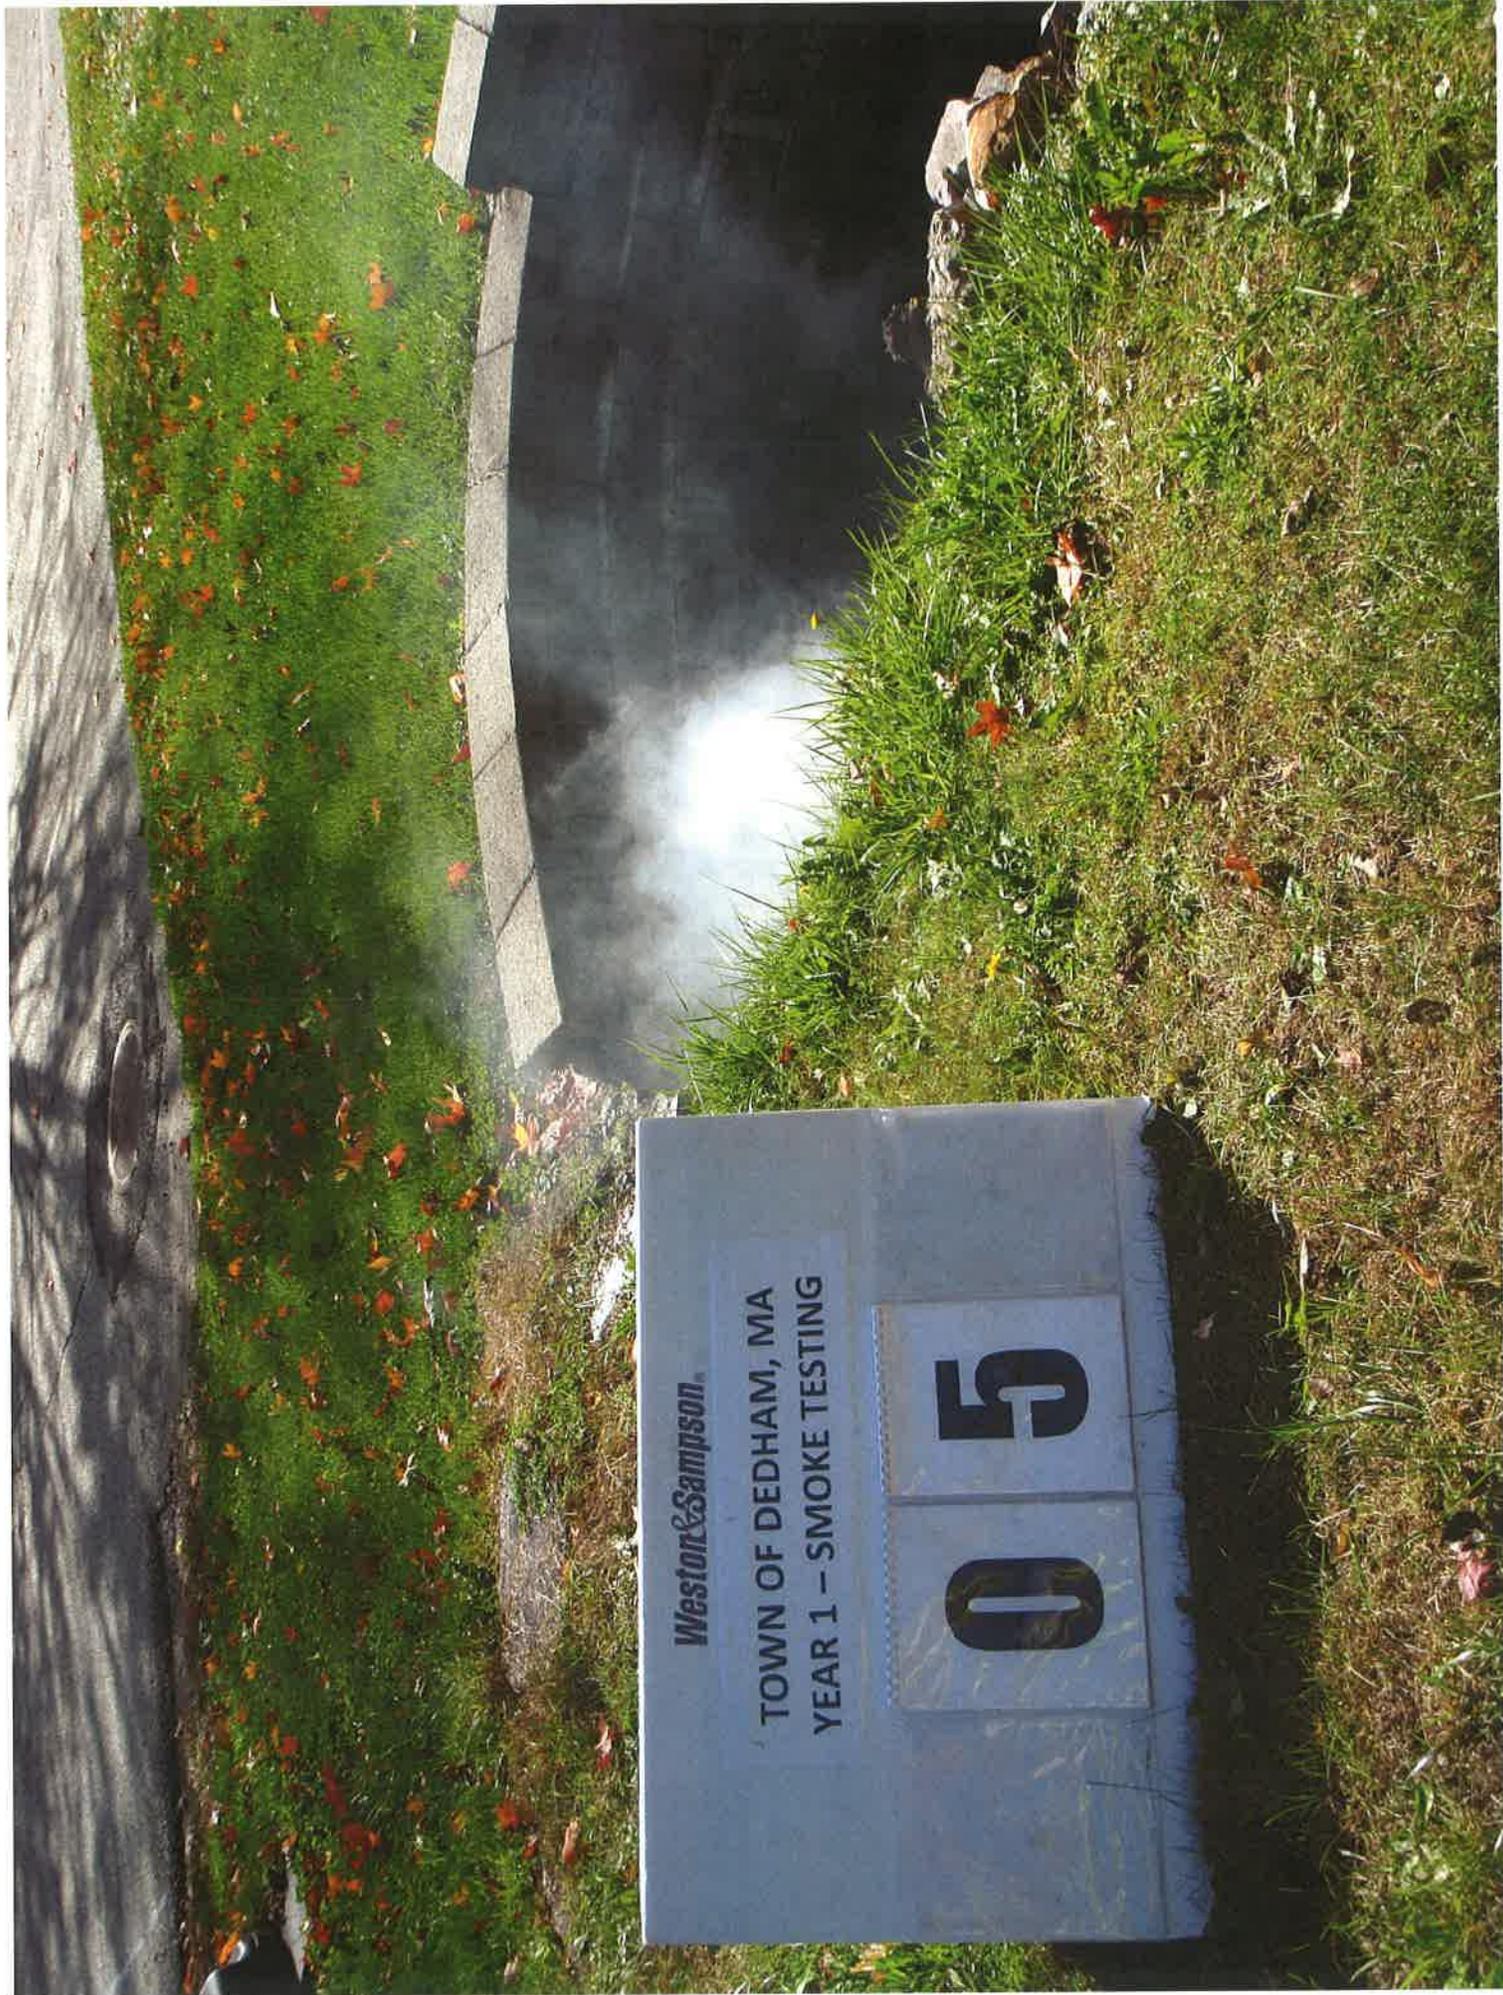
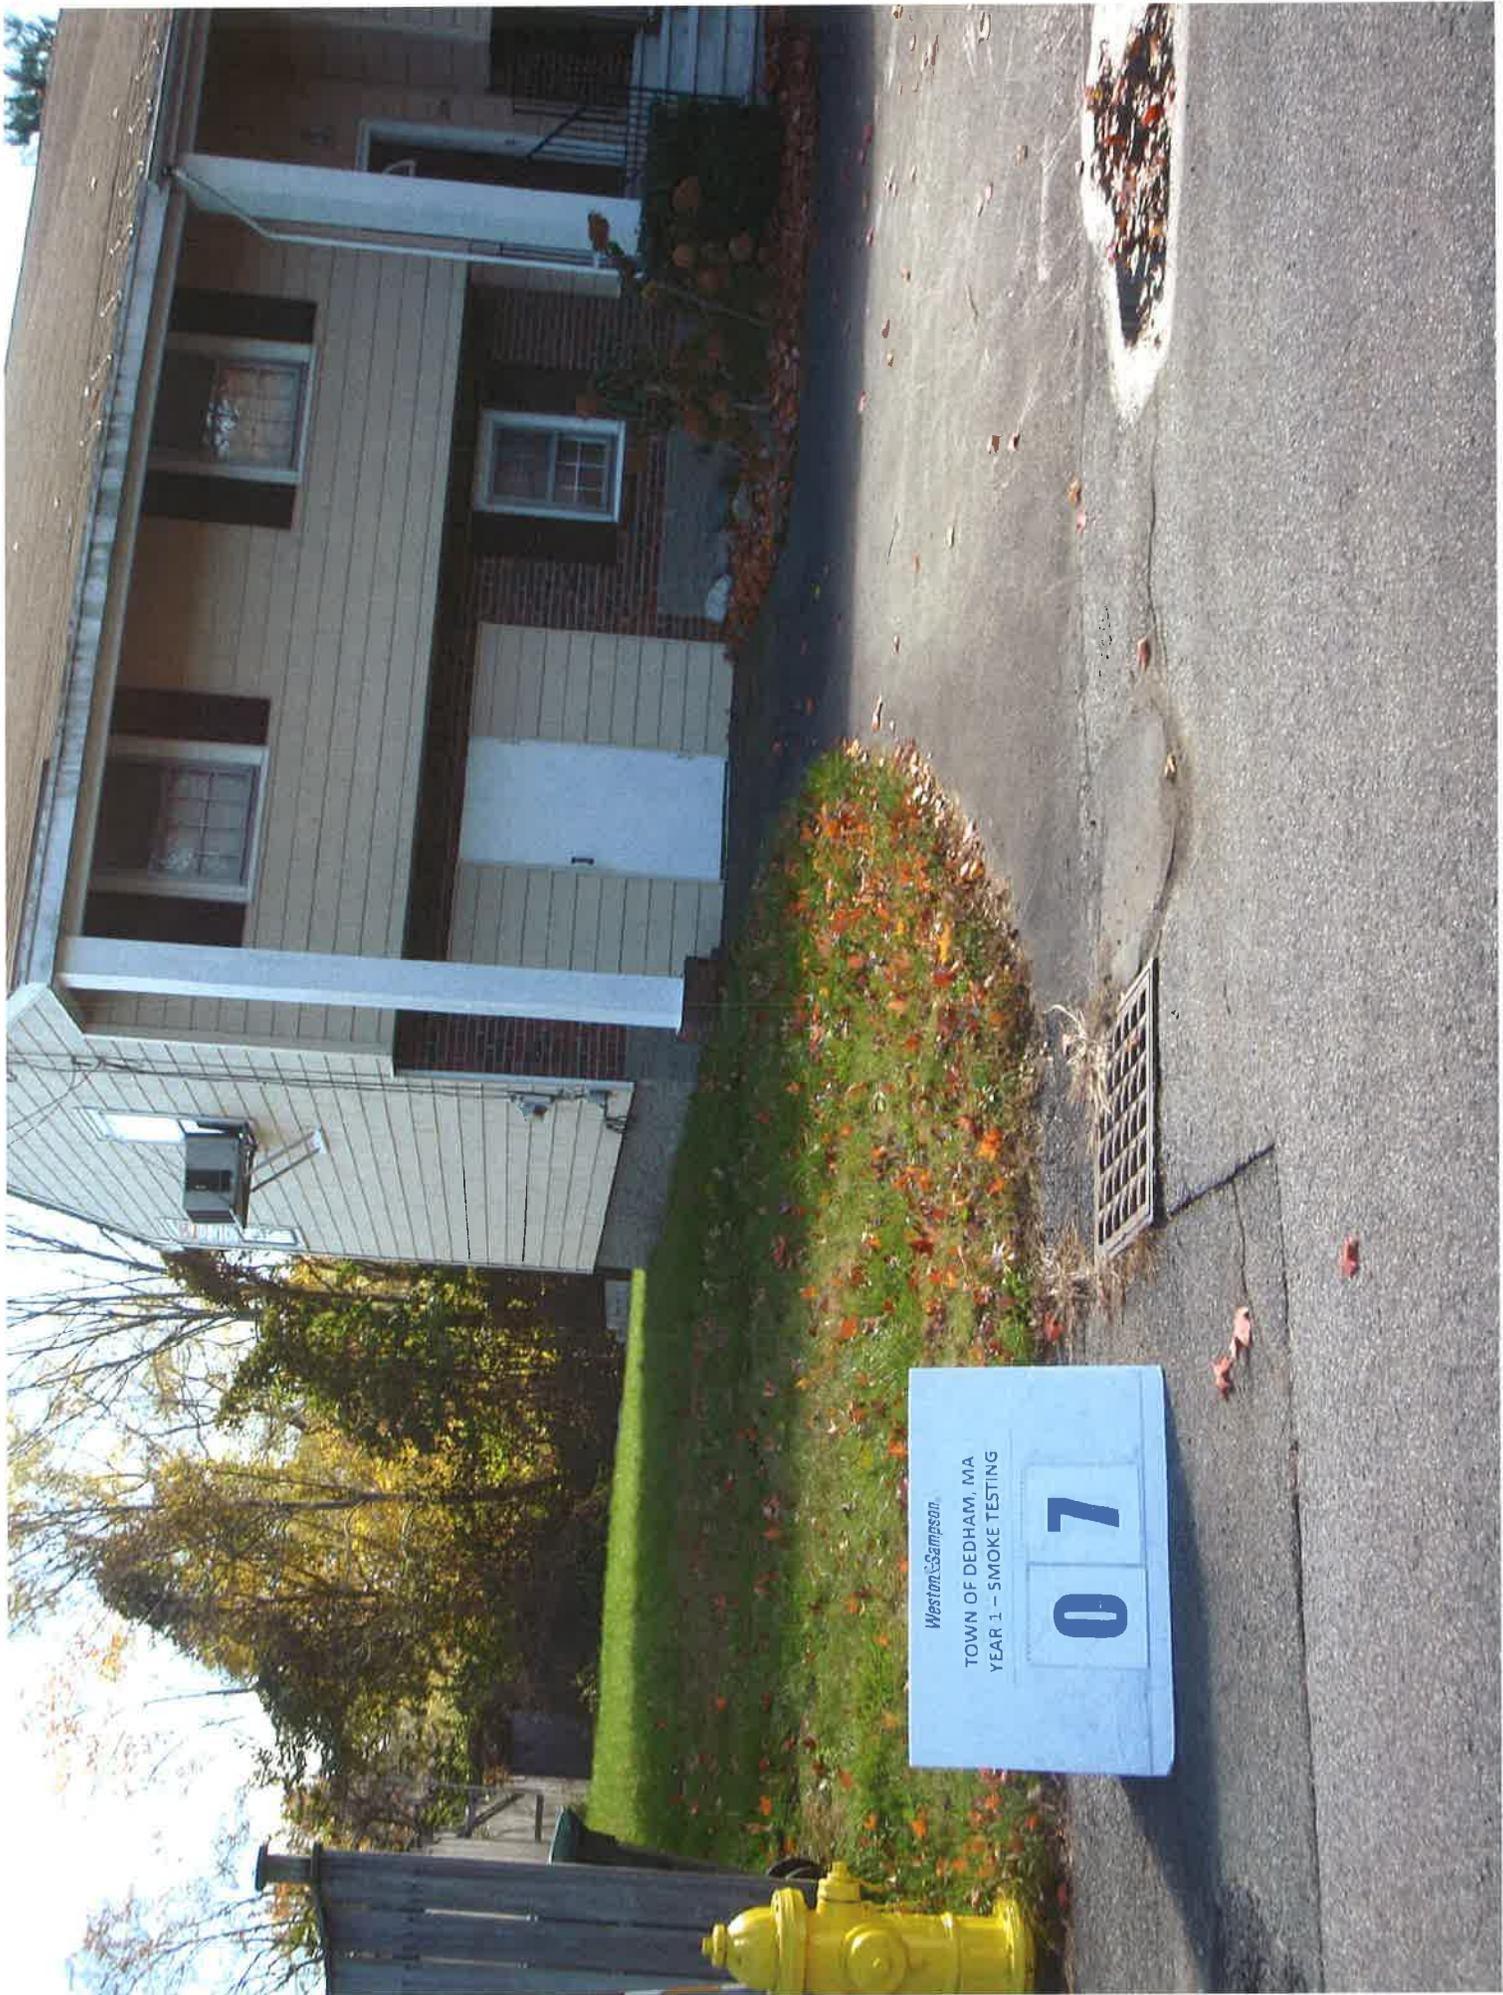
DEFECT: 5 thru 7

DEFECT	DESCRIPTION	Drainage Area (ft <sup>2</sup> )	Surface Type	Severity			Picture No.(s)
				Major	Mod	Minor	
5	Light Smoke from Open Drain Pipe near house #217	690	Gravel		x		40
6	Light Smoke from Catch Basin near house #205	2,148	Asphalt		x		42
7	Light Smoke from Catch Basin near house #212	2,148	Asphalt		x		46

**Service Connection**

**Cross-Connection**

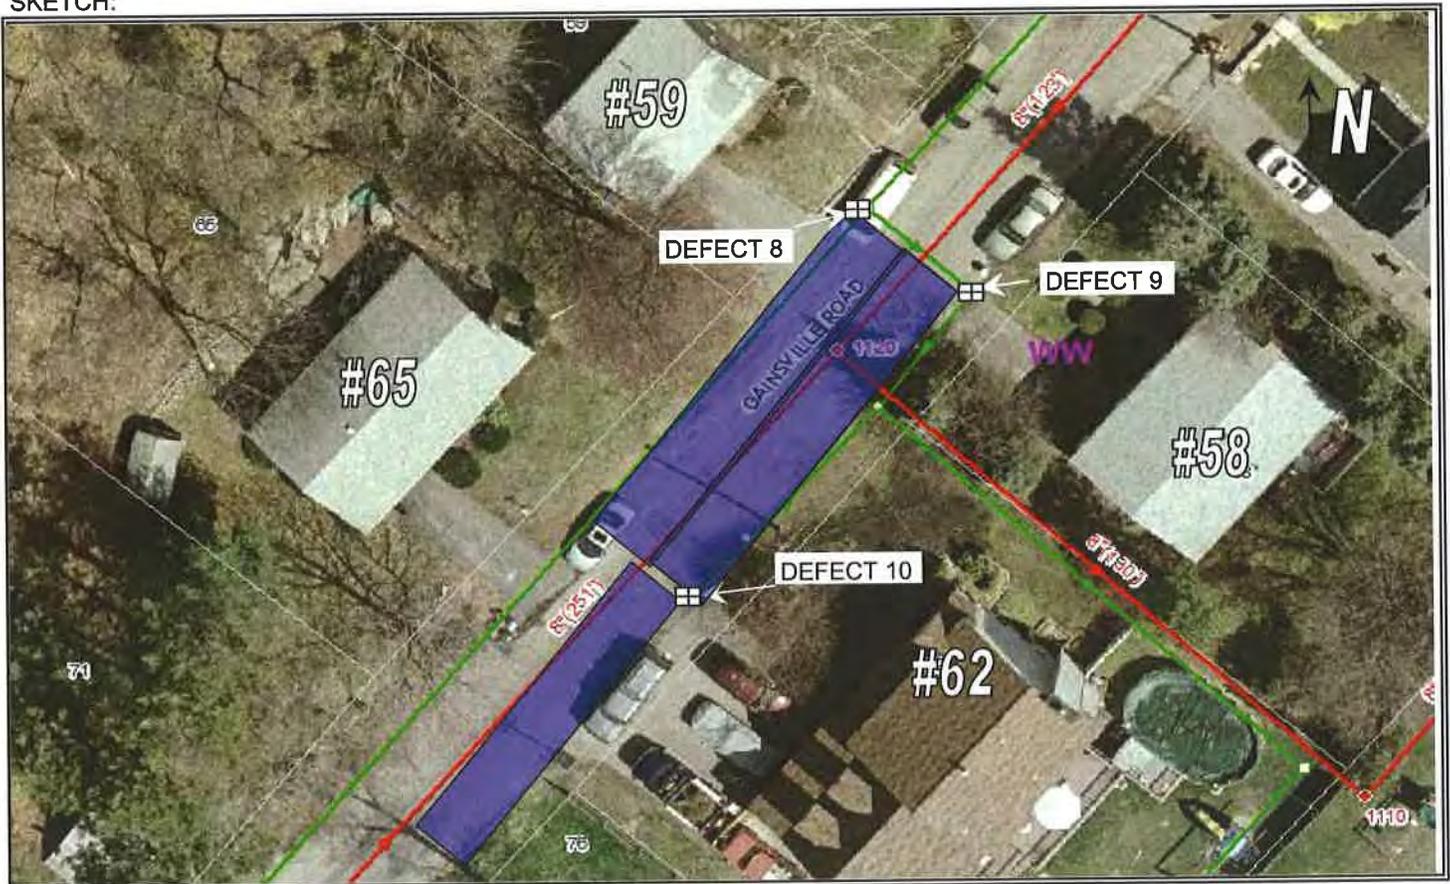
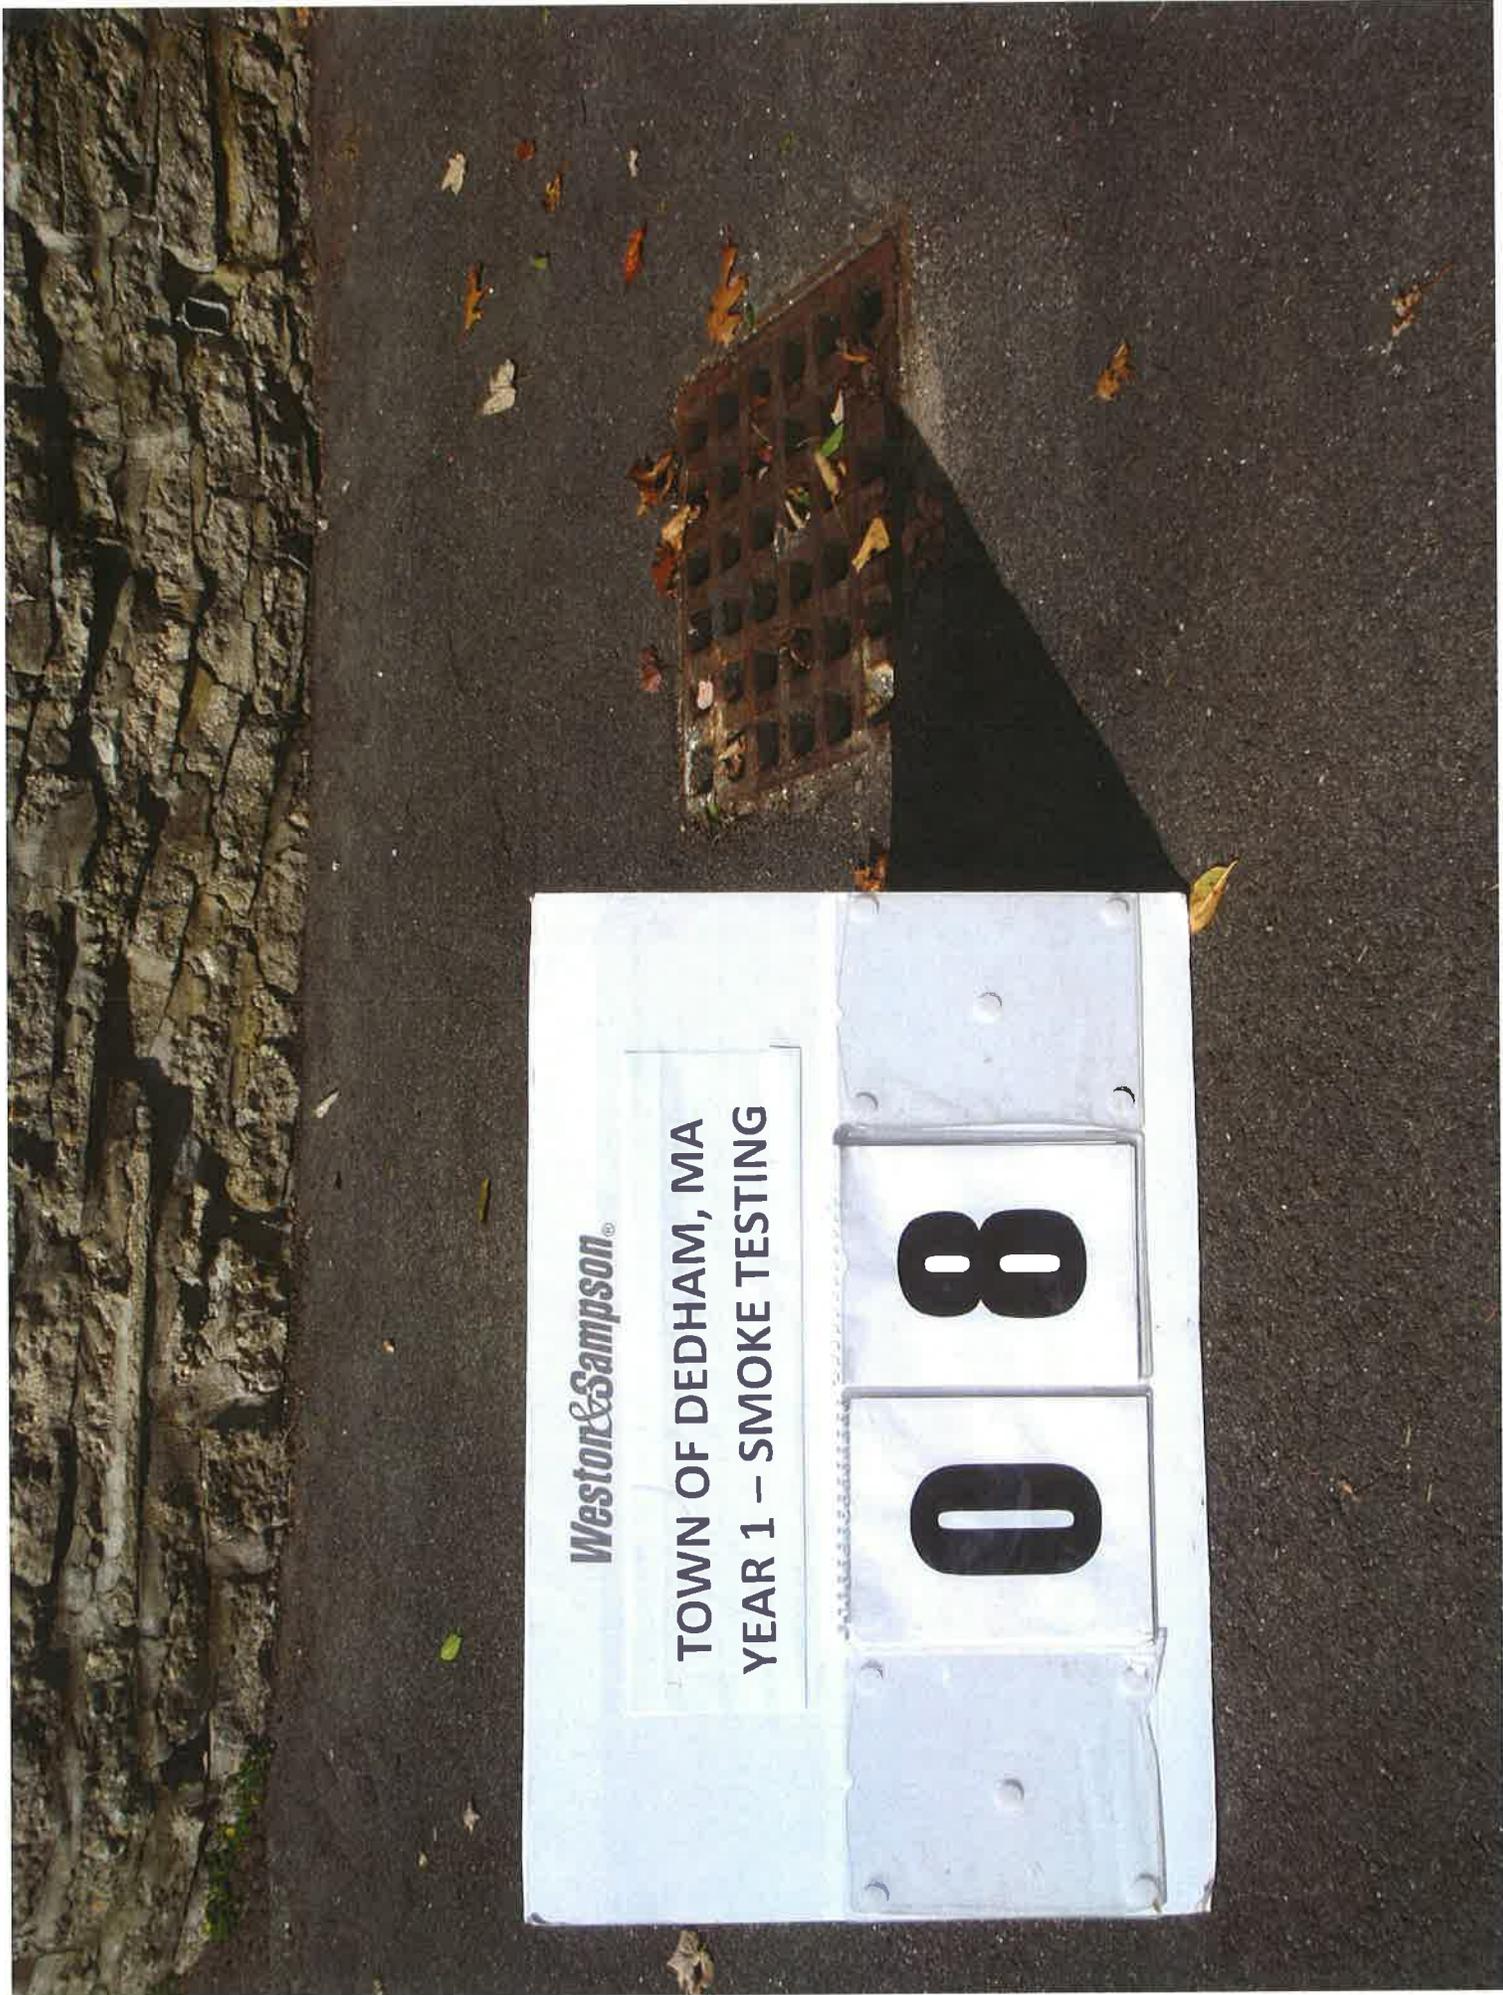
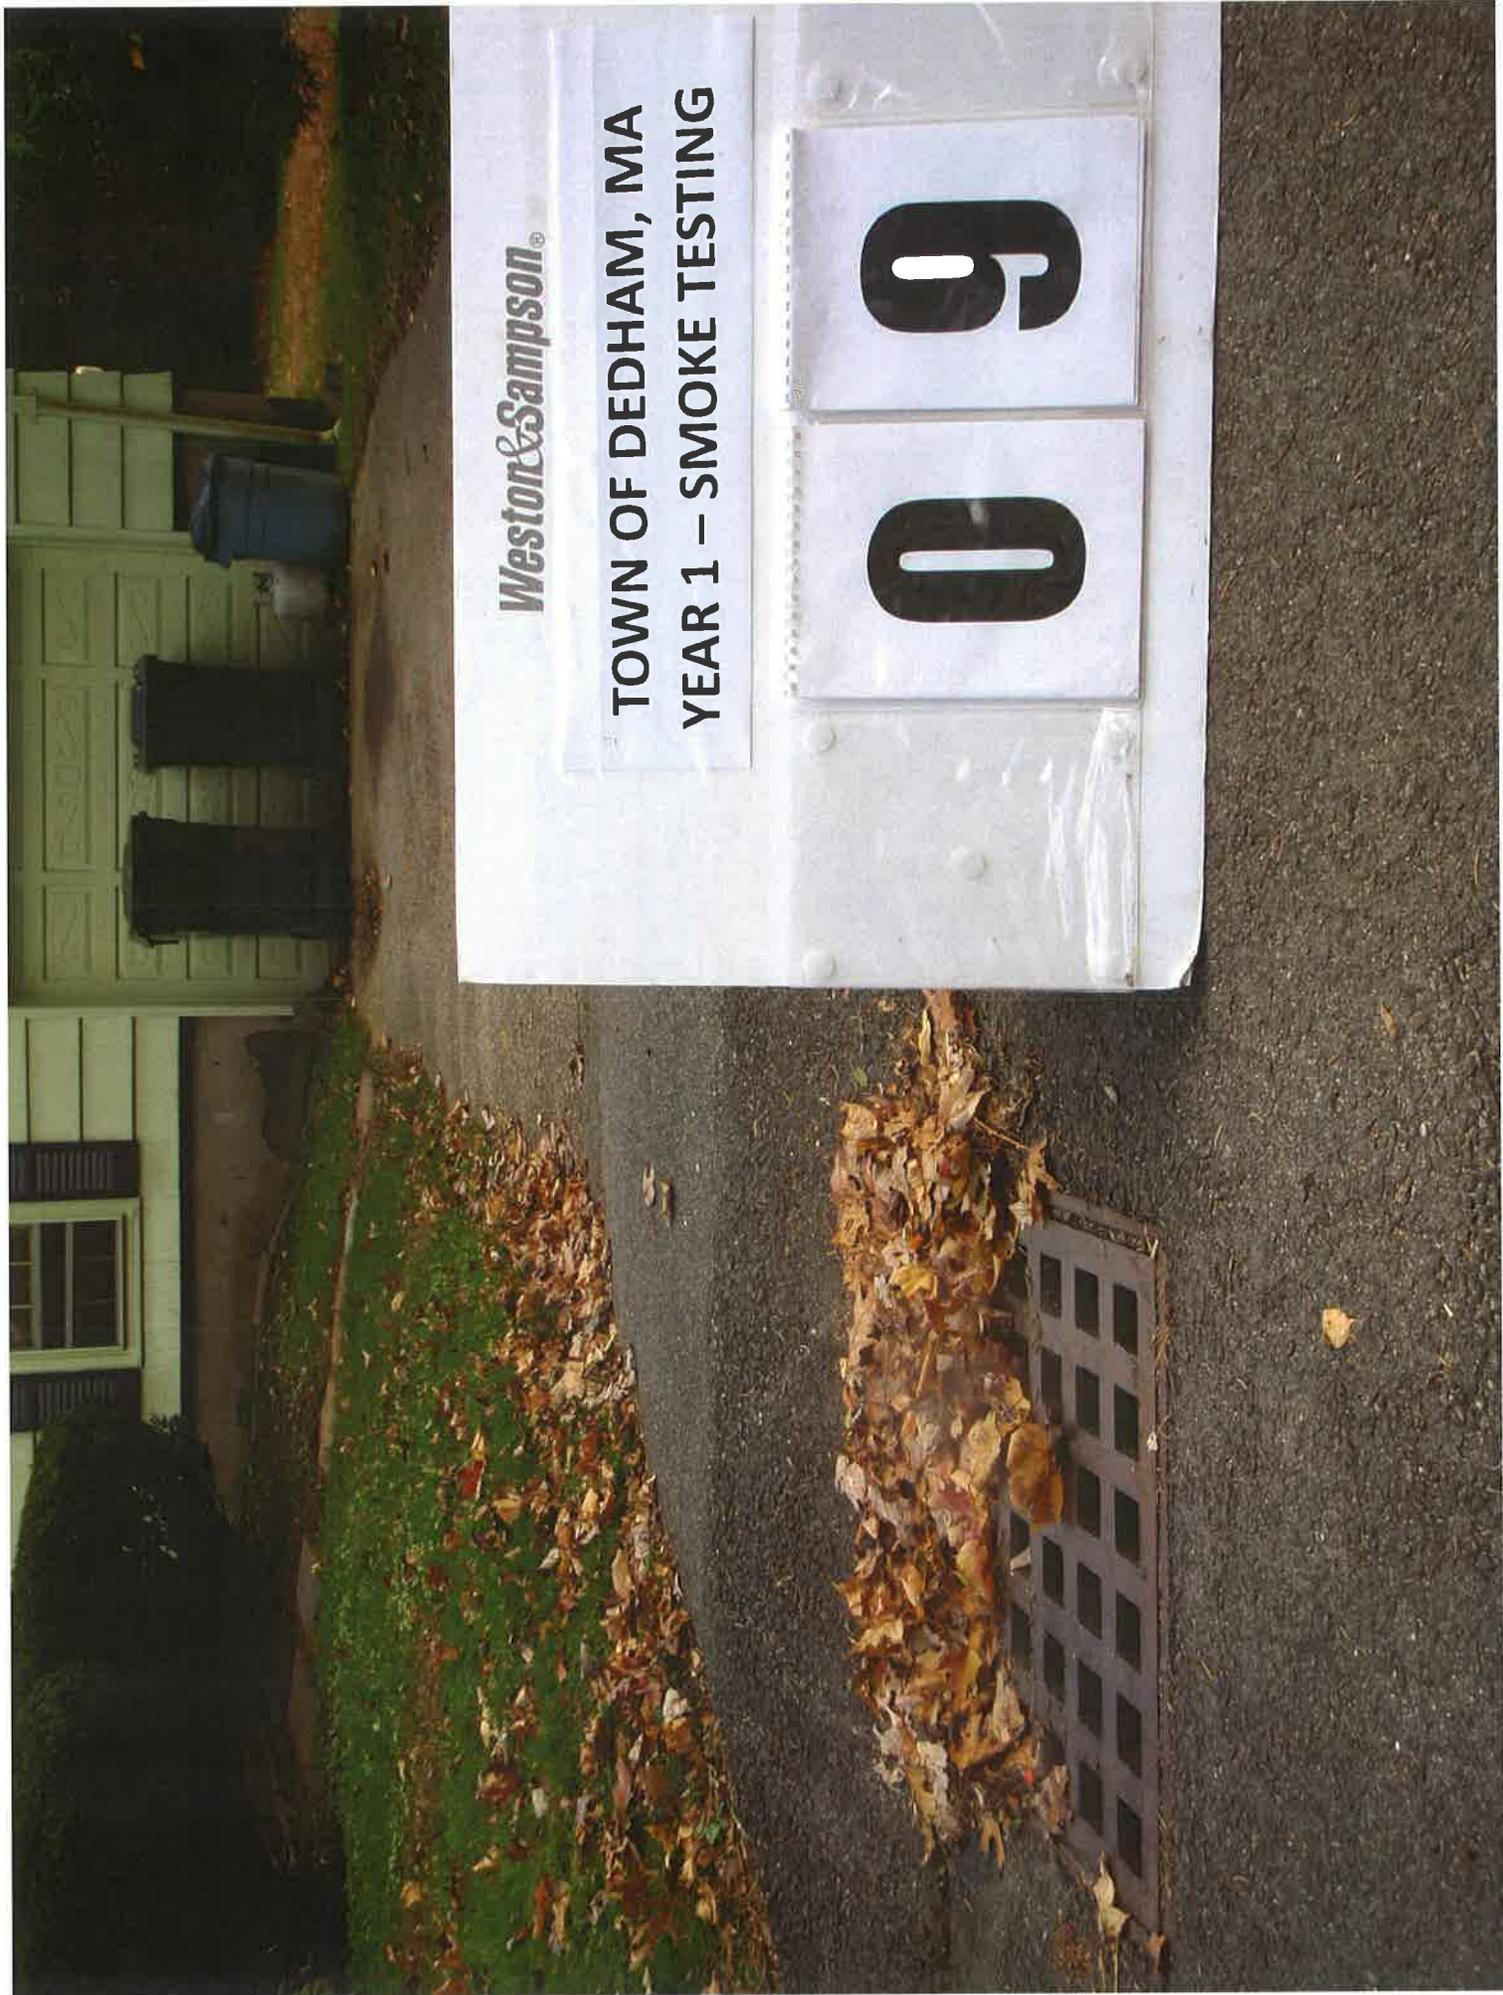
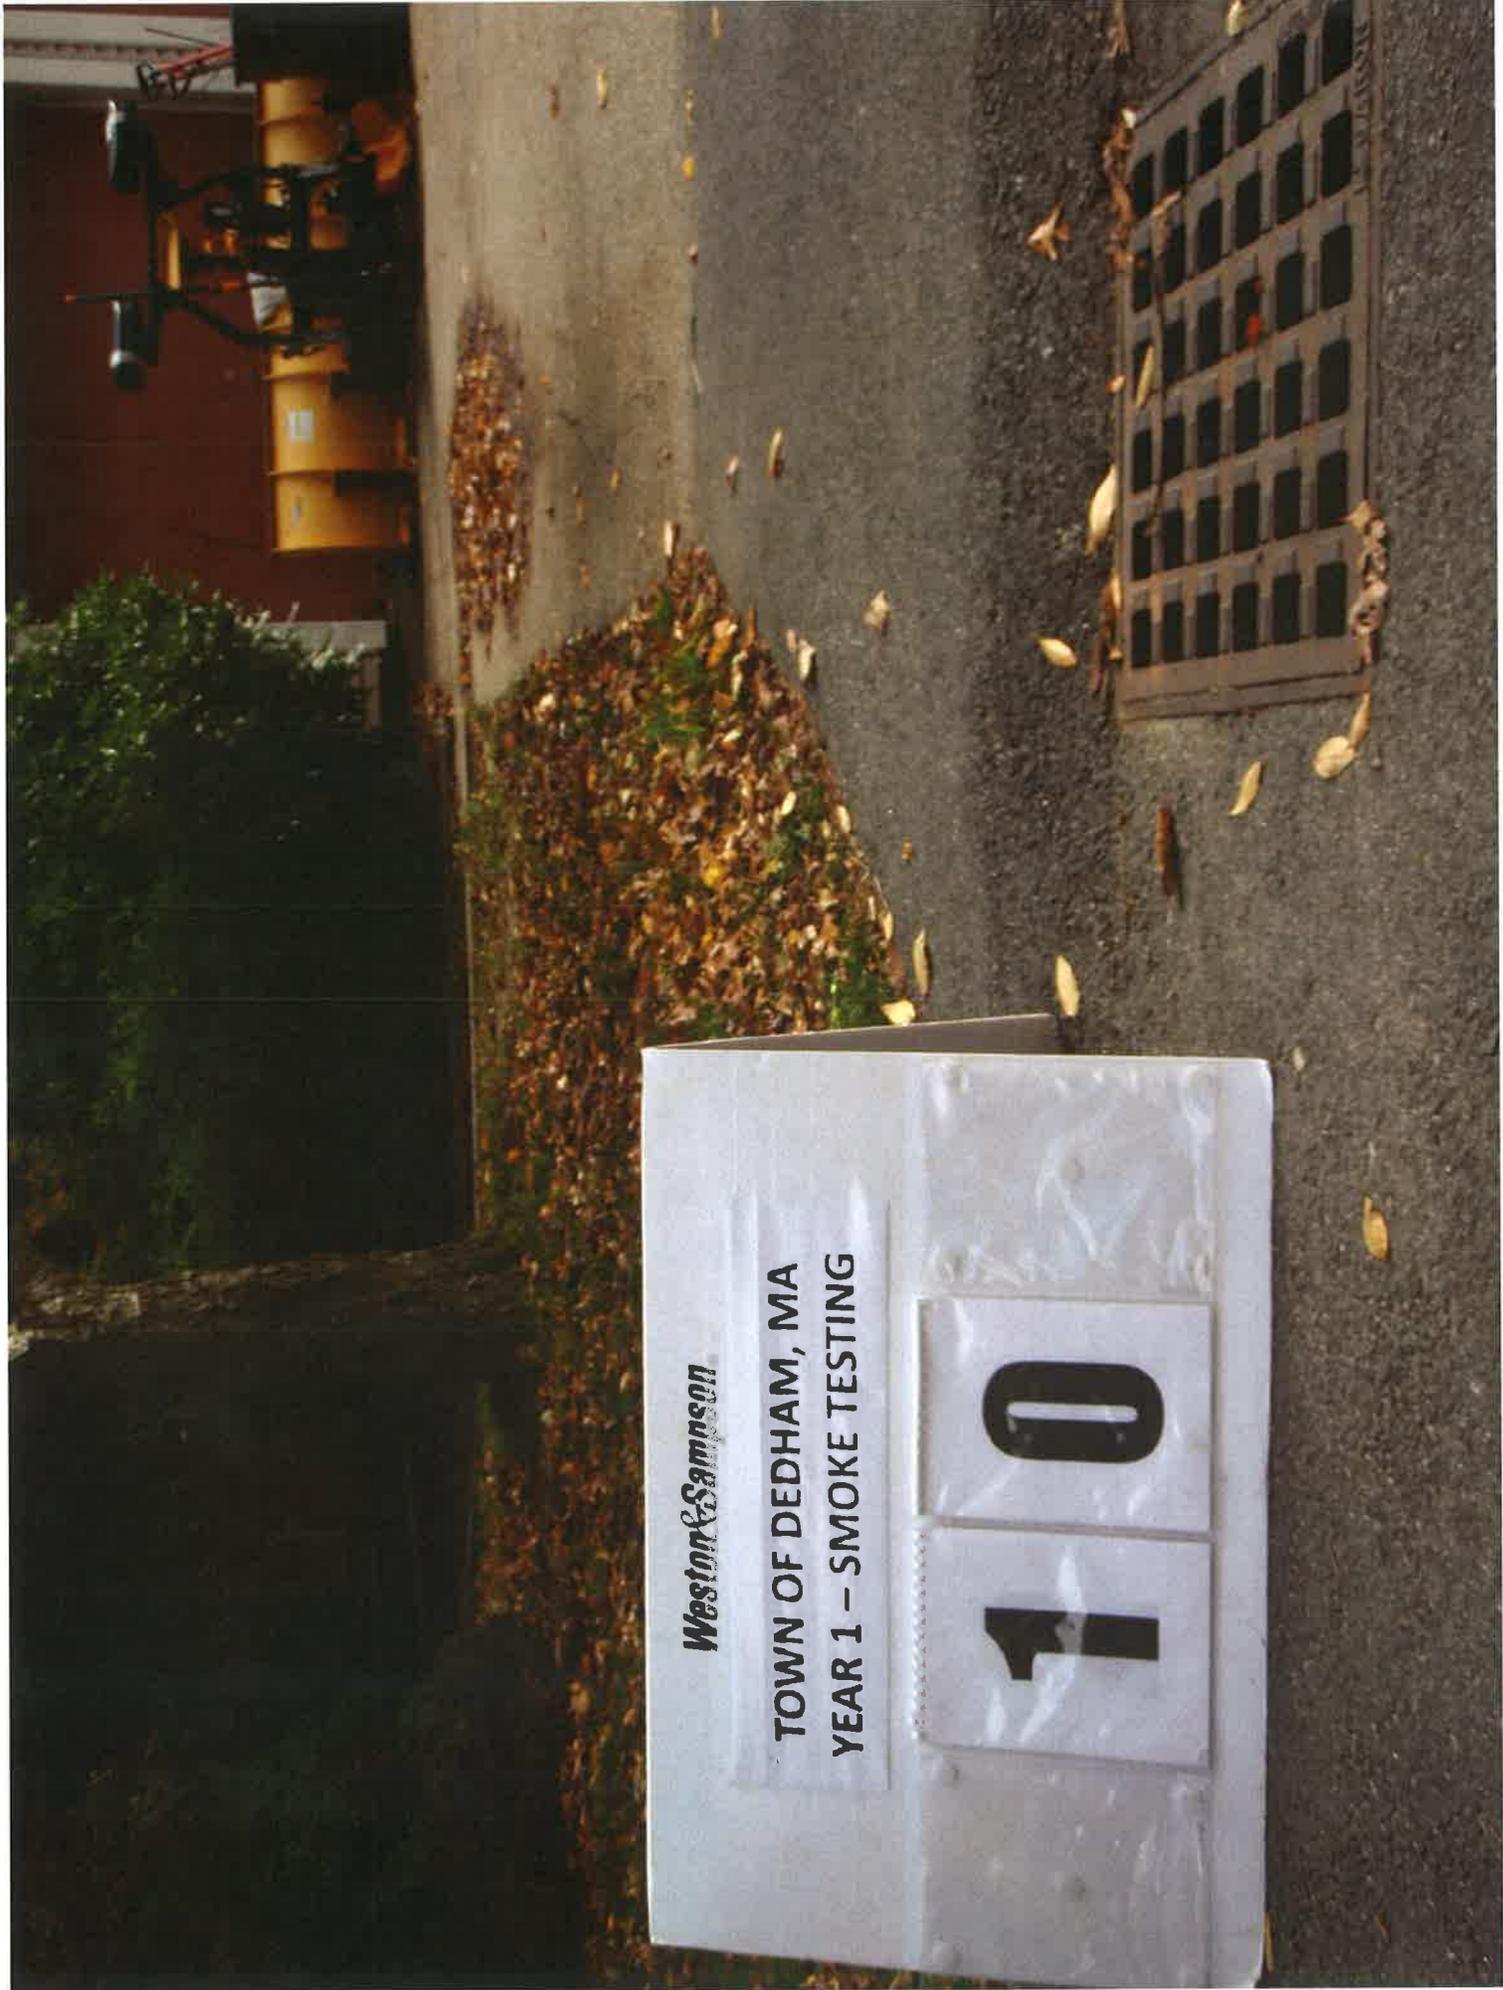
DEFECT: 8 thru 10

DEFECT	DESCRIPTION	Drainage Area (ft <sup>2</sup> )	Surface Type	Severity			Picture No.(s)
				Major	Mod	Minor	
8	Light Smoke from Catch Basin near house #59	936	Asphalt			x	57
9	Light Smoke from Catch Basin near house #58	936	Asphalt			x	58
10	Light Smoke from Catch Basin near house #62	936	Asphalt			x	59
