# **Report**

## **Town of Dedham, MA**

### **2012 Inflow Investigation**

February 2013

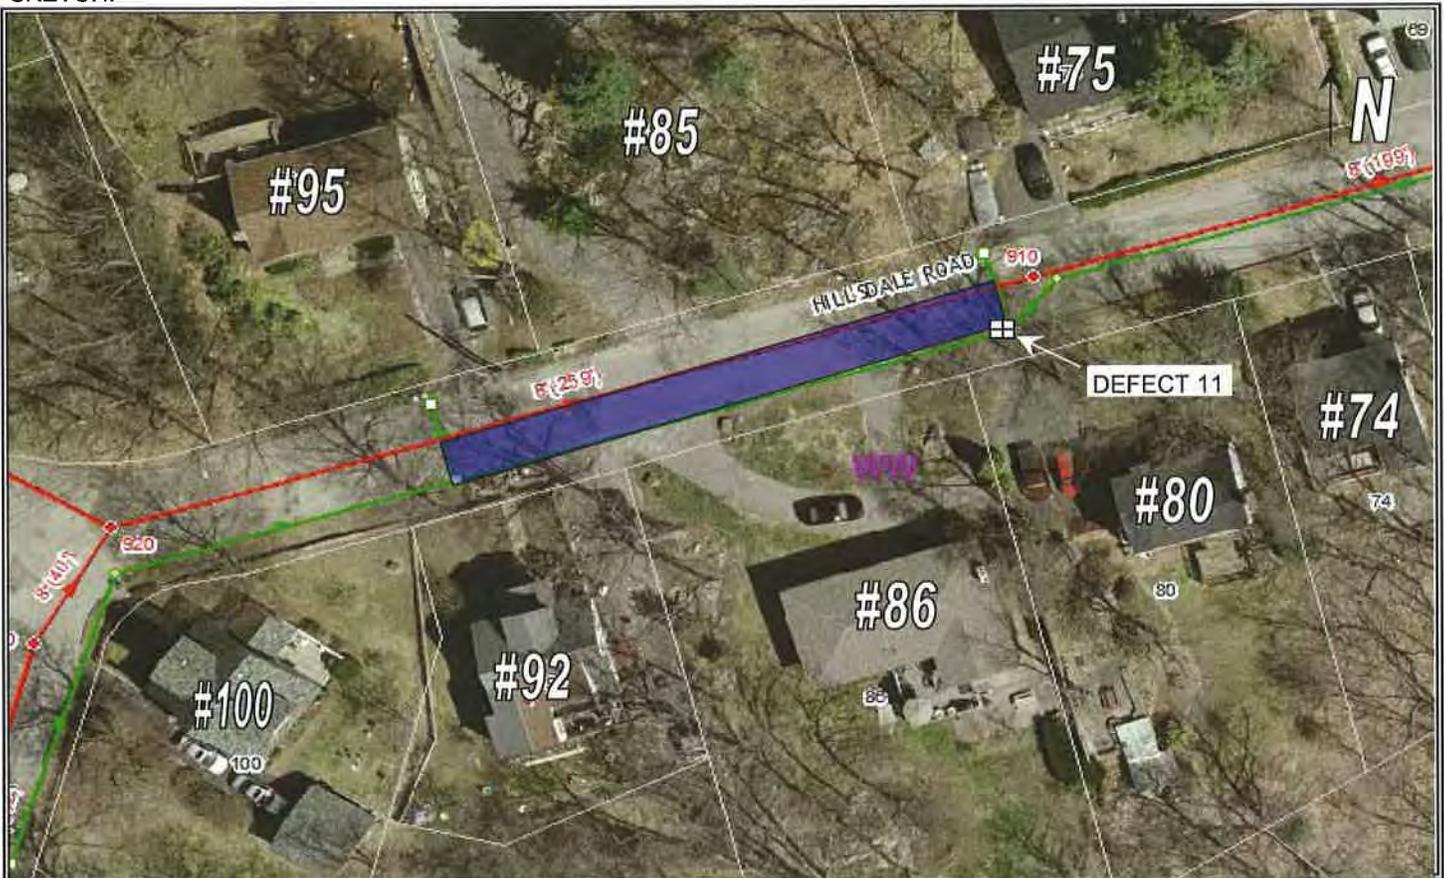
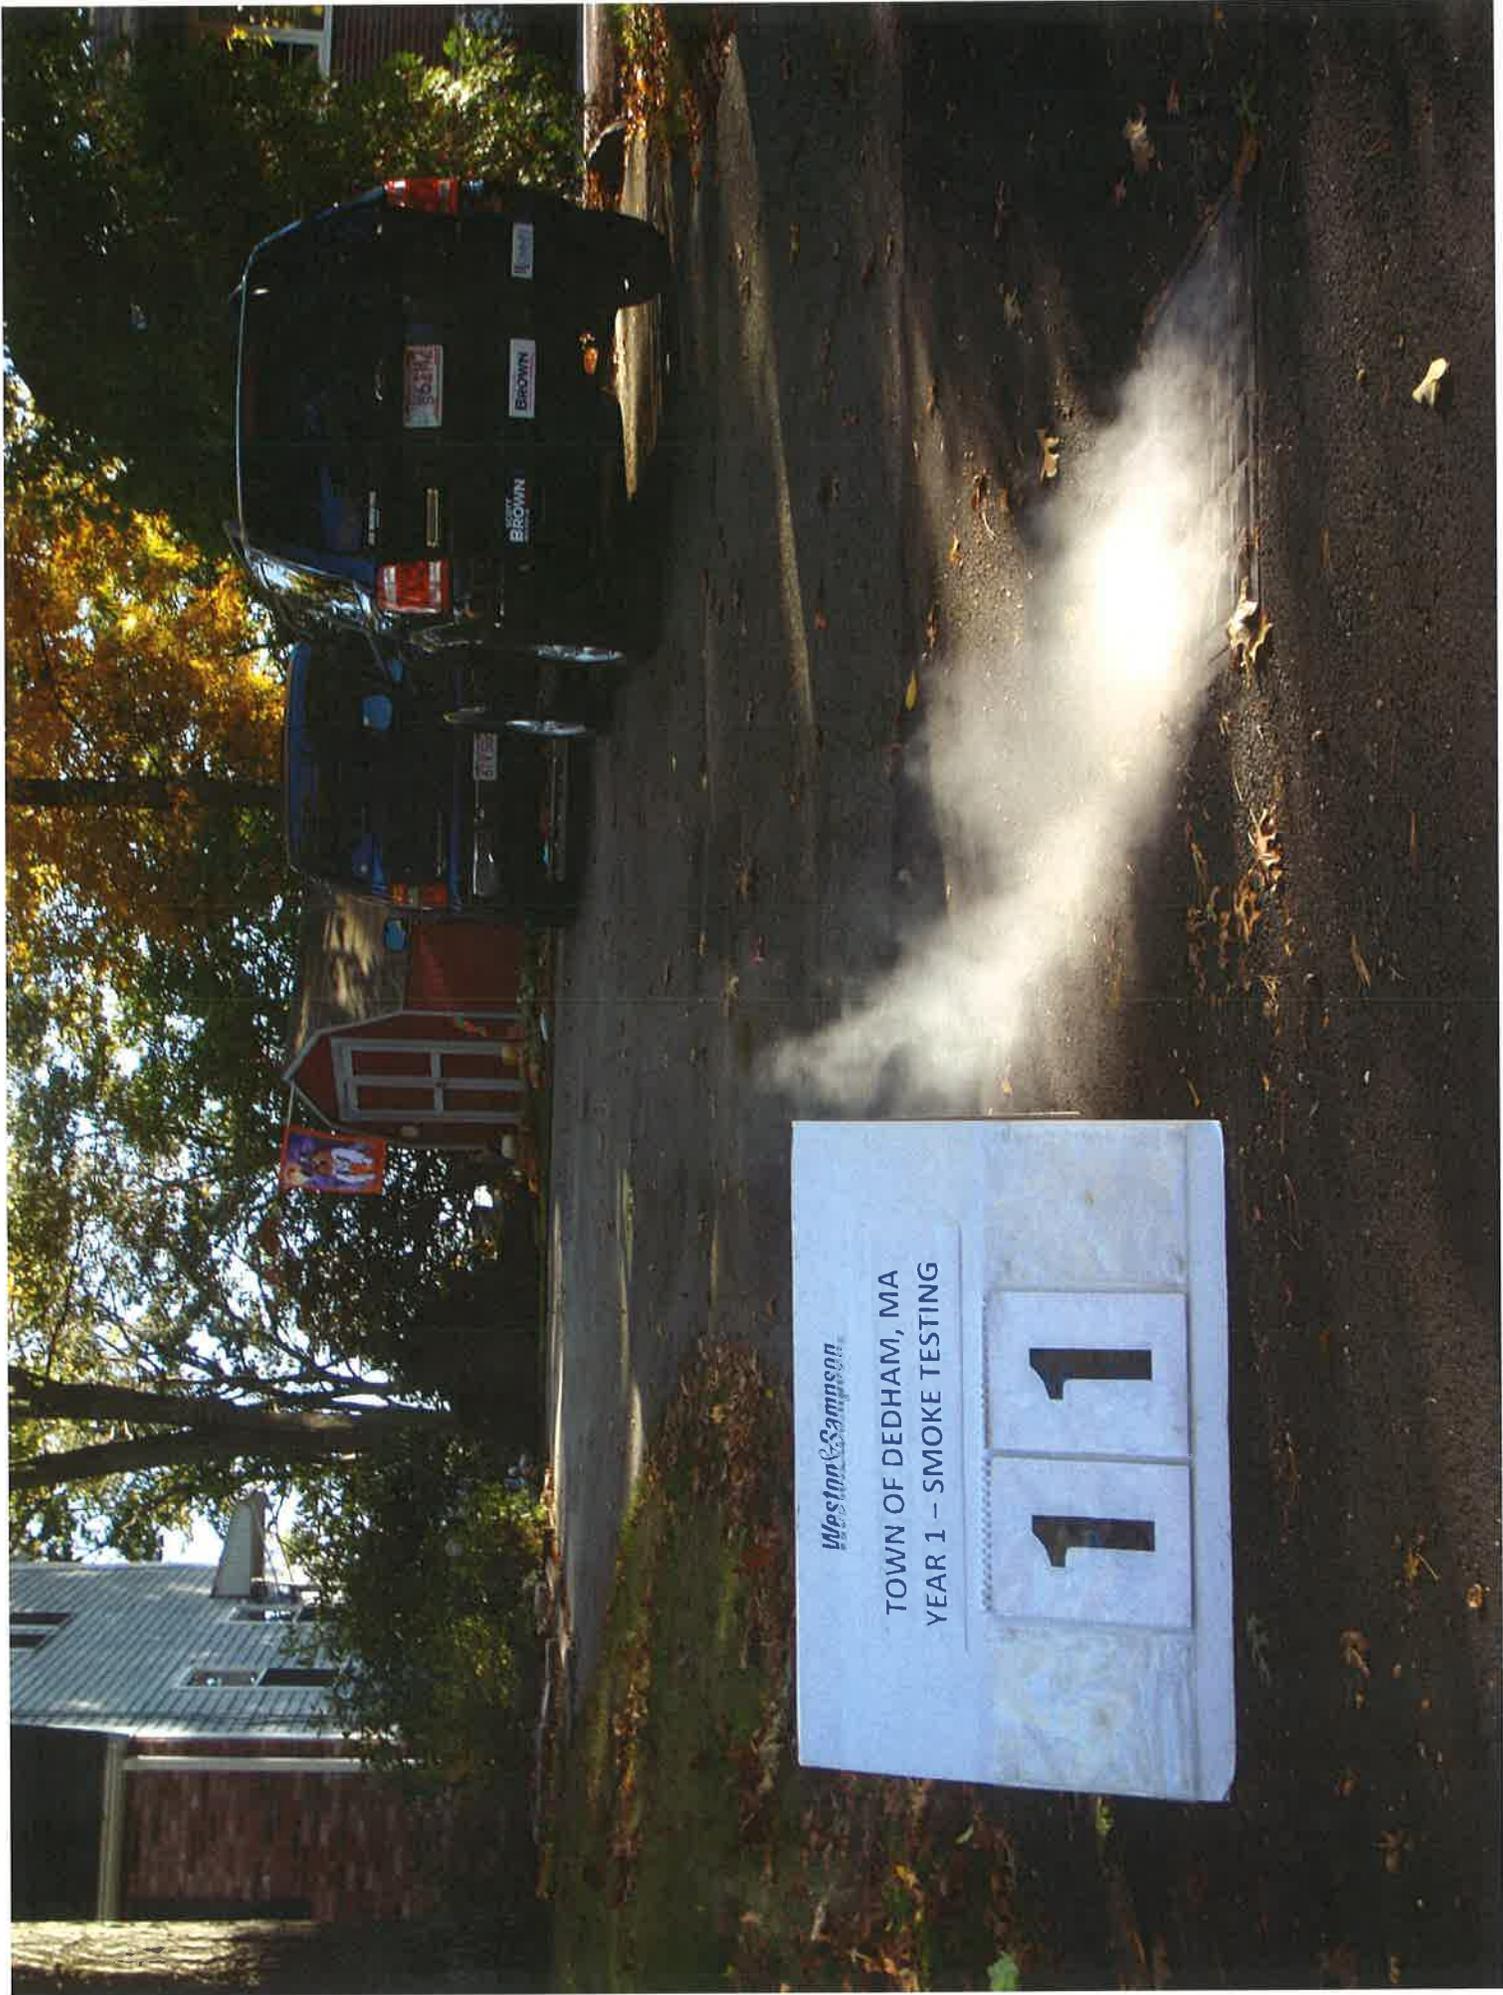
DEFECT: 11 thru 11

DEFECT	DESCRIPTION	Drainage Area (ft <sup>2</sup> )	Surface Type	Severity			Picture No.(s)
				Major	Mod	Minor	
11	Moderate Smoke from Catch Basin near house #80	3,744	Asphalt		x		60

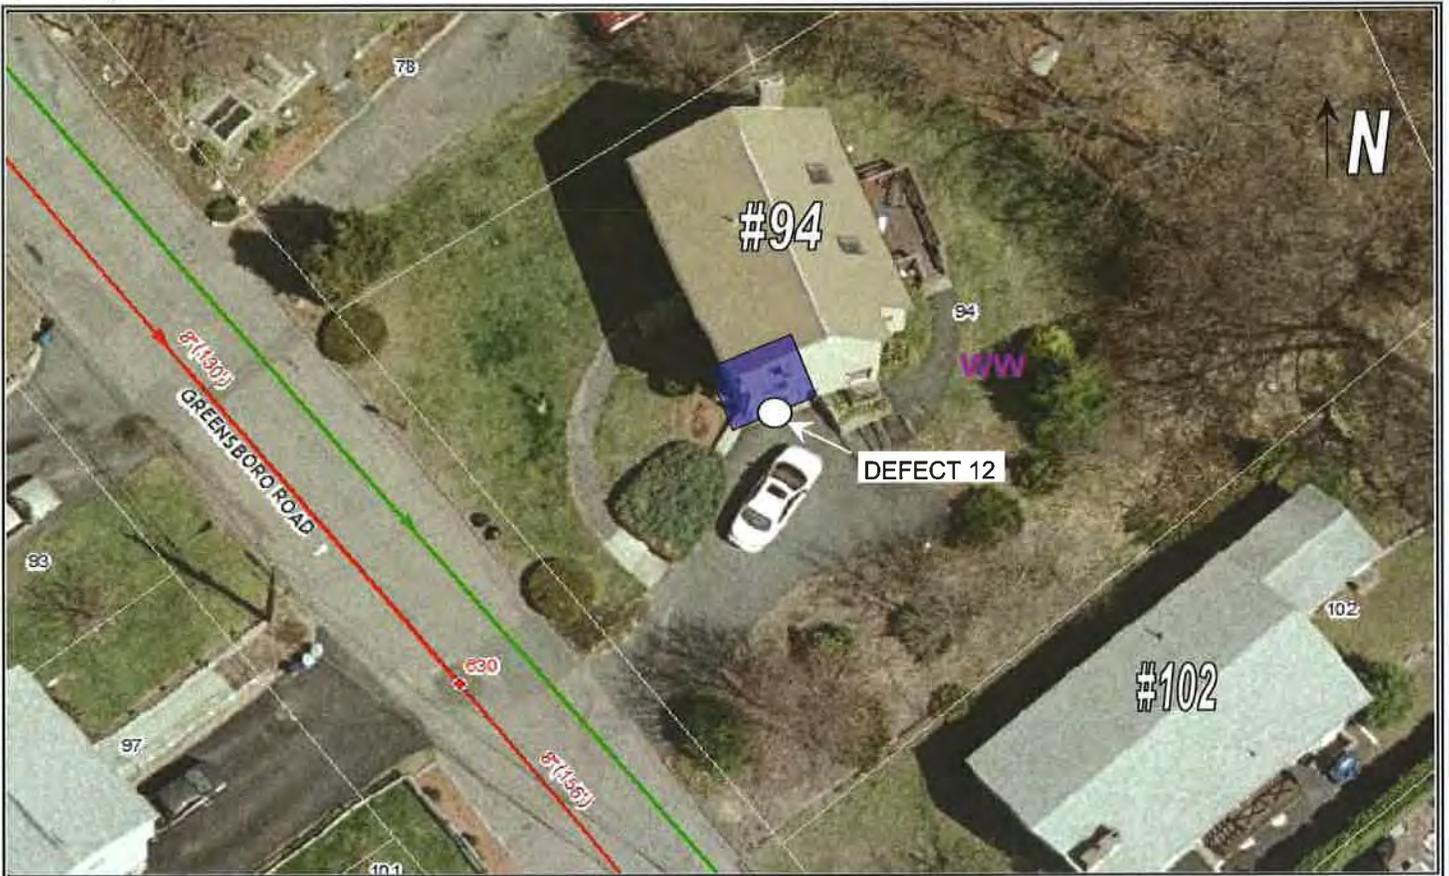
DEFECT: 12 thru 12

DEFECT	DESCRIPTION	Drainage Area (ft <sup>2</sup> )	Surface Type	Severity			Picture No.(s)
				Major	Mod	Minor	
12	Light Smoke from Edge of Pavement at Garage Door / Potential Garage Drain or Broken SVC	150	Concrete			x	61

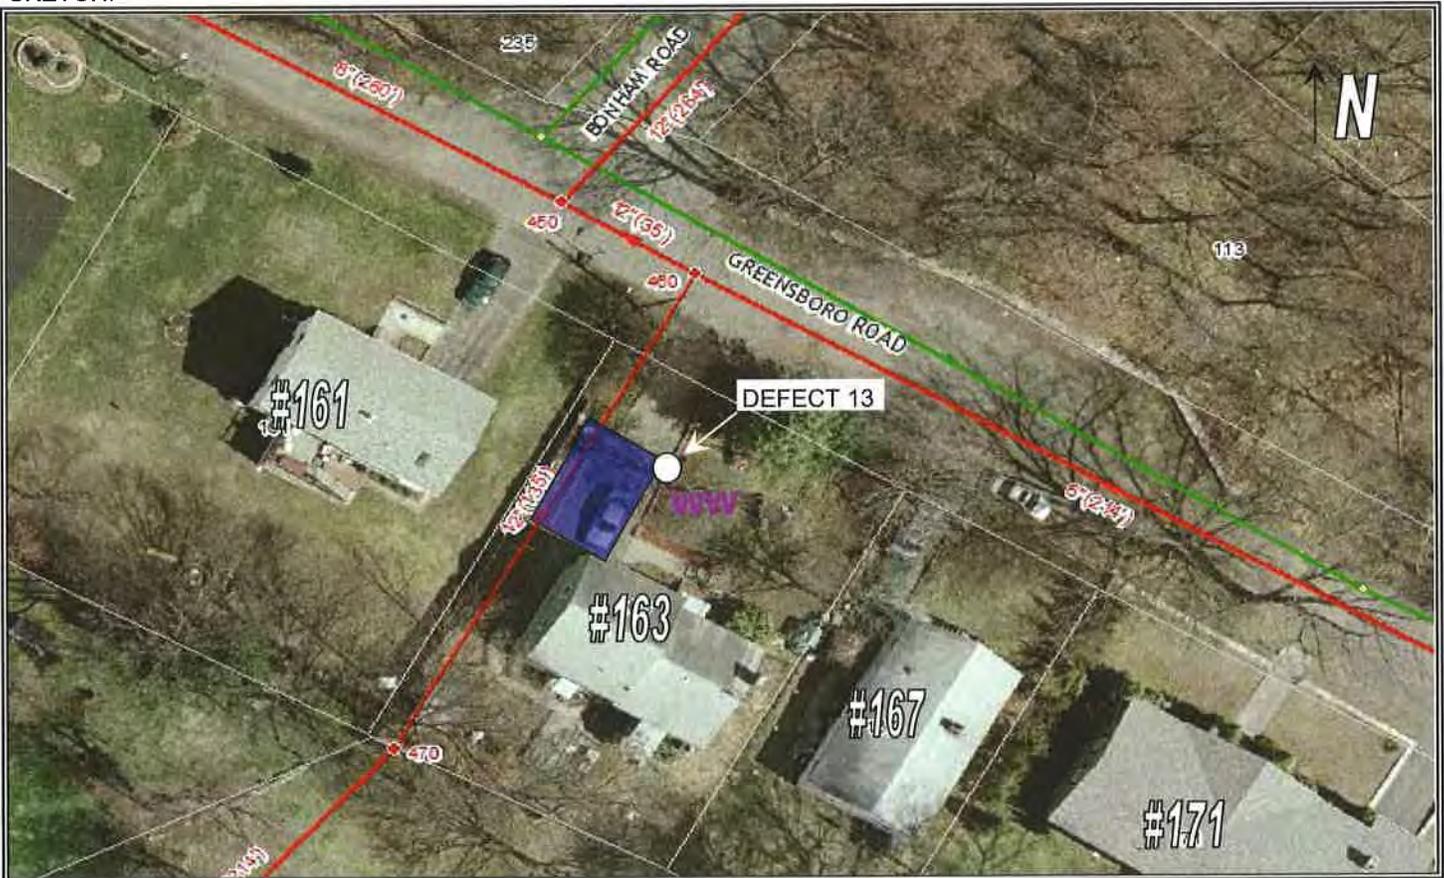
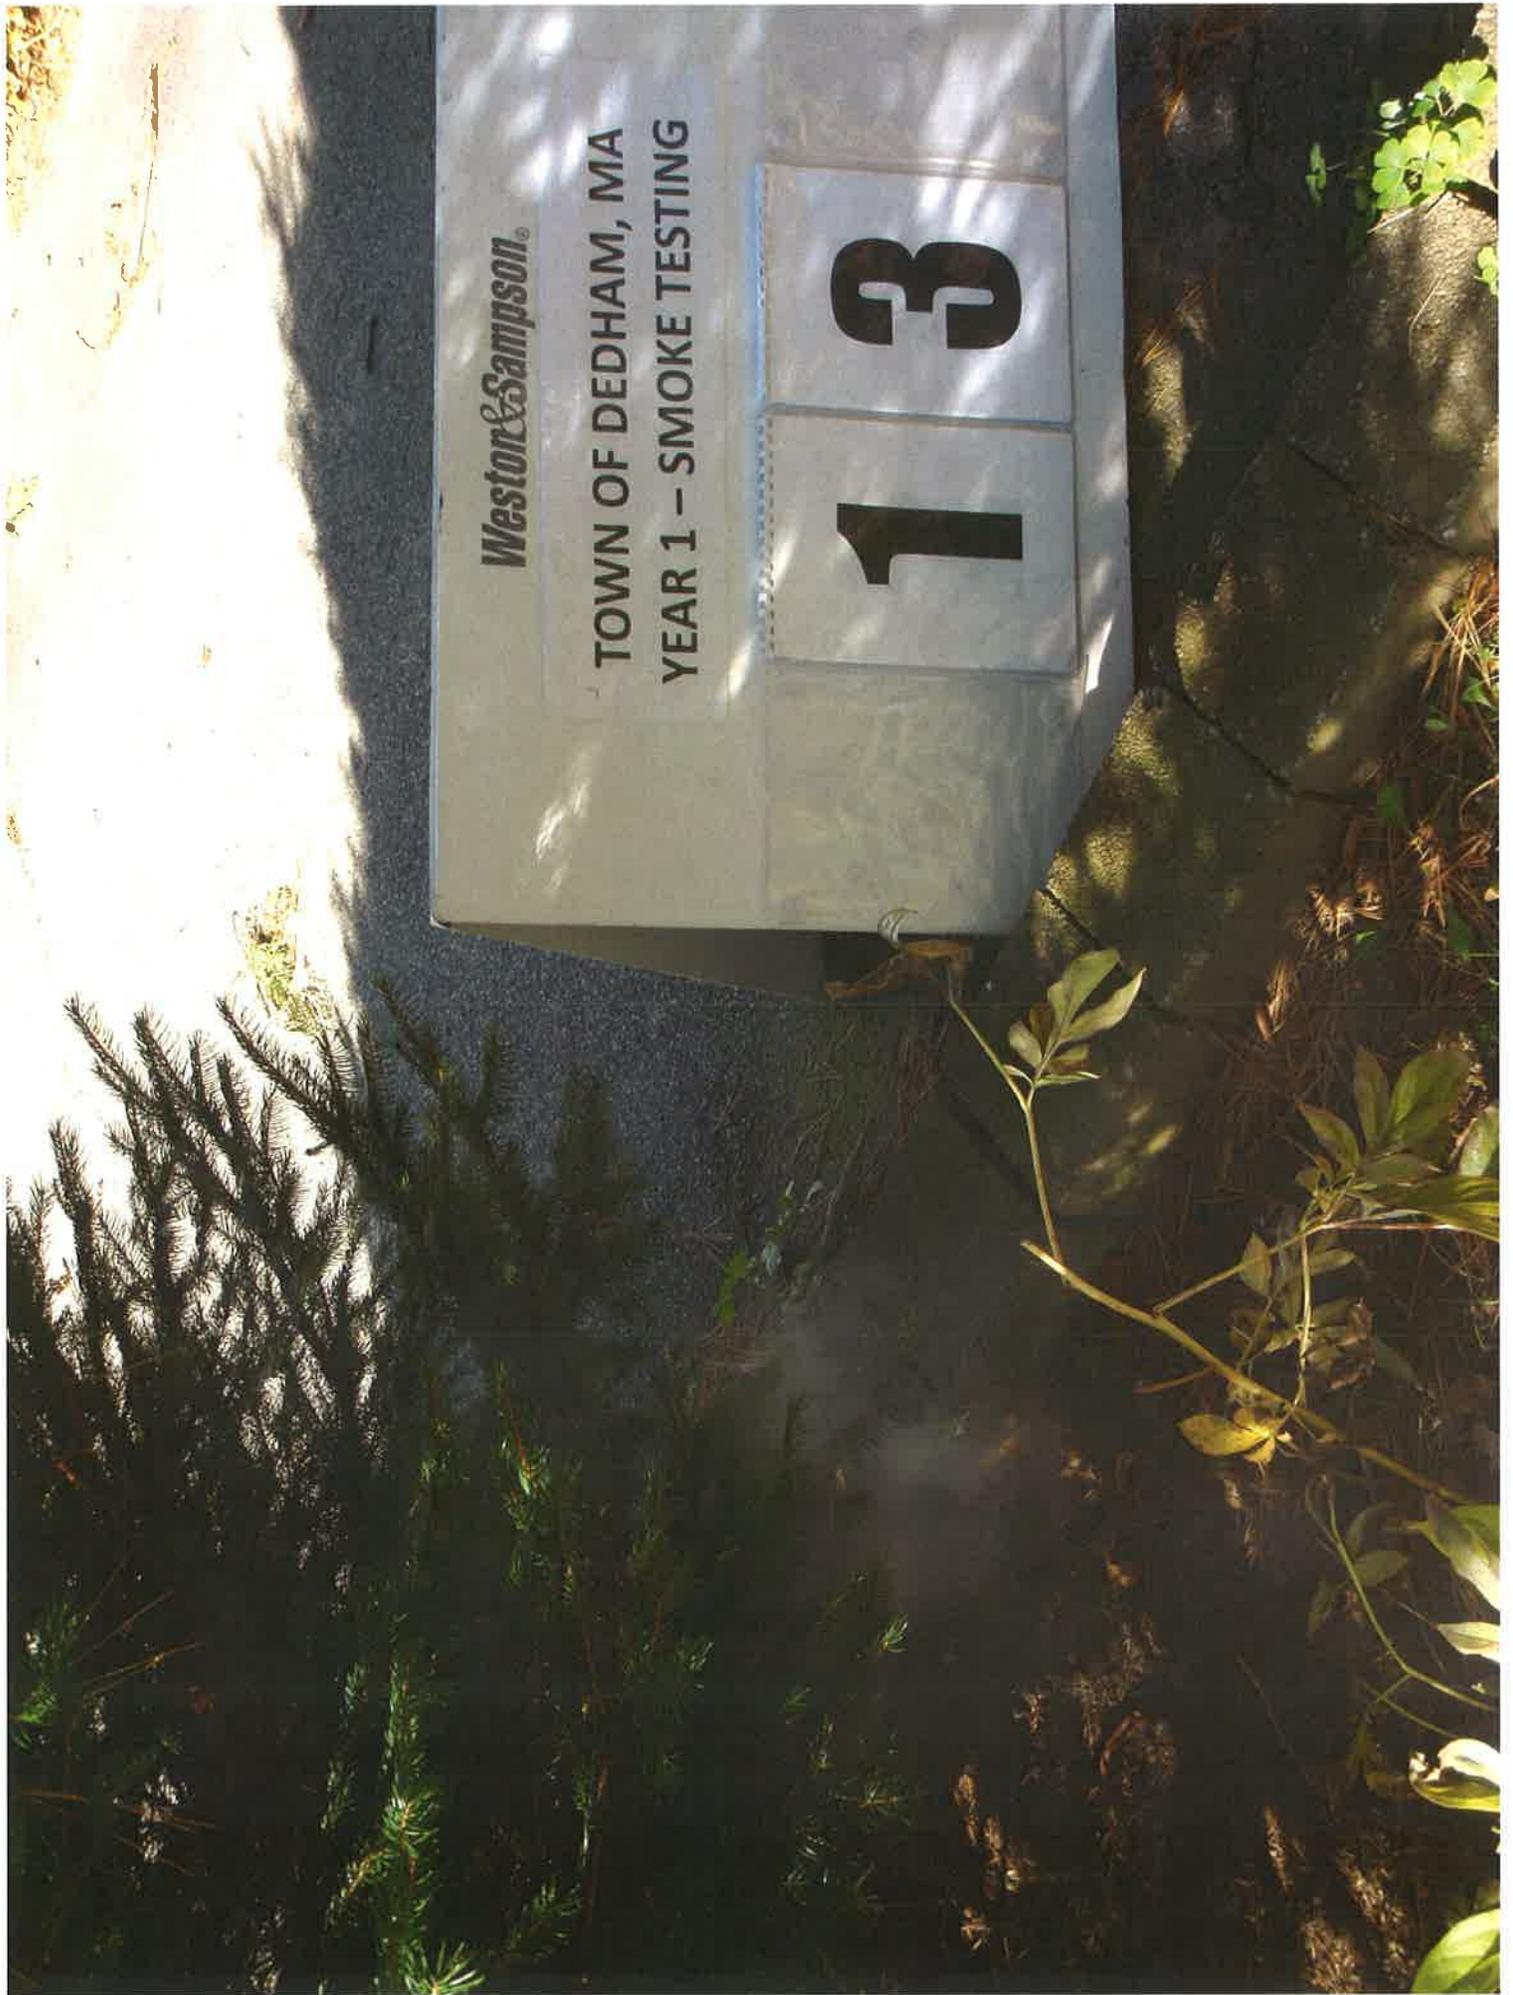
DEFECT: 13 thru 13

DEFECT	DESCRIPTION	Drainage Area (ft <sup>2</sup> )	Surface Type	Severity			Picture No.(s)
				Major	Mod	Minor	
13	Open Cleanout	372	Asphalt	x			62 - 63

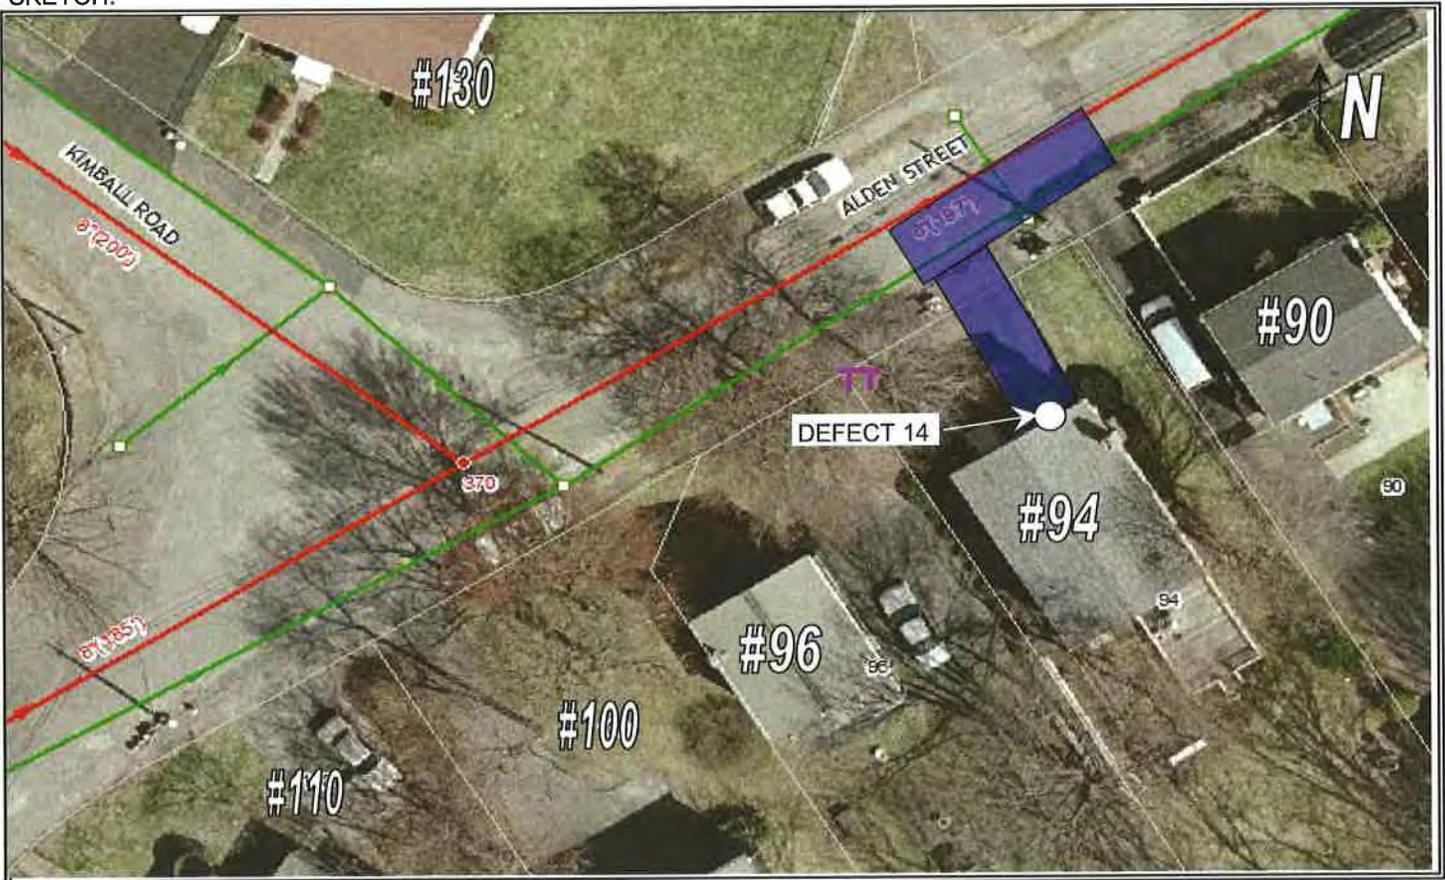
DEFECT: 14 thru 14

DEFECT	DESCRIPTION	Drainage Area (ft <sup>2</sup> )	Surface Type	Severity			Picture No.(s)
				Major	Mod	Minor	
14	Moderate Smoke from Driveway Drain	960	Asphalt	x			64

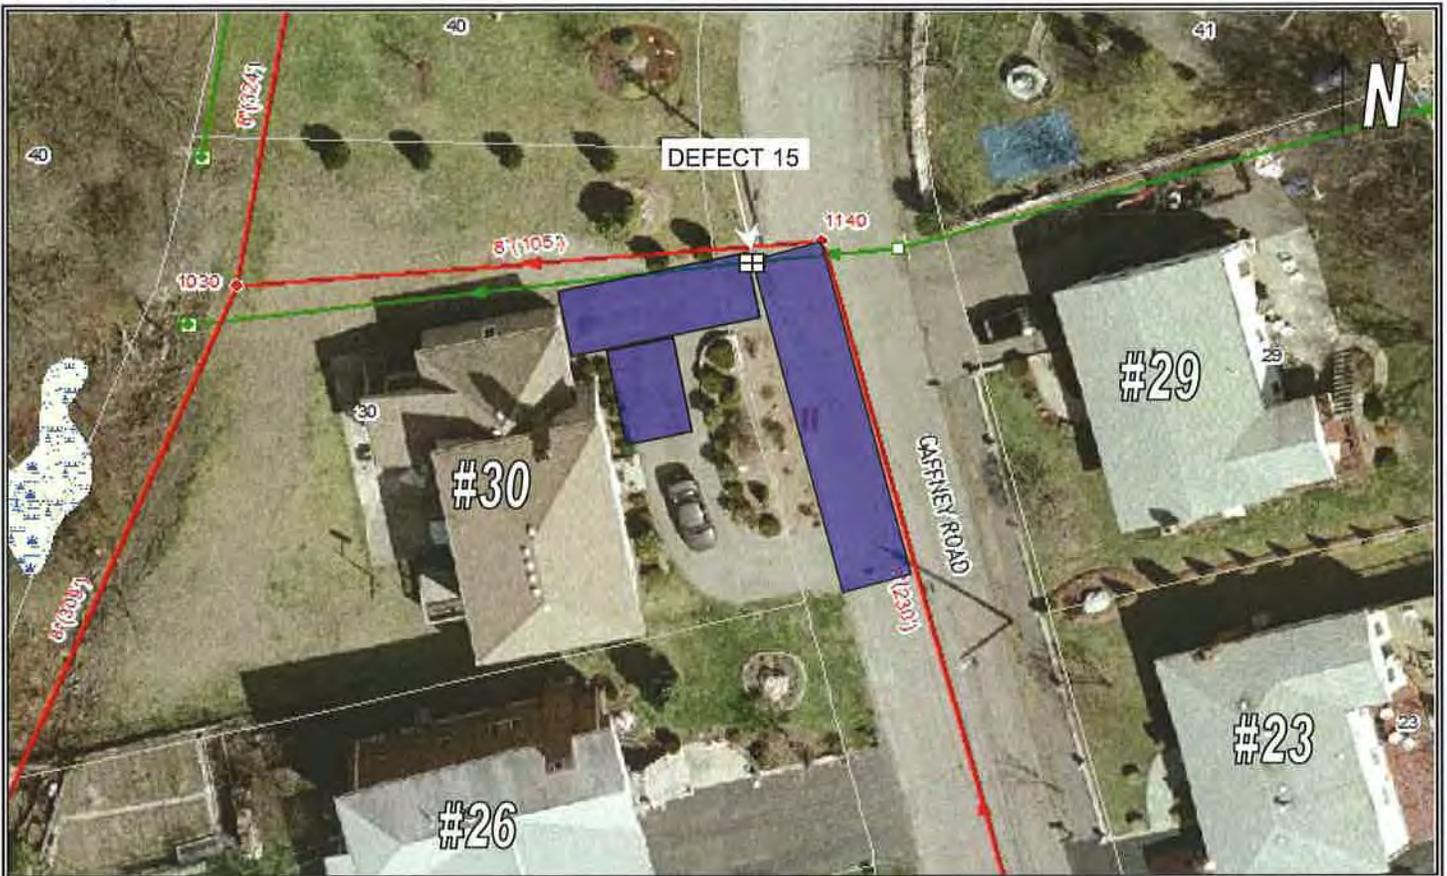
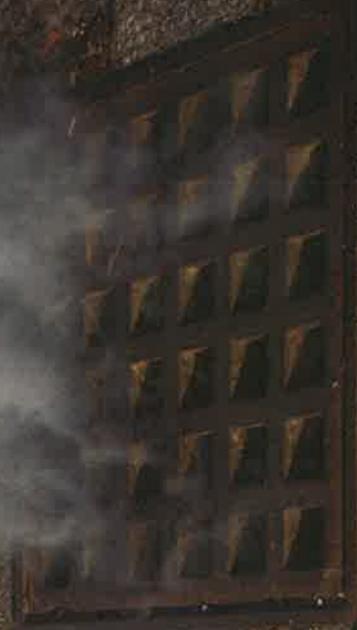
DEFECT: 15 thru 15

DEFECT	DESCRIPTION	Drainage Area (ft <sup>2</sup> )	Surface Type	Severity			Picture No.(s)
				Major	Mod	Minor	
15	Moderate Smoke from Catch Basin near house #30	1,321	Asphalt		x		69

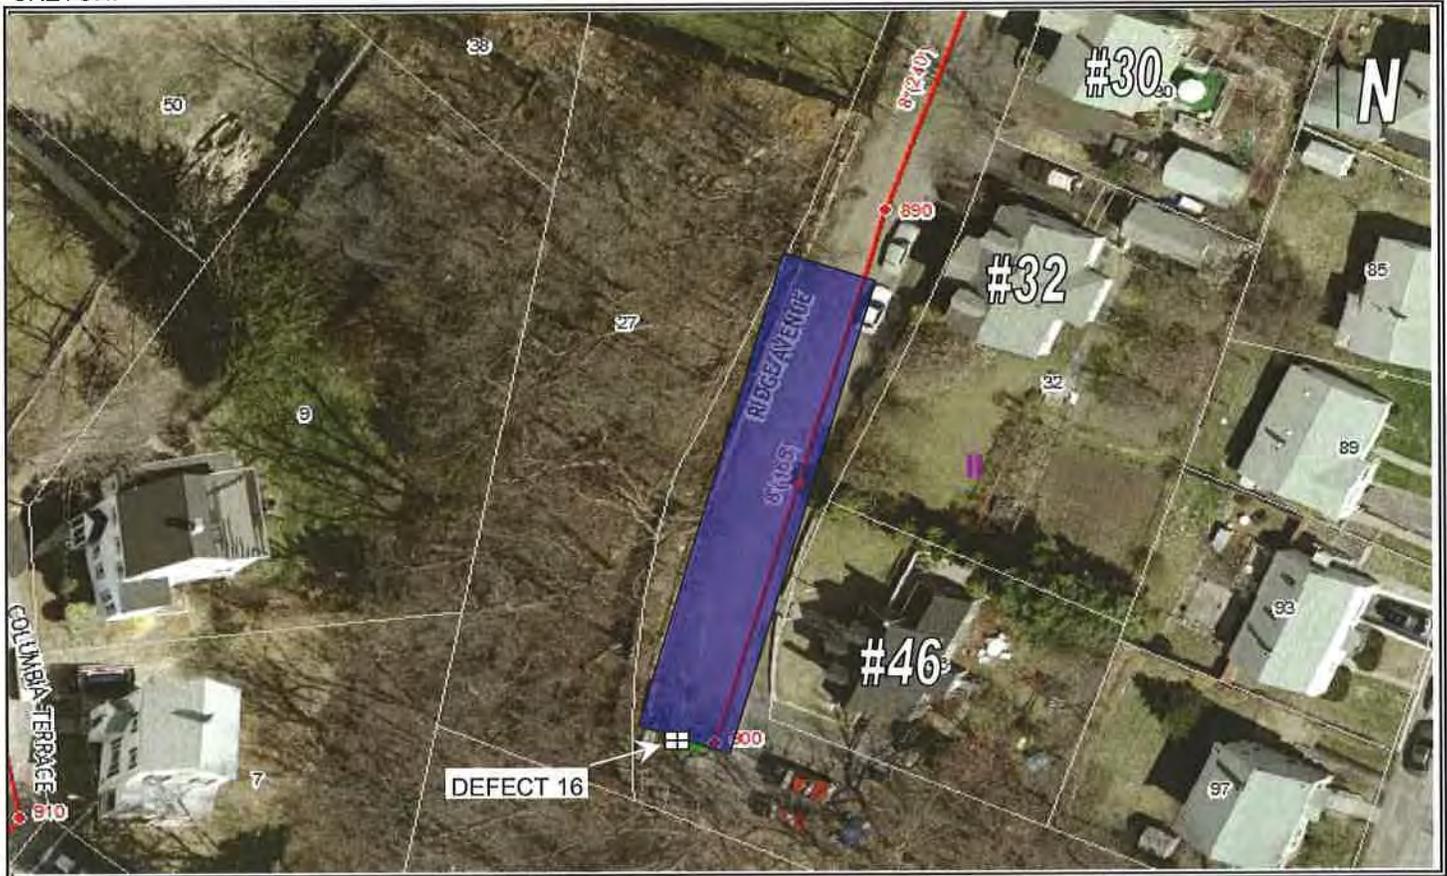
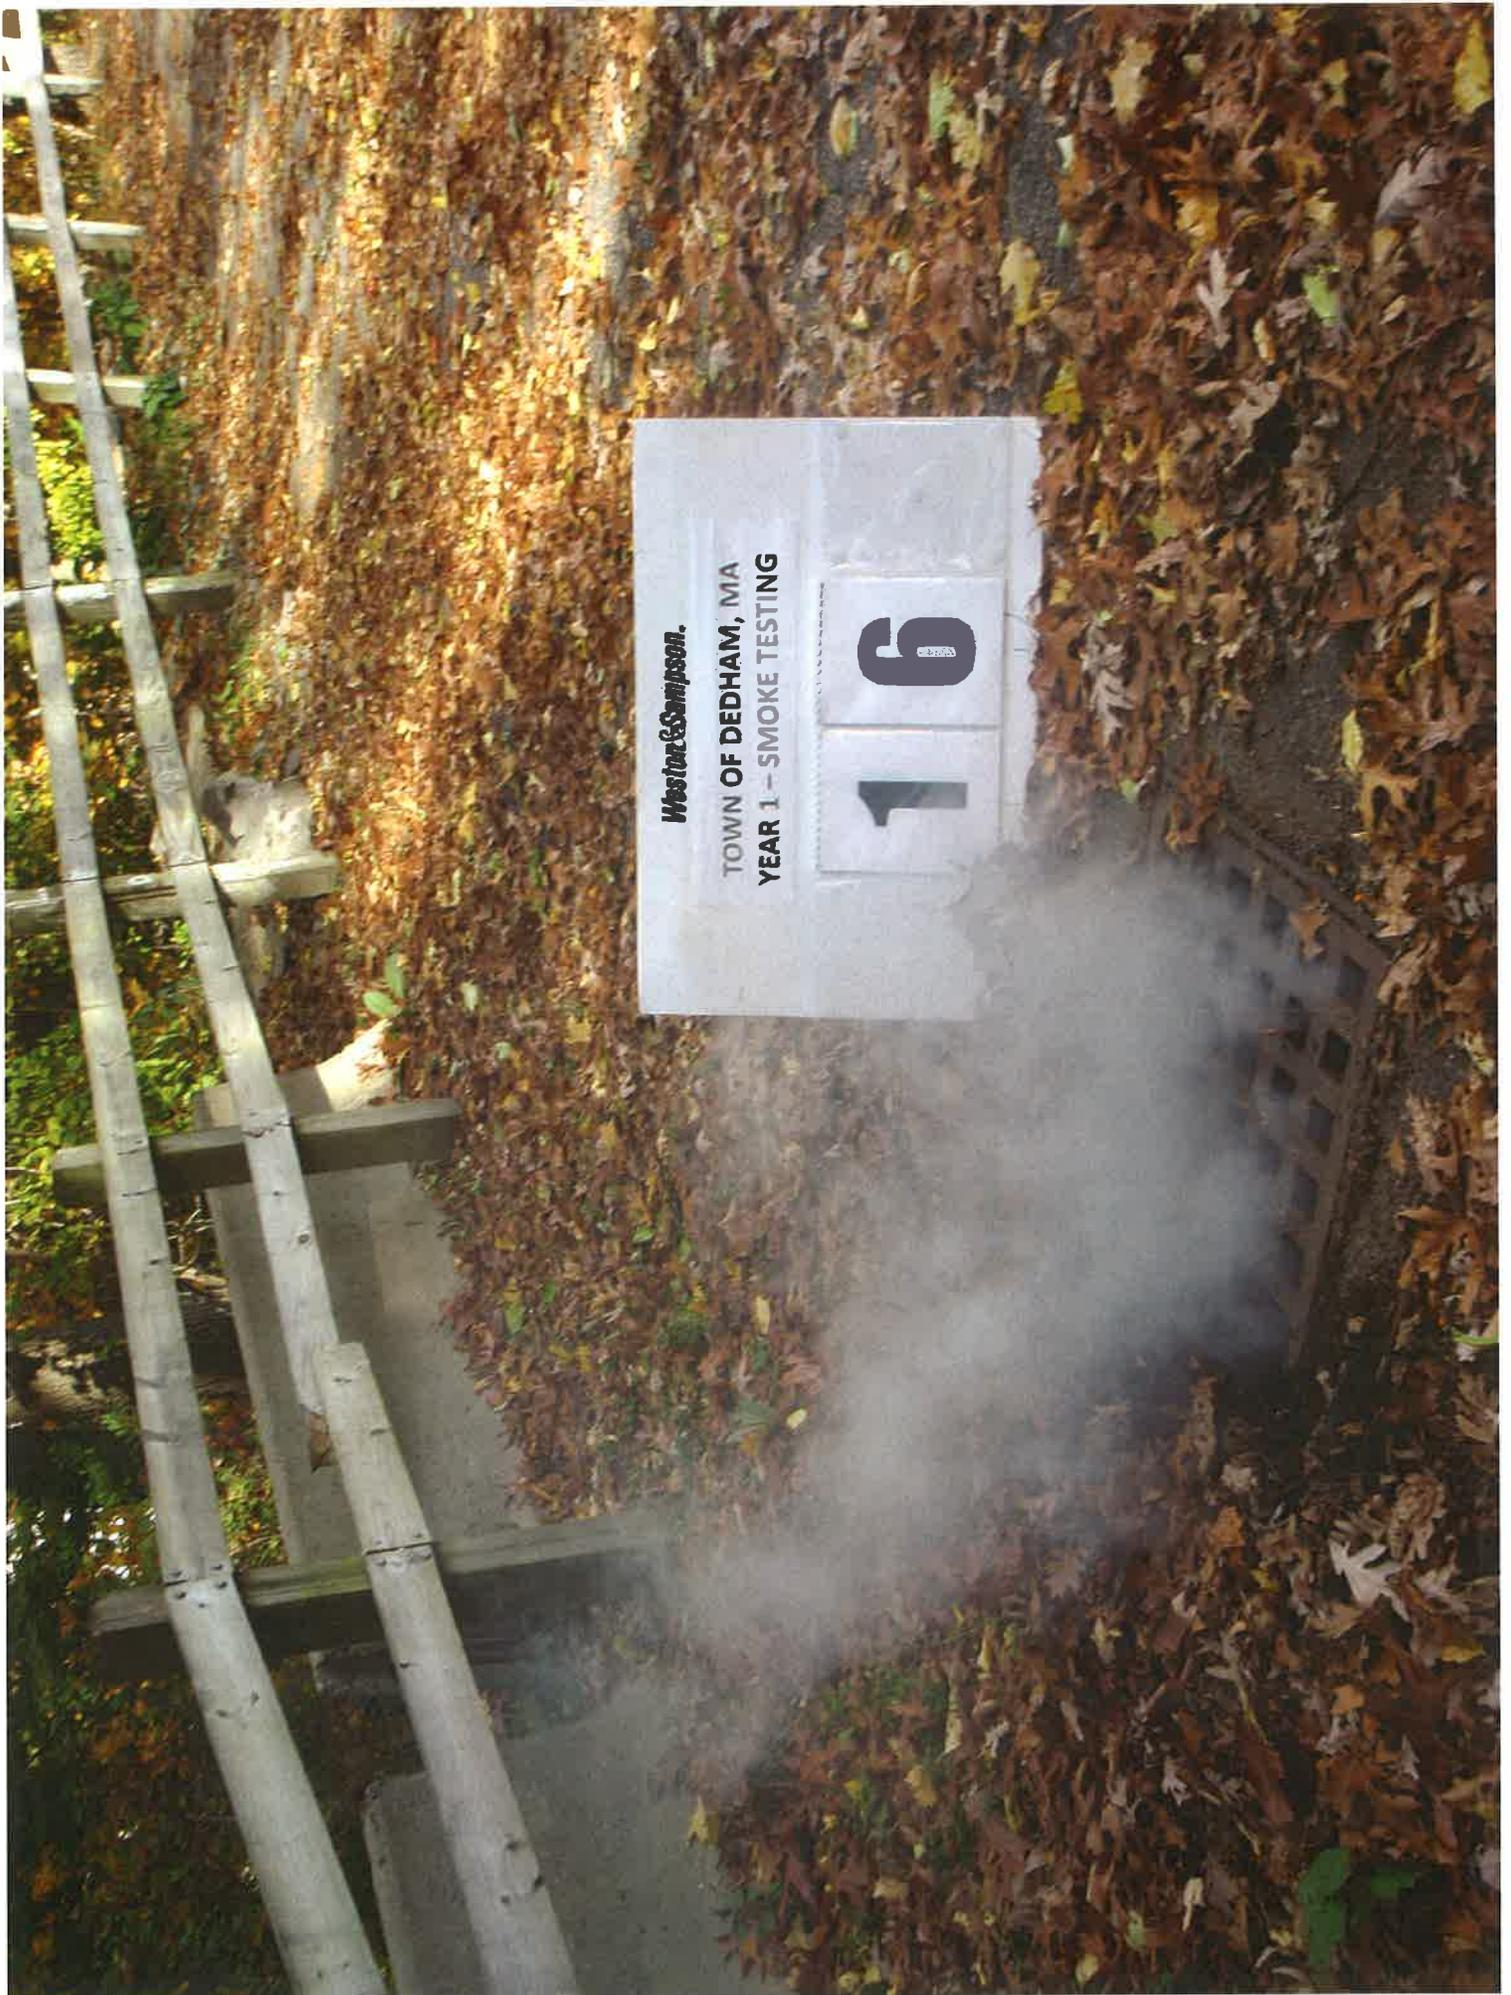
DEFECT: 16 thru 16

DEFECT	DESCRIPTION	Drainage Area (ft <sup>2</sup> )	Surface Type	Severity			Picture No.(s)
				Major	Mod	Minor	
16	Heavy Smoke from Catch Basin (Direct) near house #46	4,500	Asphalt	x			73-76

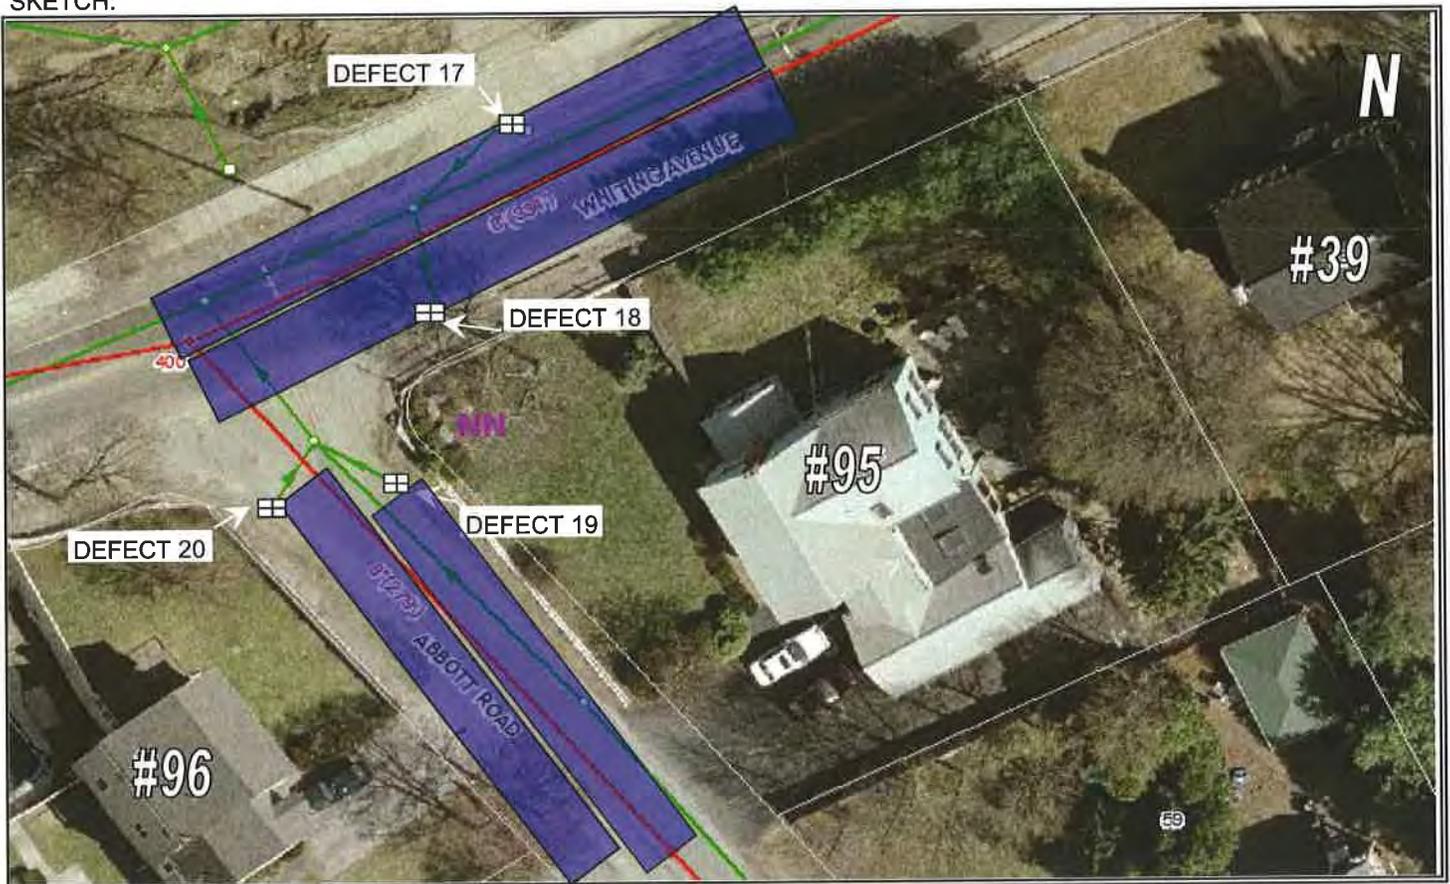
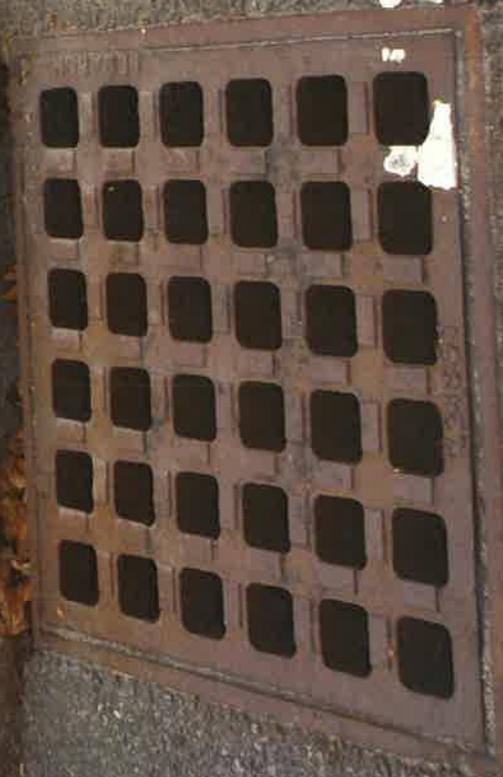
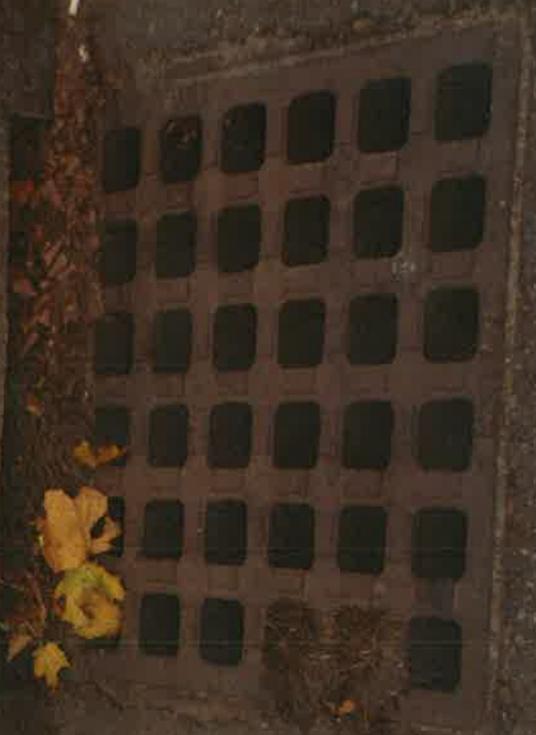
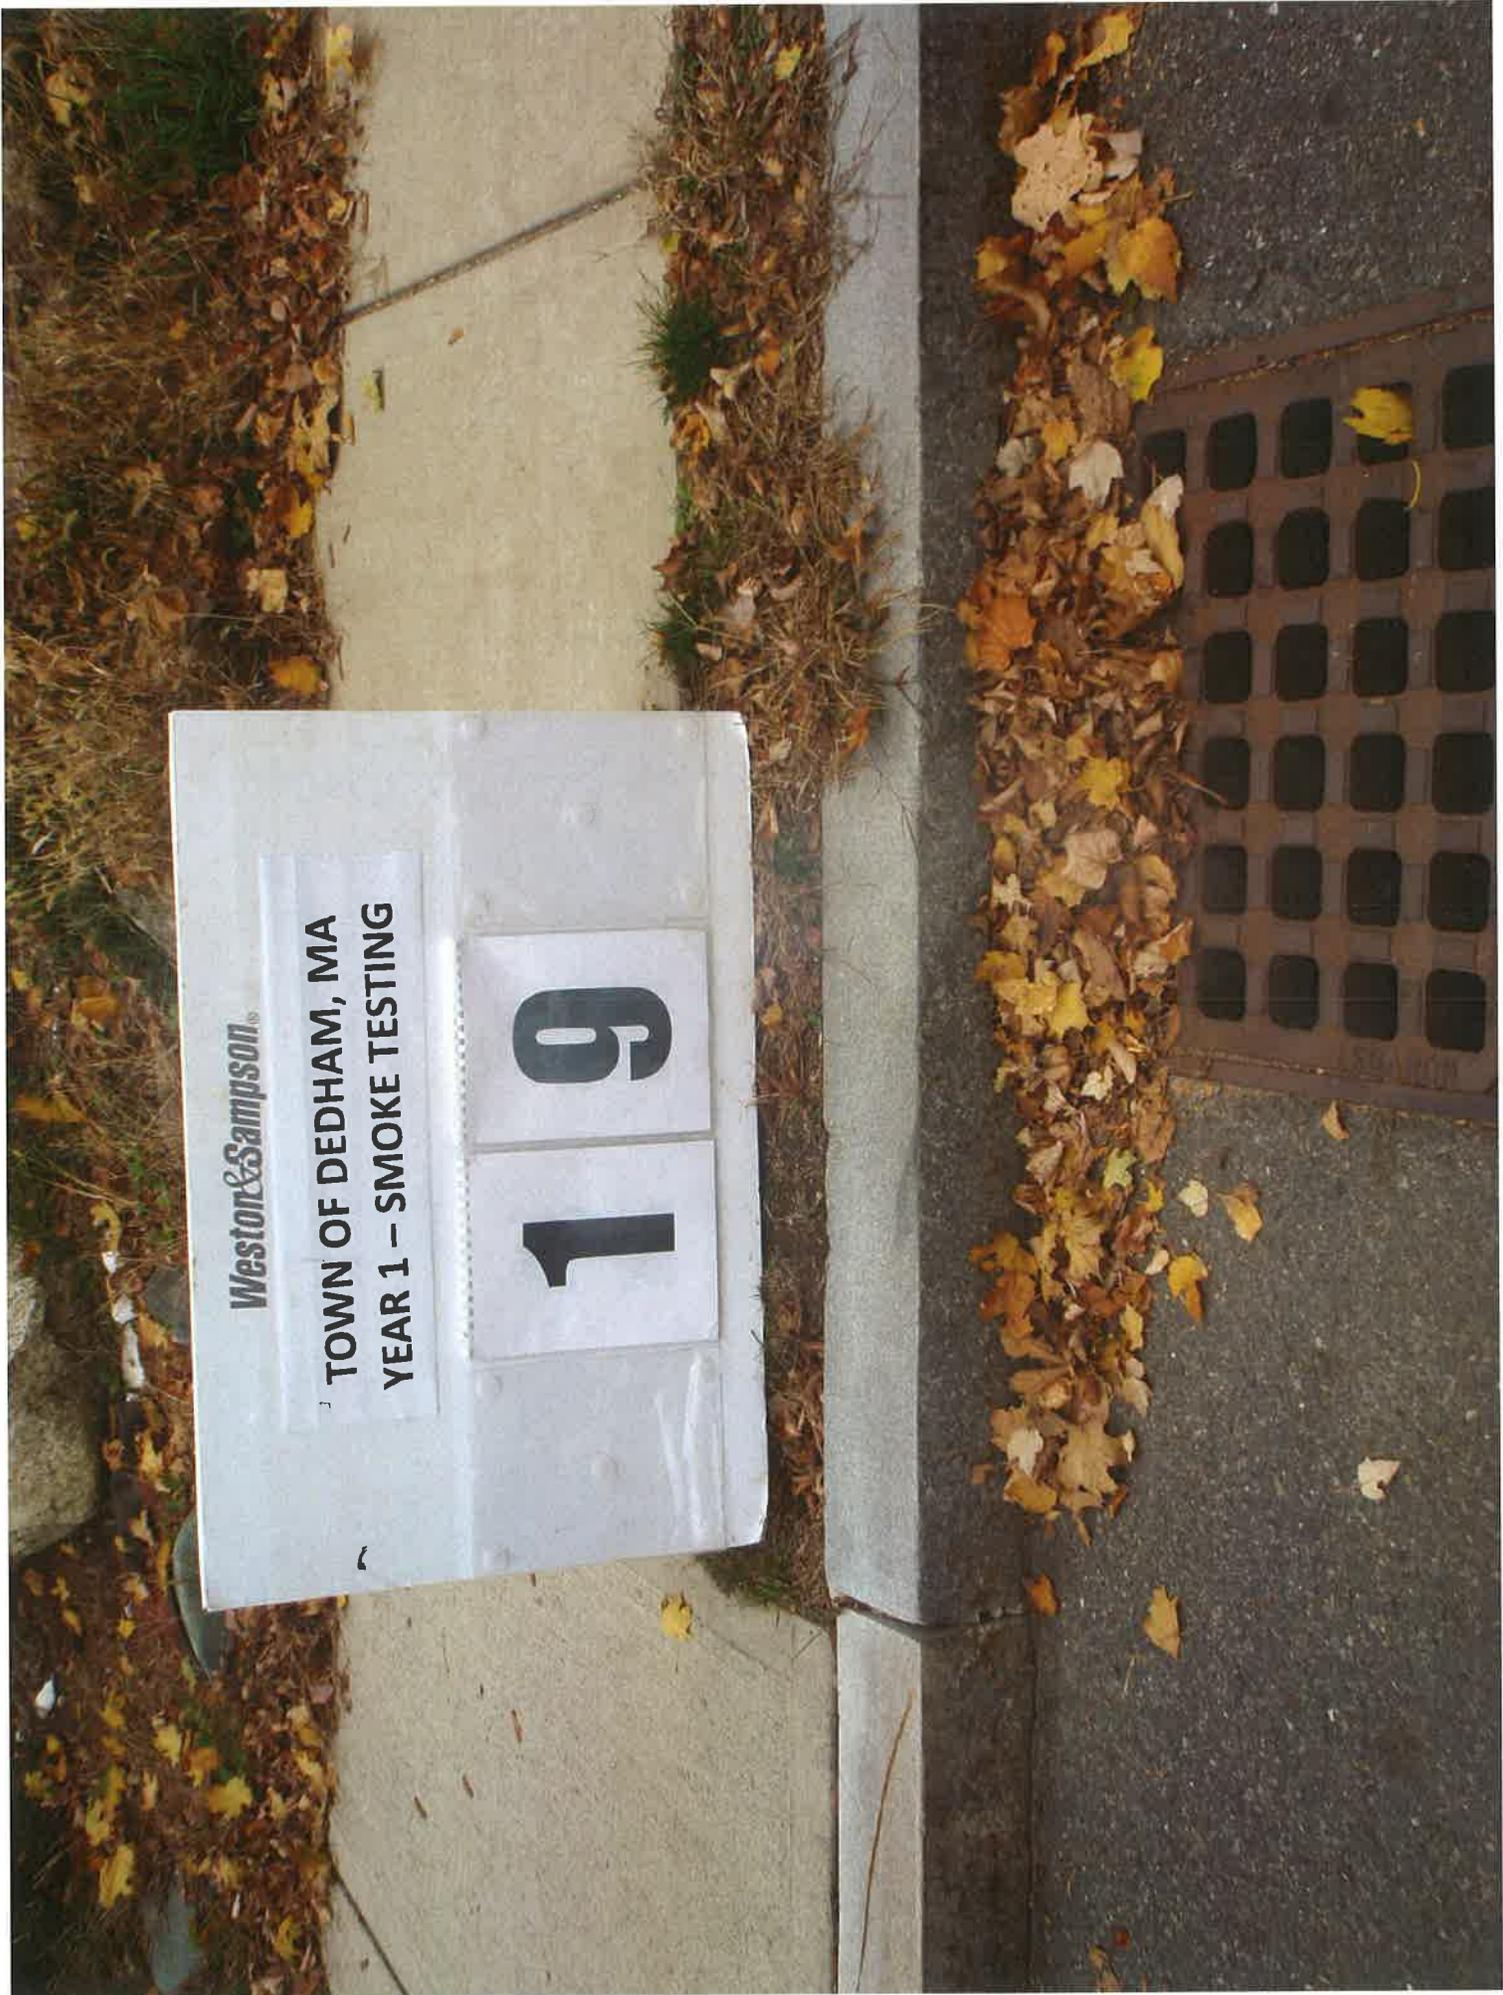
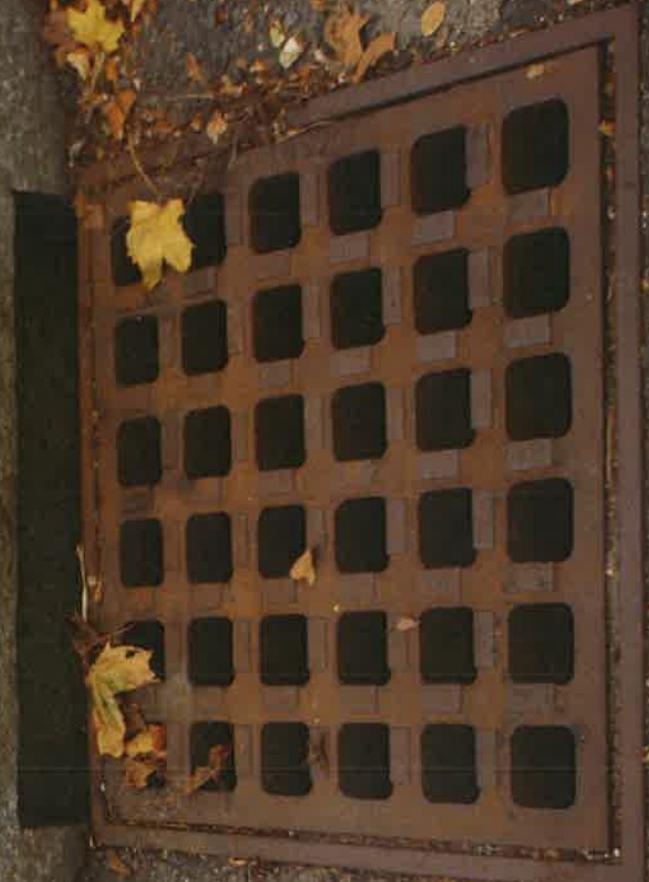
DEFECT: 17 thru 20

DEFECT	DESCRIPTION	Drainage Area (ft <sup>2</sup> )	Surface Type	Severity			Picture No.(s)
				Major	Mod	Minor	
17	Light Smoke from Catch Basin near house #70	3,600	Asphalt			x	80
18	Light Smoke from Catch Basin near house #95	3,600	Asphalt			x	81-82
19	Light Smoke from Catch Basin near house #95	3,000	Asphalt			x	83-84
20	Light Smoke from Catch Basin near house #96	3,000	Asphalt			x	85-86
