# **Report**

## **Town of Dedham, MA**

### **2012 Inflow Investigation**

February 2013

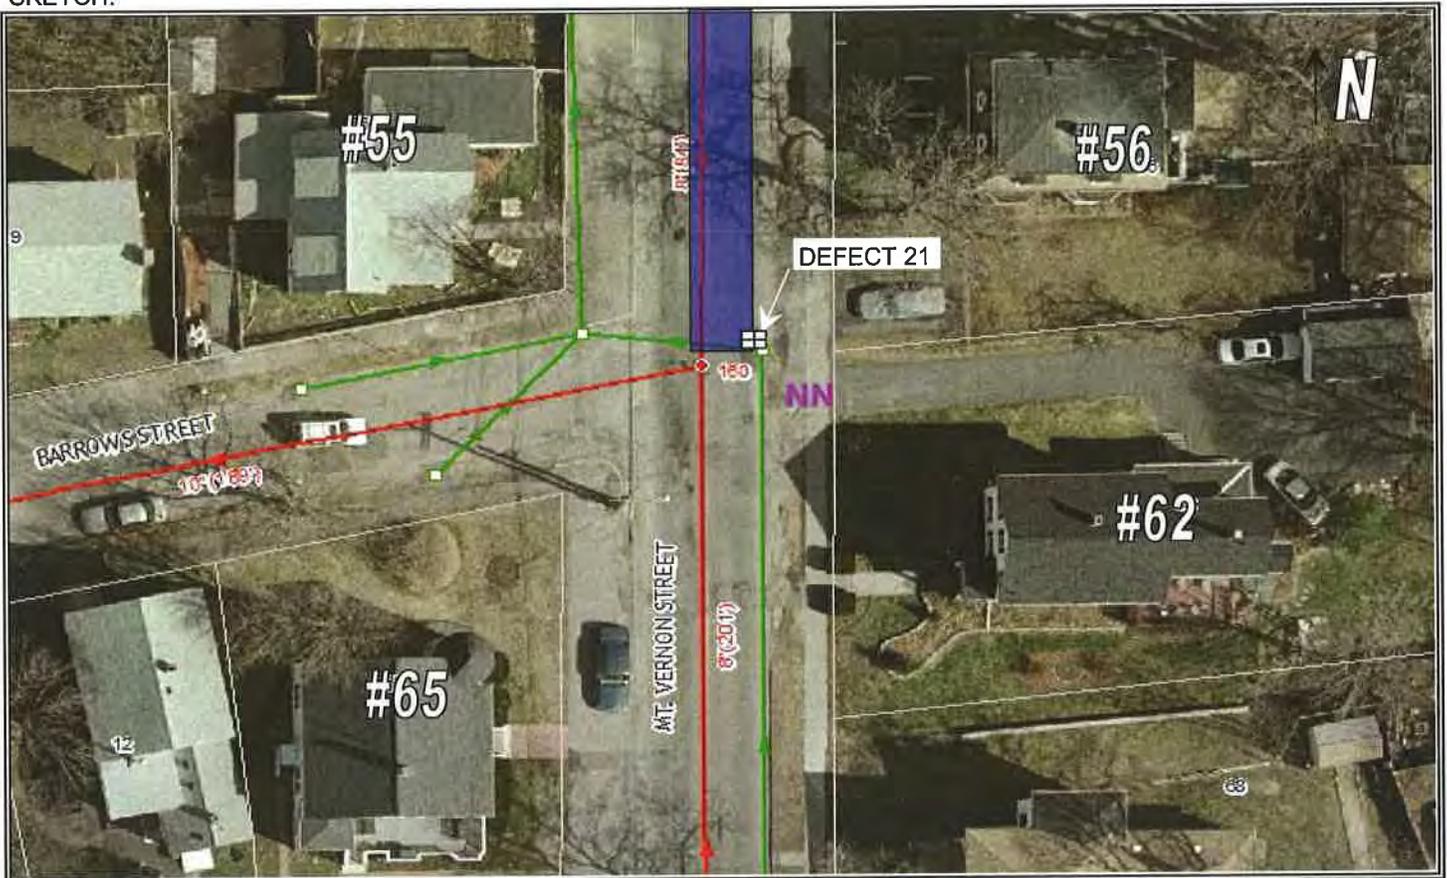
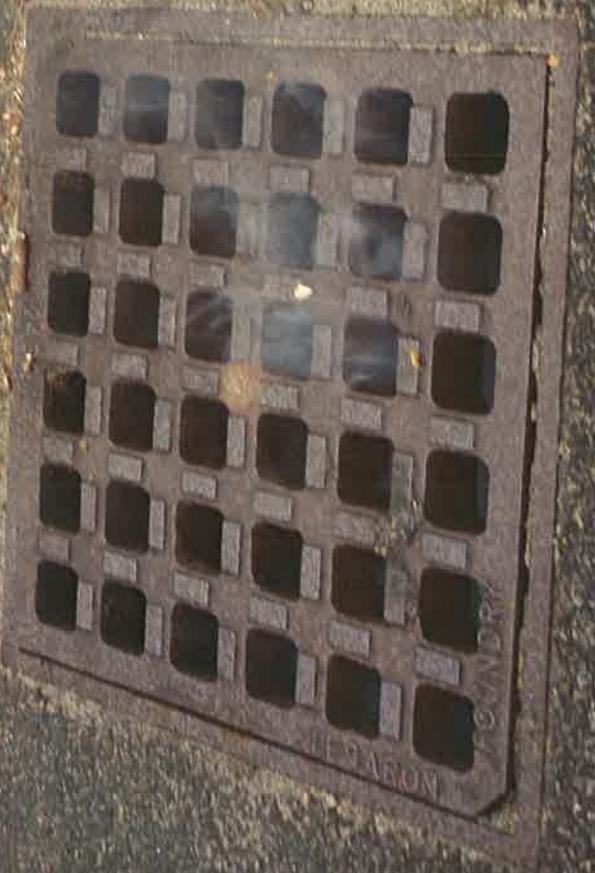
DEFECT: 21 thru 21

DEFECT	DESCRIPTION	Drainage Area (ft <sup>2</sup> )	Surface Type	Severity			Picture No.(s)
				Major	Mod	Minor	
21	Light Smoke from Catch Basin near house #56	2,100	Asphalt			x

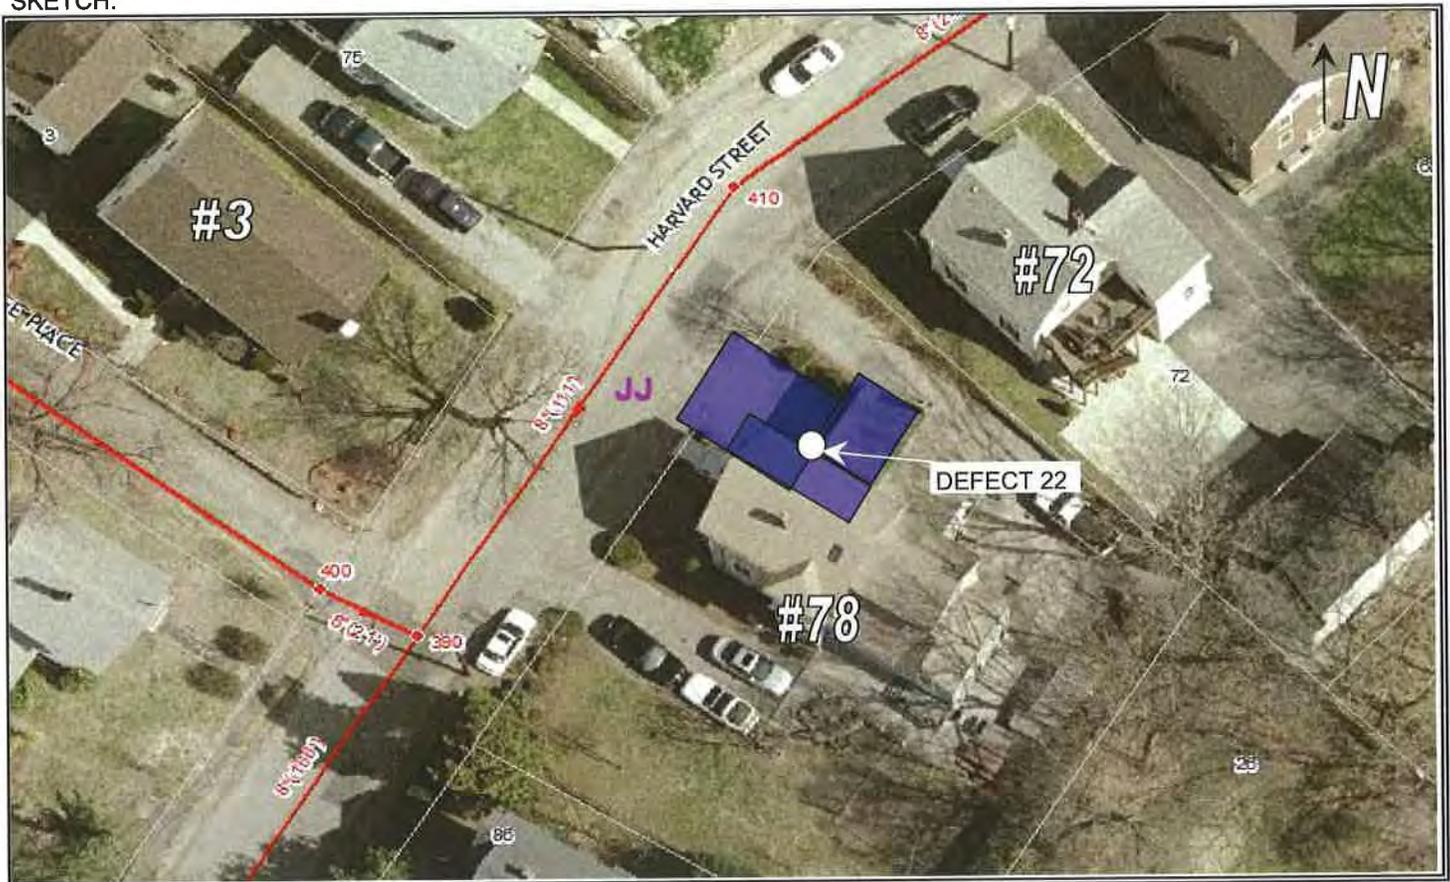
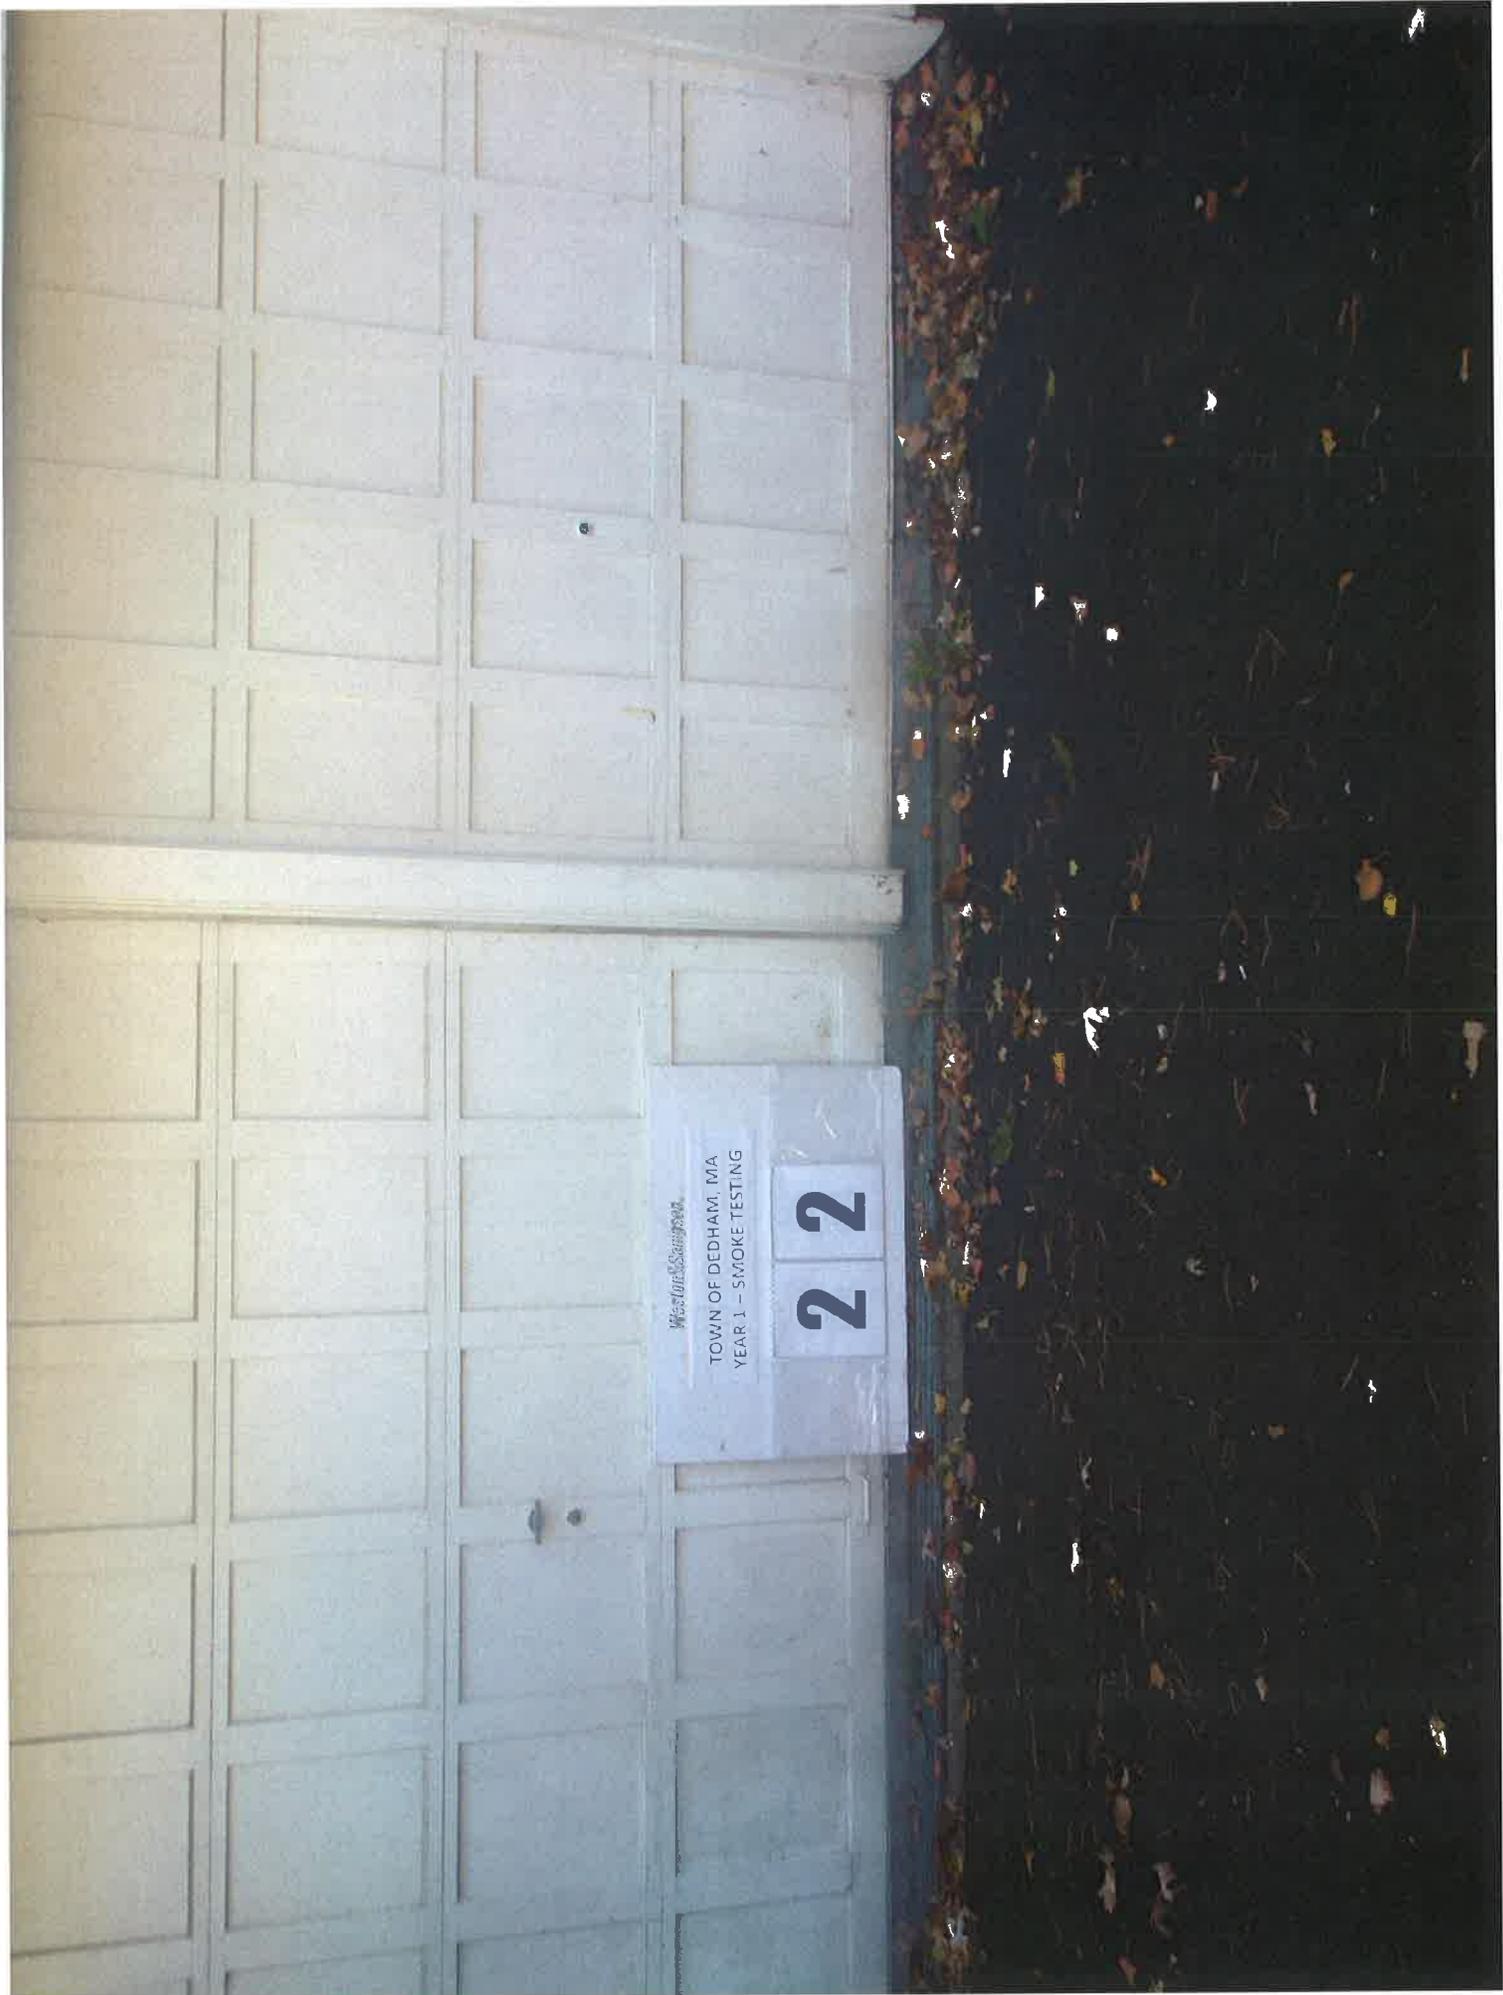
DEFECT: 22 thru 22

DEFECT	DESCRIPTION	Drainage Area (ft <sup>2</sup> )	Surface Type	Severity			Picture No.(s)
				Major	Mod	Minor	
22	Heavy Smoke from Driveway Drain (3 roof leaders discharge to driveway)	800	Asphalt	x			94-95
		1,800	Shingle

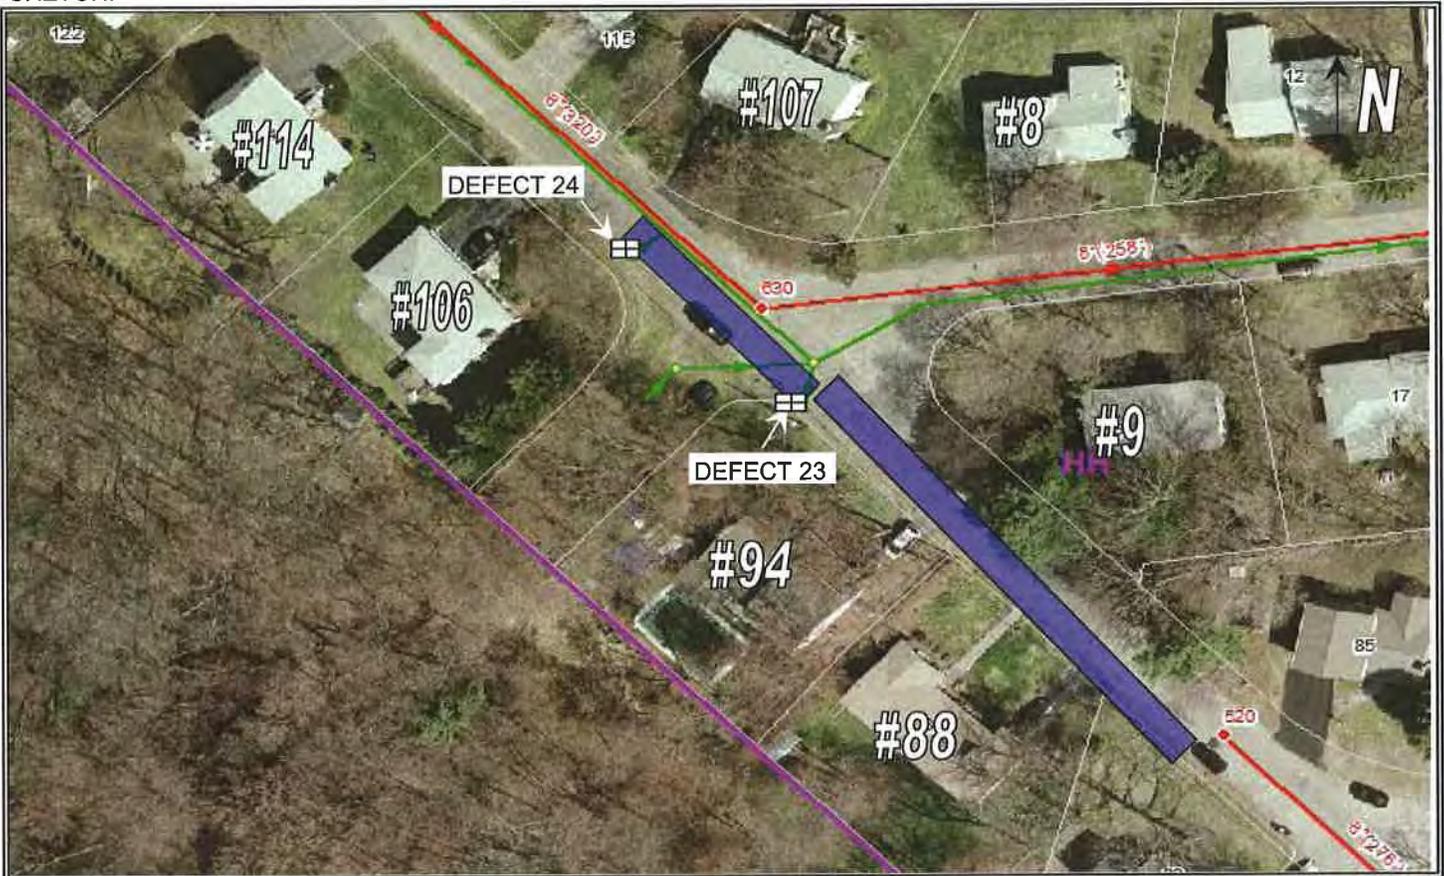
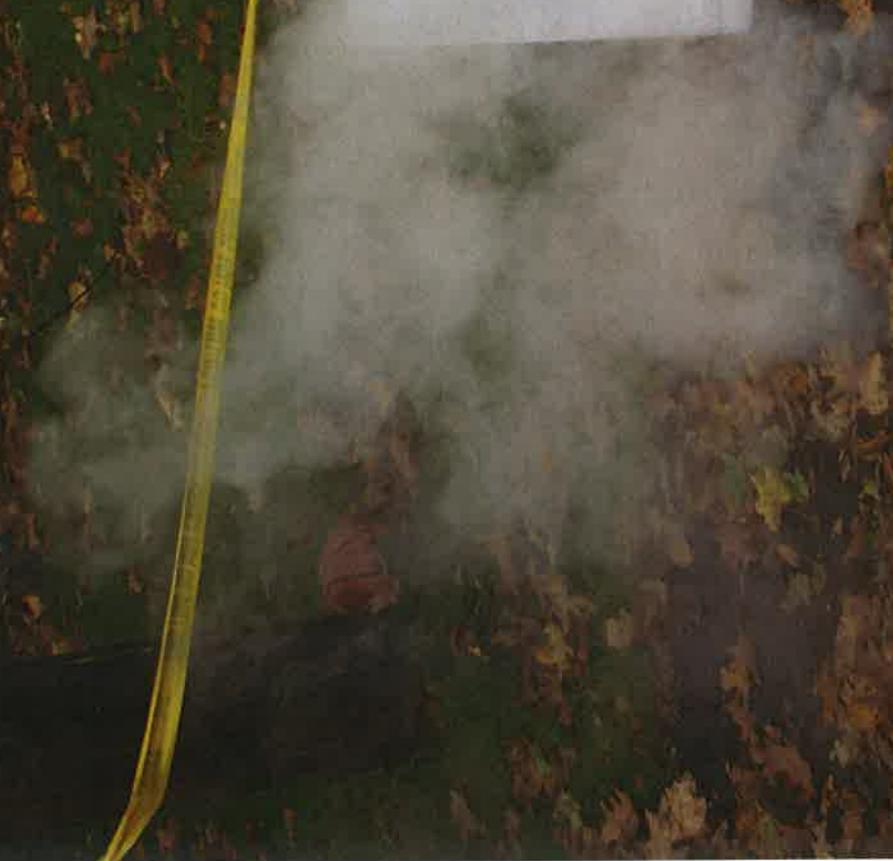
DEFECT: 23 thru 24

DEFECT	DESCRIPTION	Drainage Area (ft <sup>2</sup> )	Surface Type	Severity			Picture No.(s)
				Major	Mod	Minor	
23	Moderate Smoke from Catch Basin near house #94	1,200	Asphalt		x		96
24	Light Smoke from Catch Basin near house #106	3,600	Asphalt			x	97

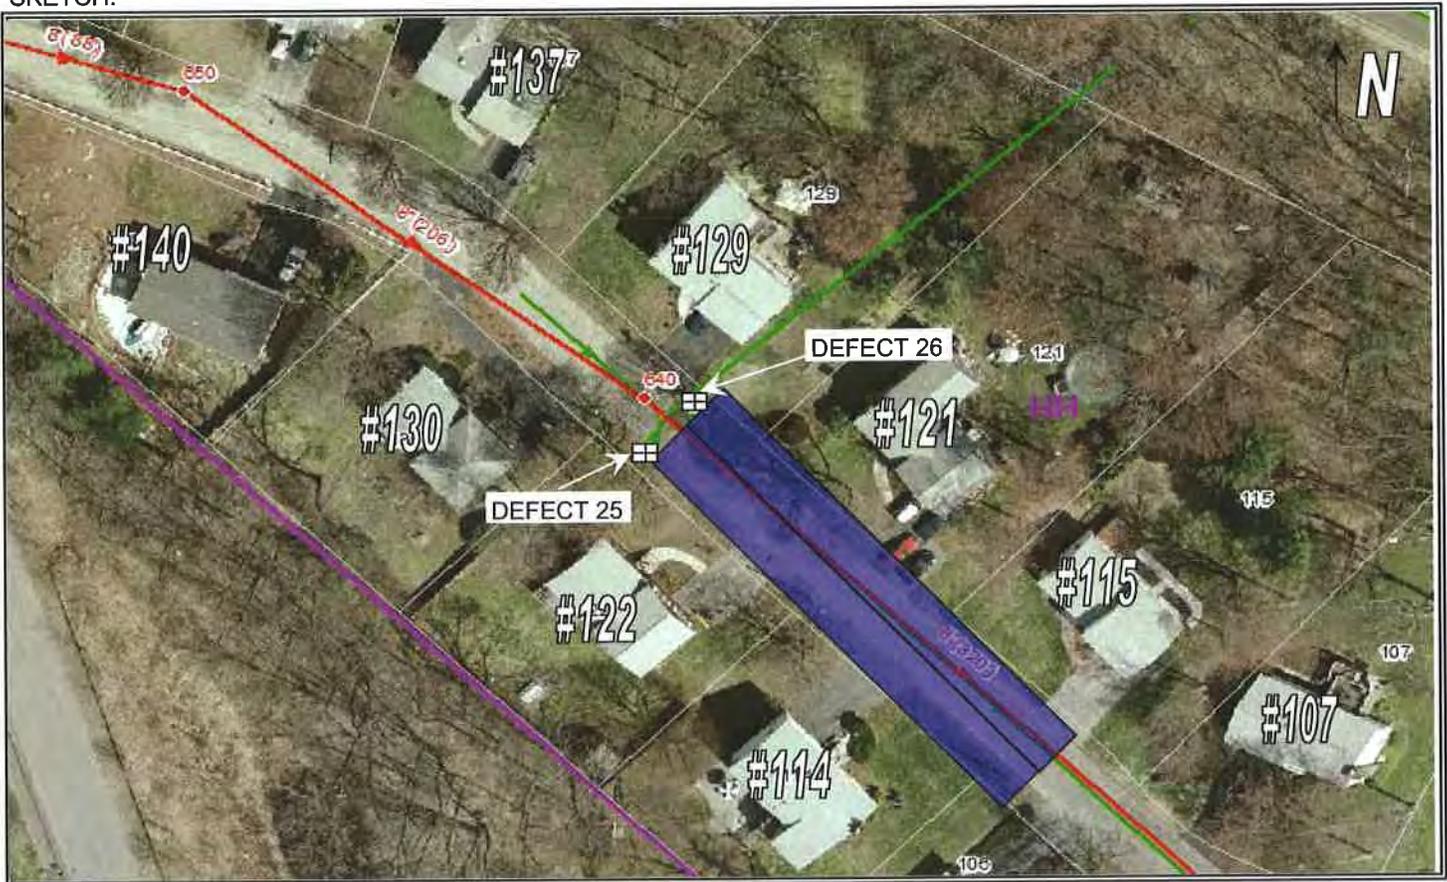
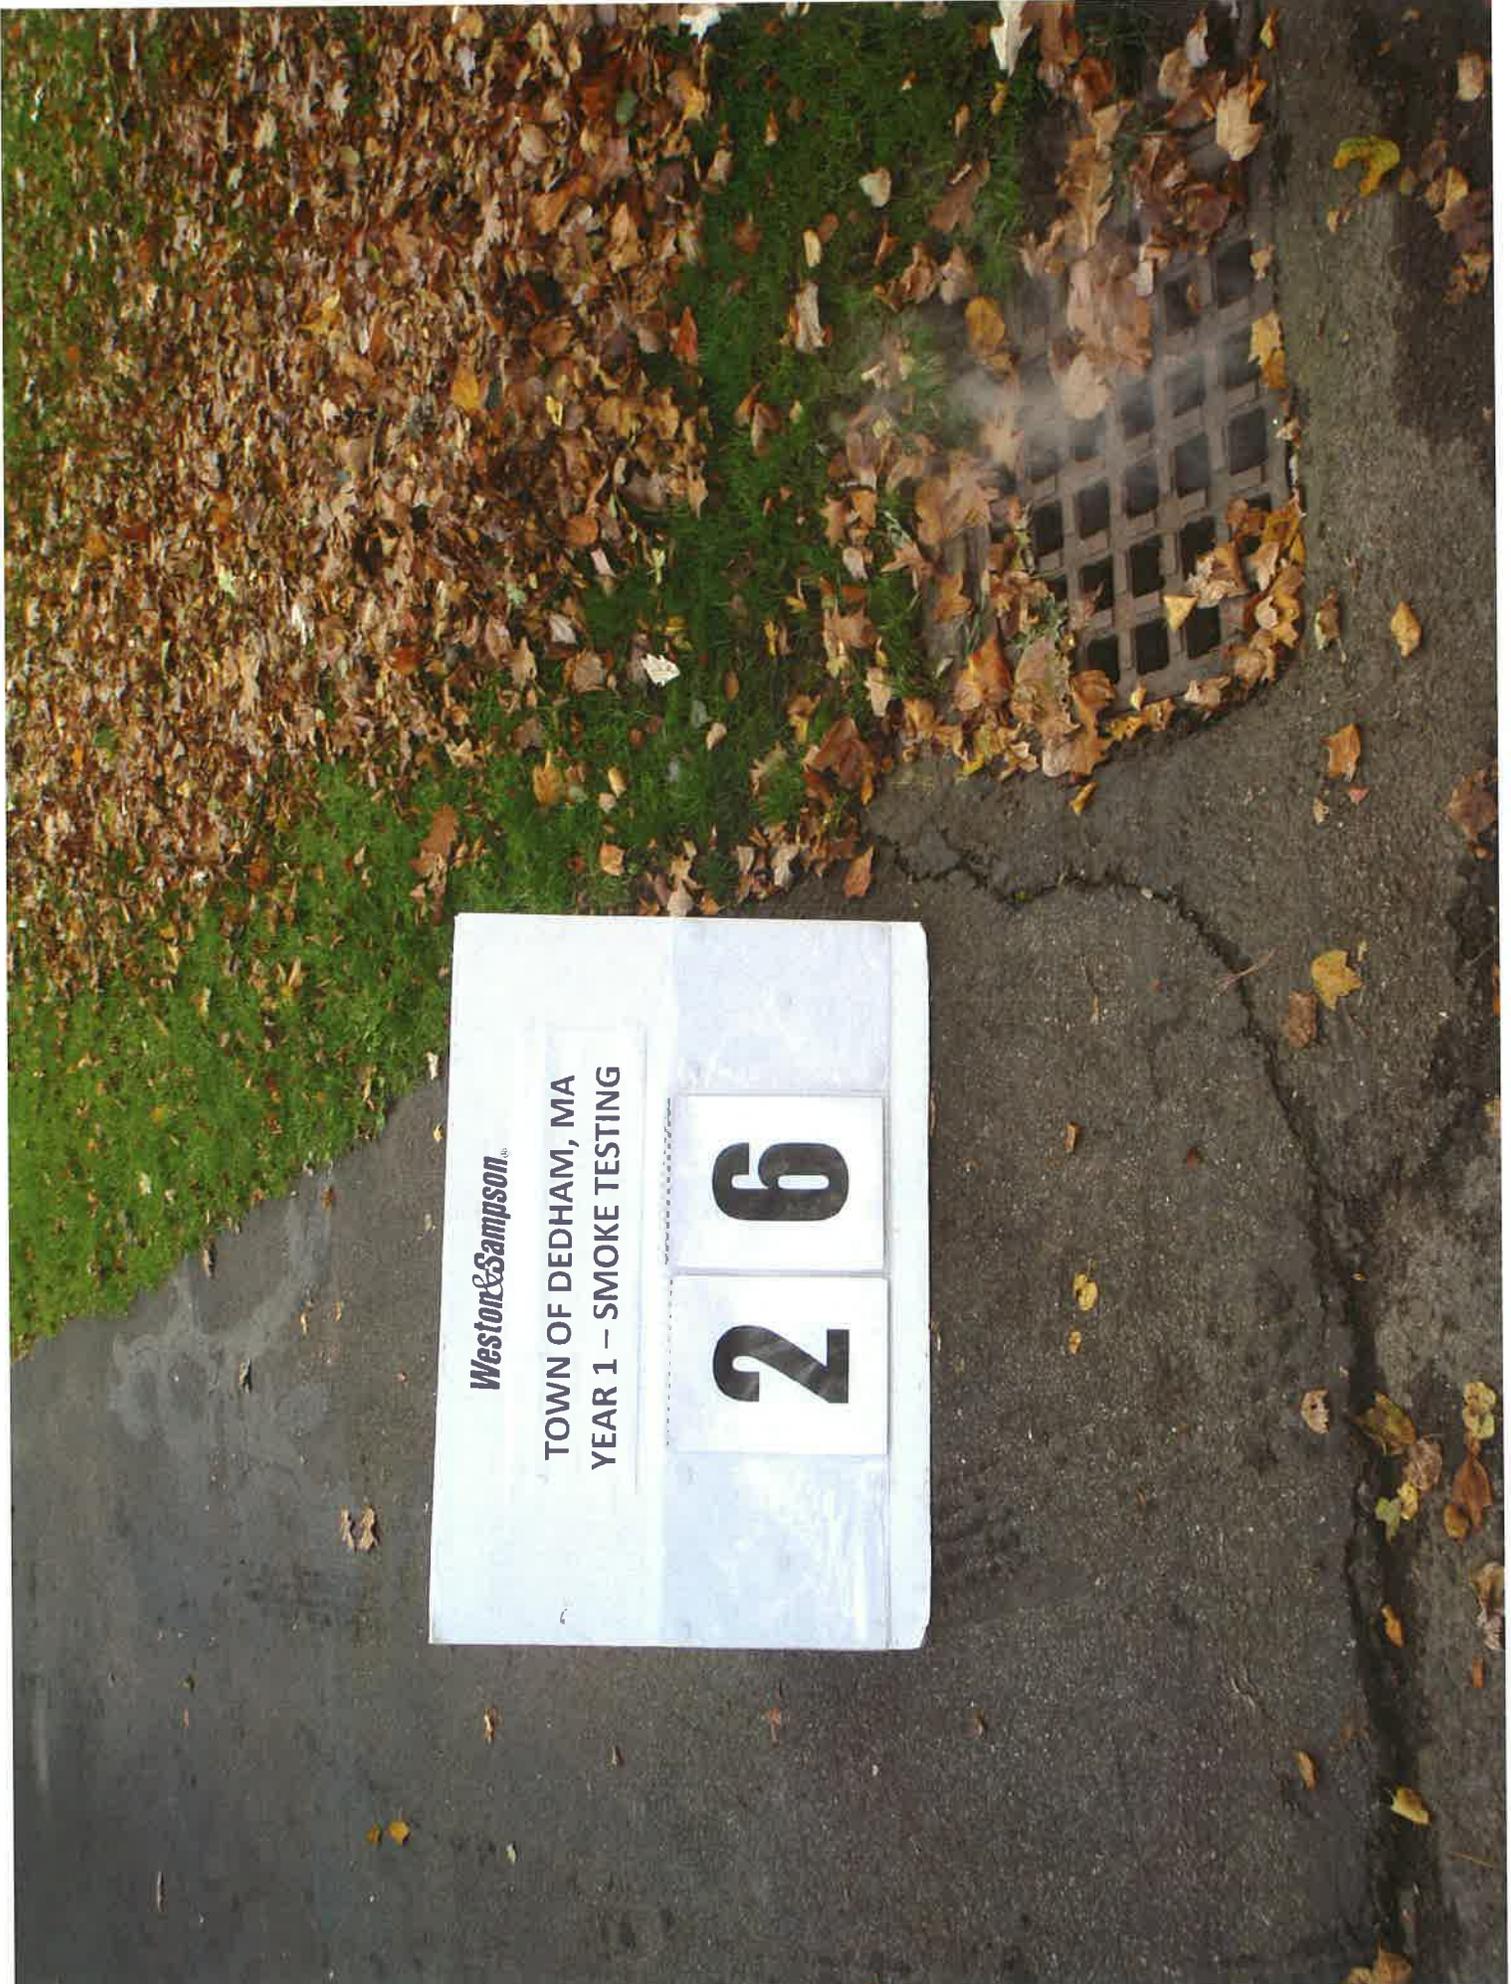
DEFECT: 25 thru 26

DEFECT	DESCRIPTION	Drainage Area (ft <sup>2</sup> )	Surface Type	Severity			Picture No.(s)
				Major	Mod	Minor	
25	Moderate Smoke from Catch Basin near house #122	3,600	Asphalt		x		98
26	Light Smoke from Catch Basin near house #121	3,600	Asphalt			x	99

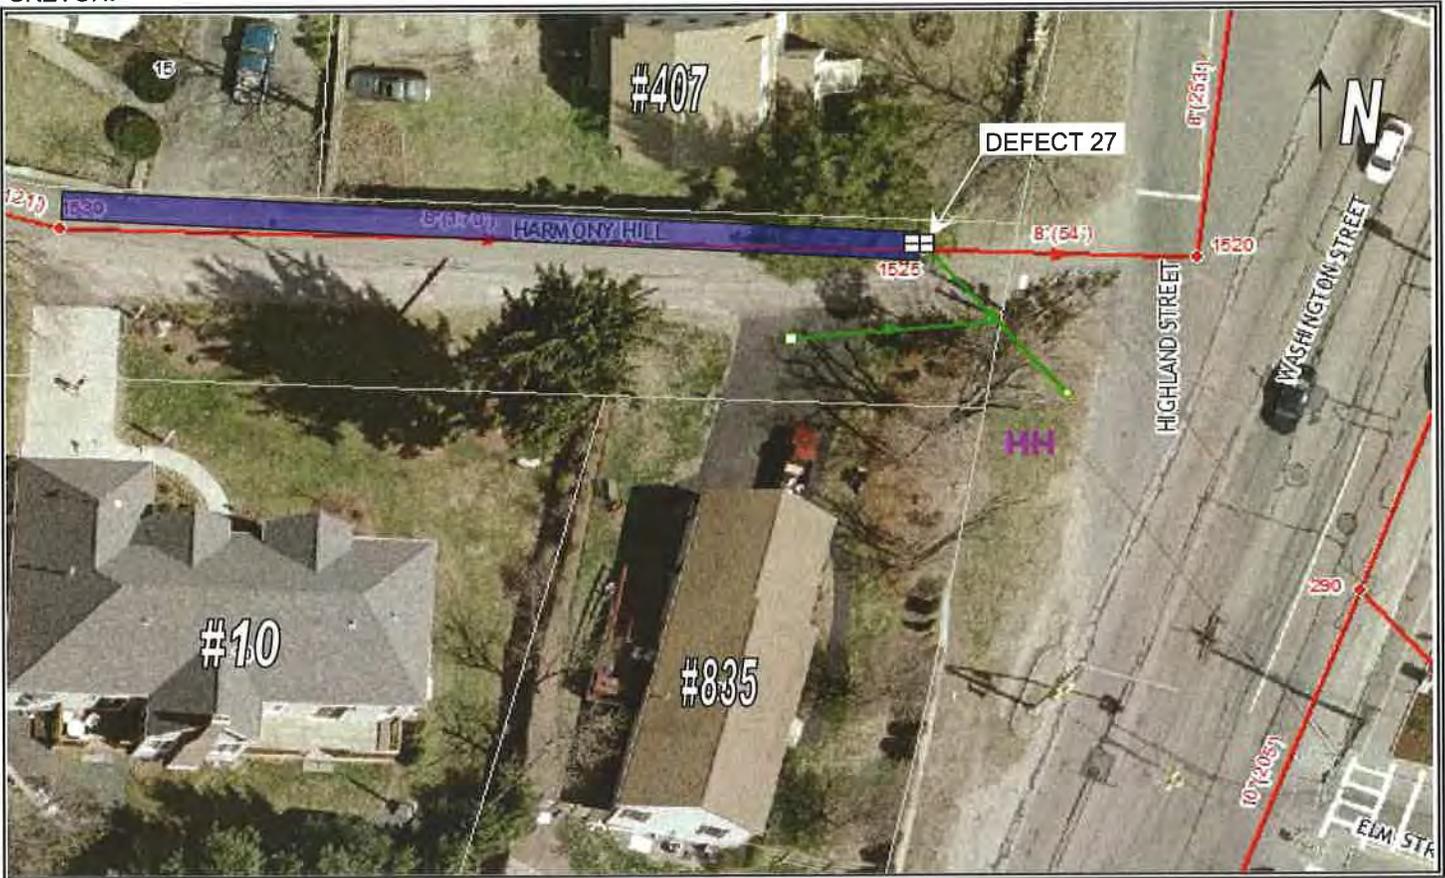
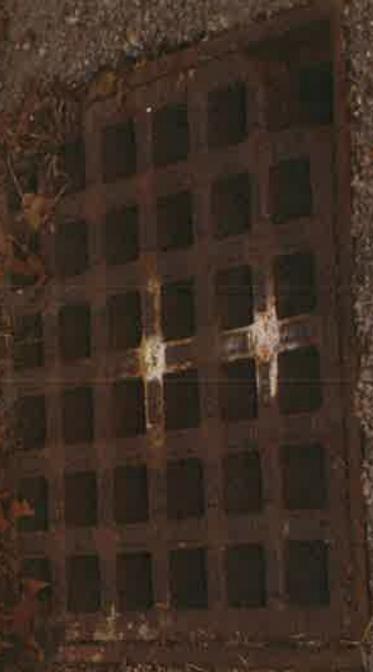
DEFECT: 27 thru 27

DEFECT	DESCRIPTION	Drainage Area (ft <sup>2</sup> )	Surface Type	Severity			Picture No.(s)
				Major	Mod	Minor	
27	Light Smoke from Catch Basin near house #407	2,040	Asphalt			x	101

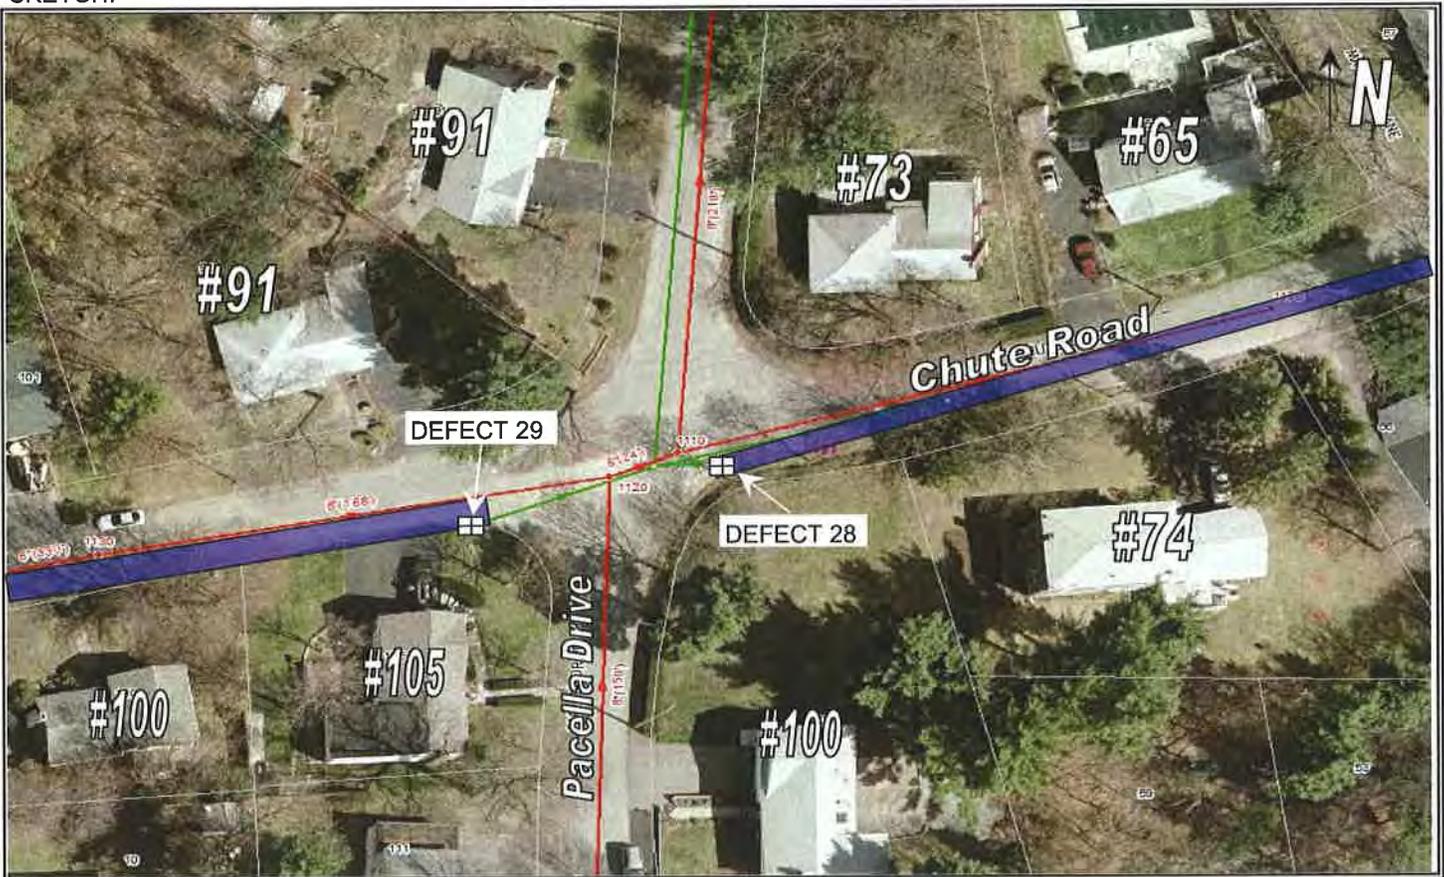
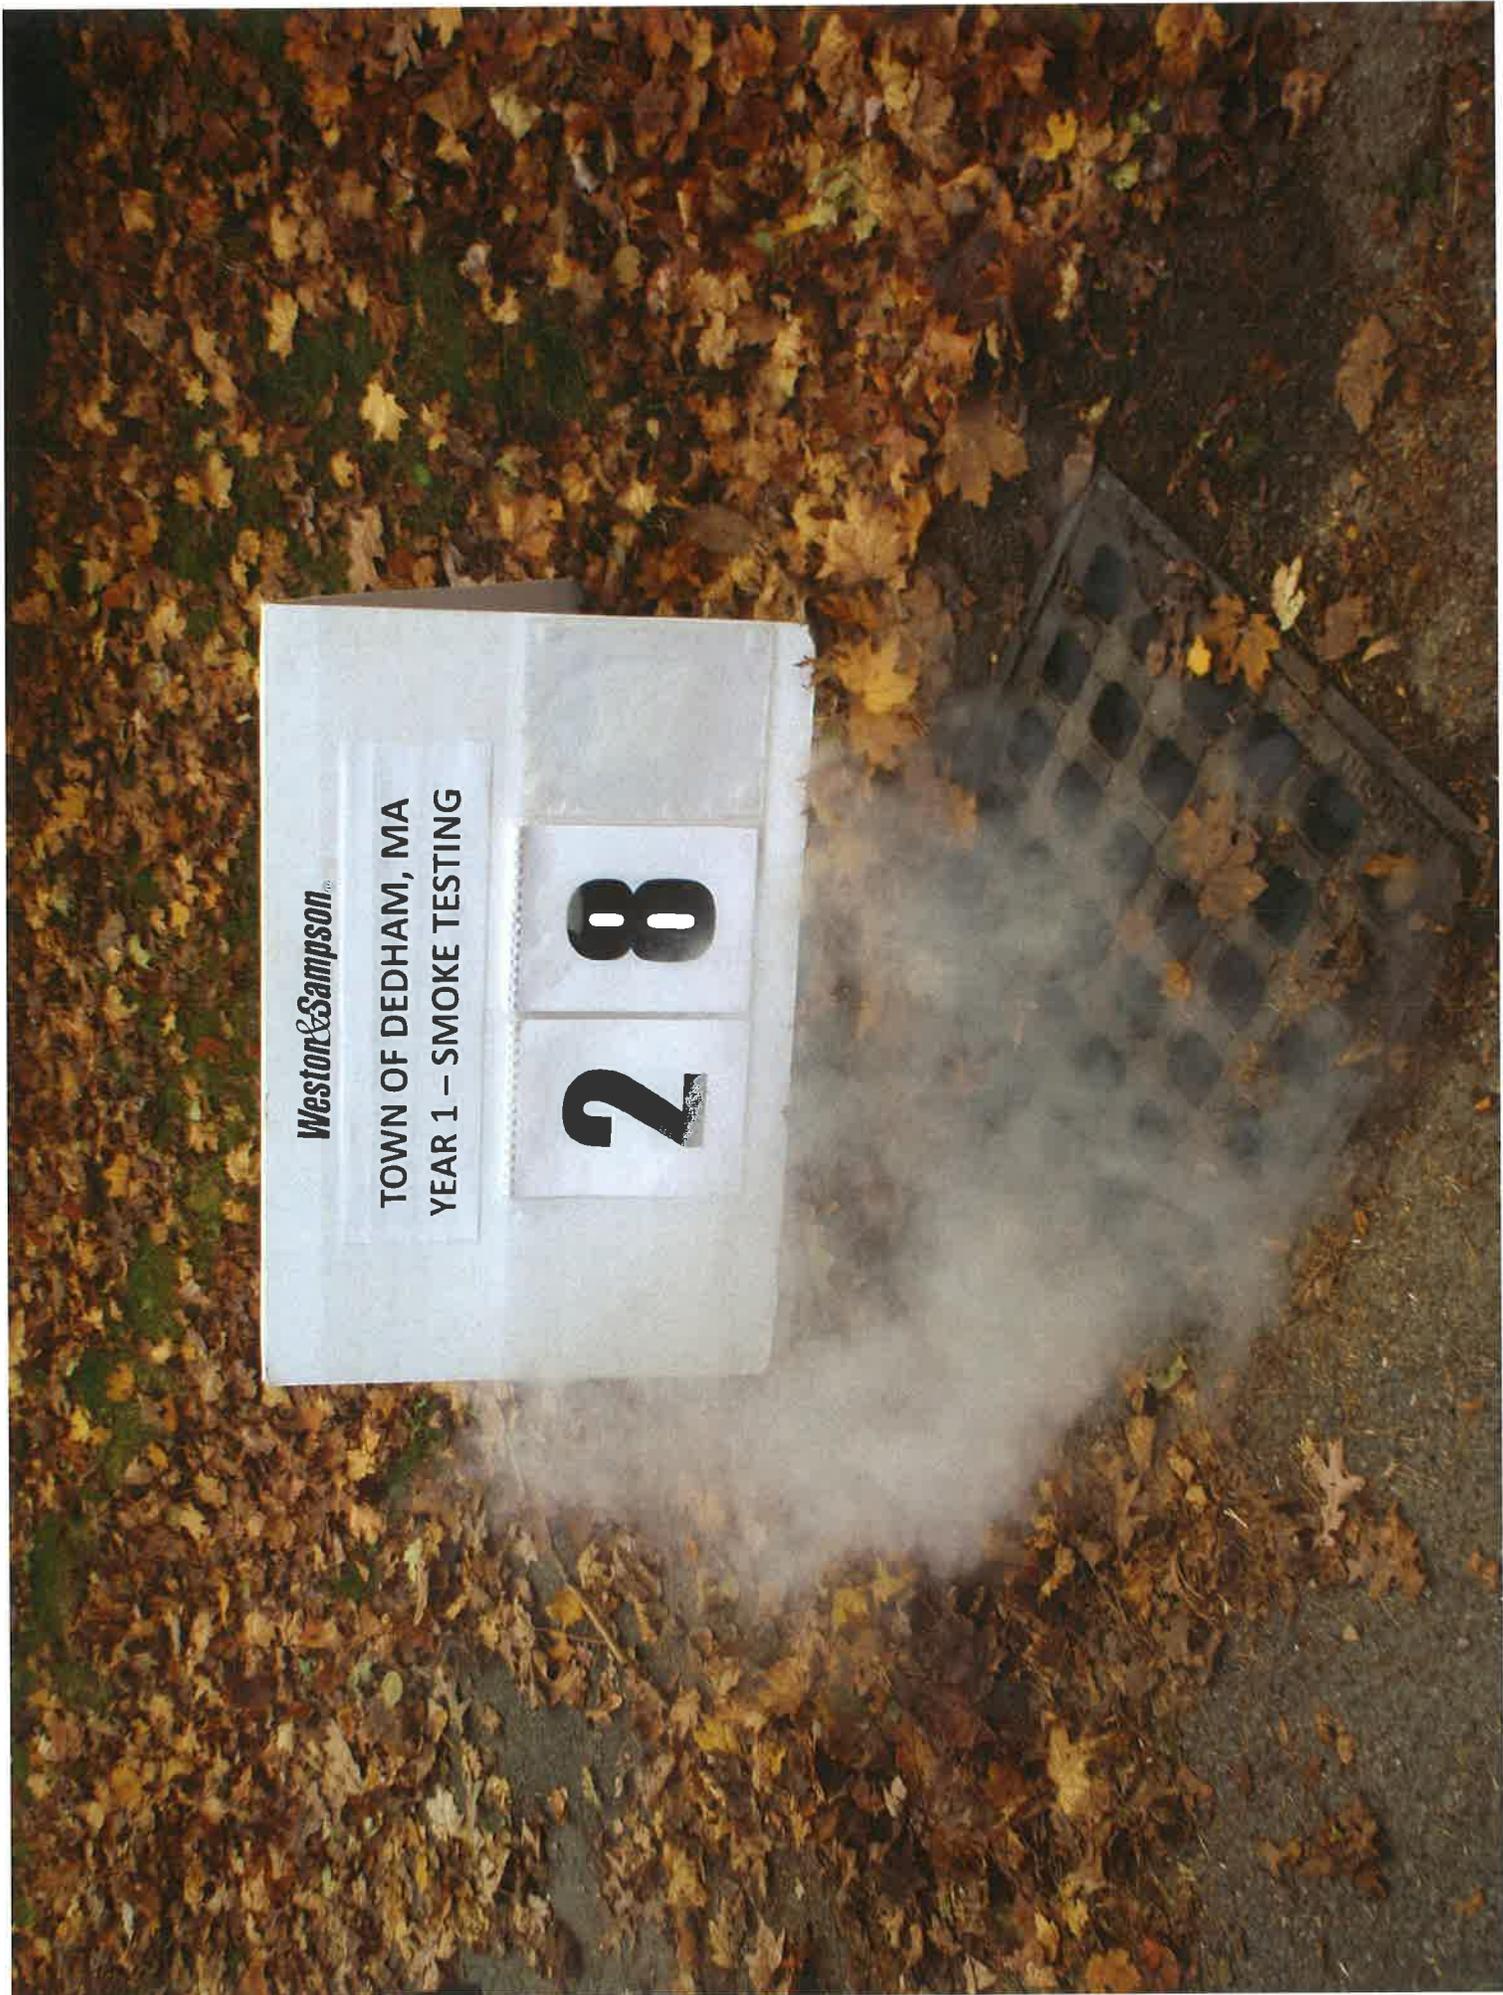
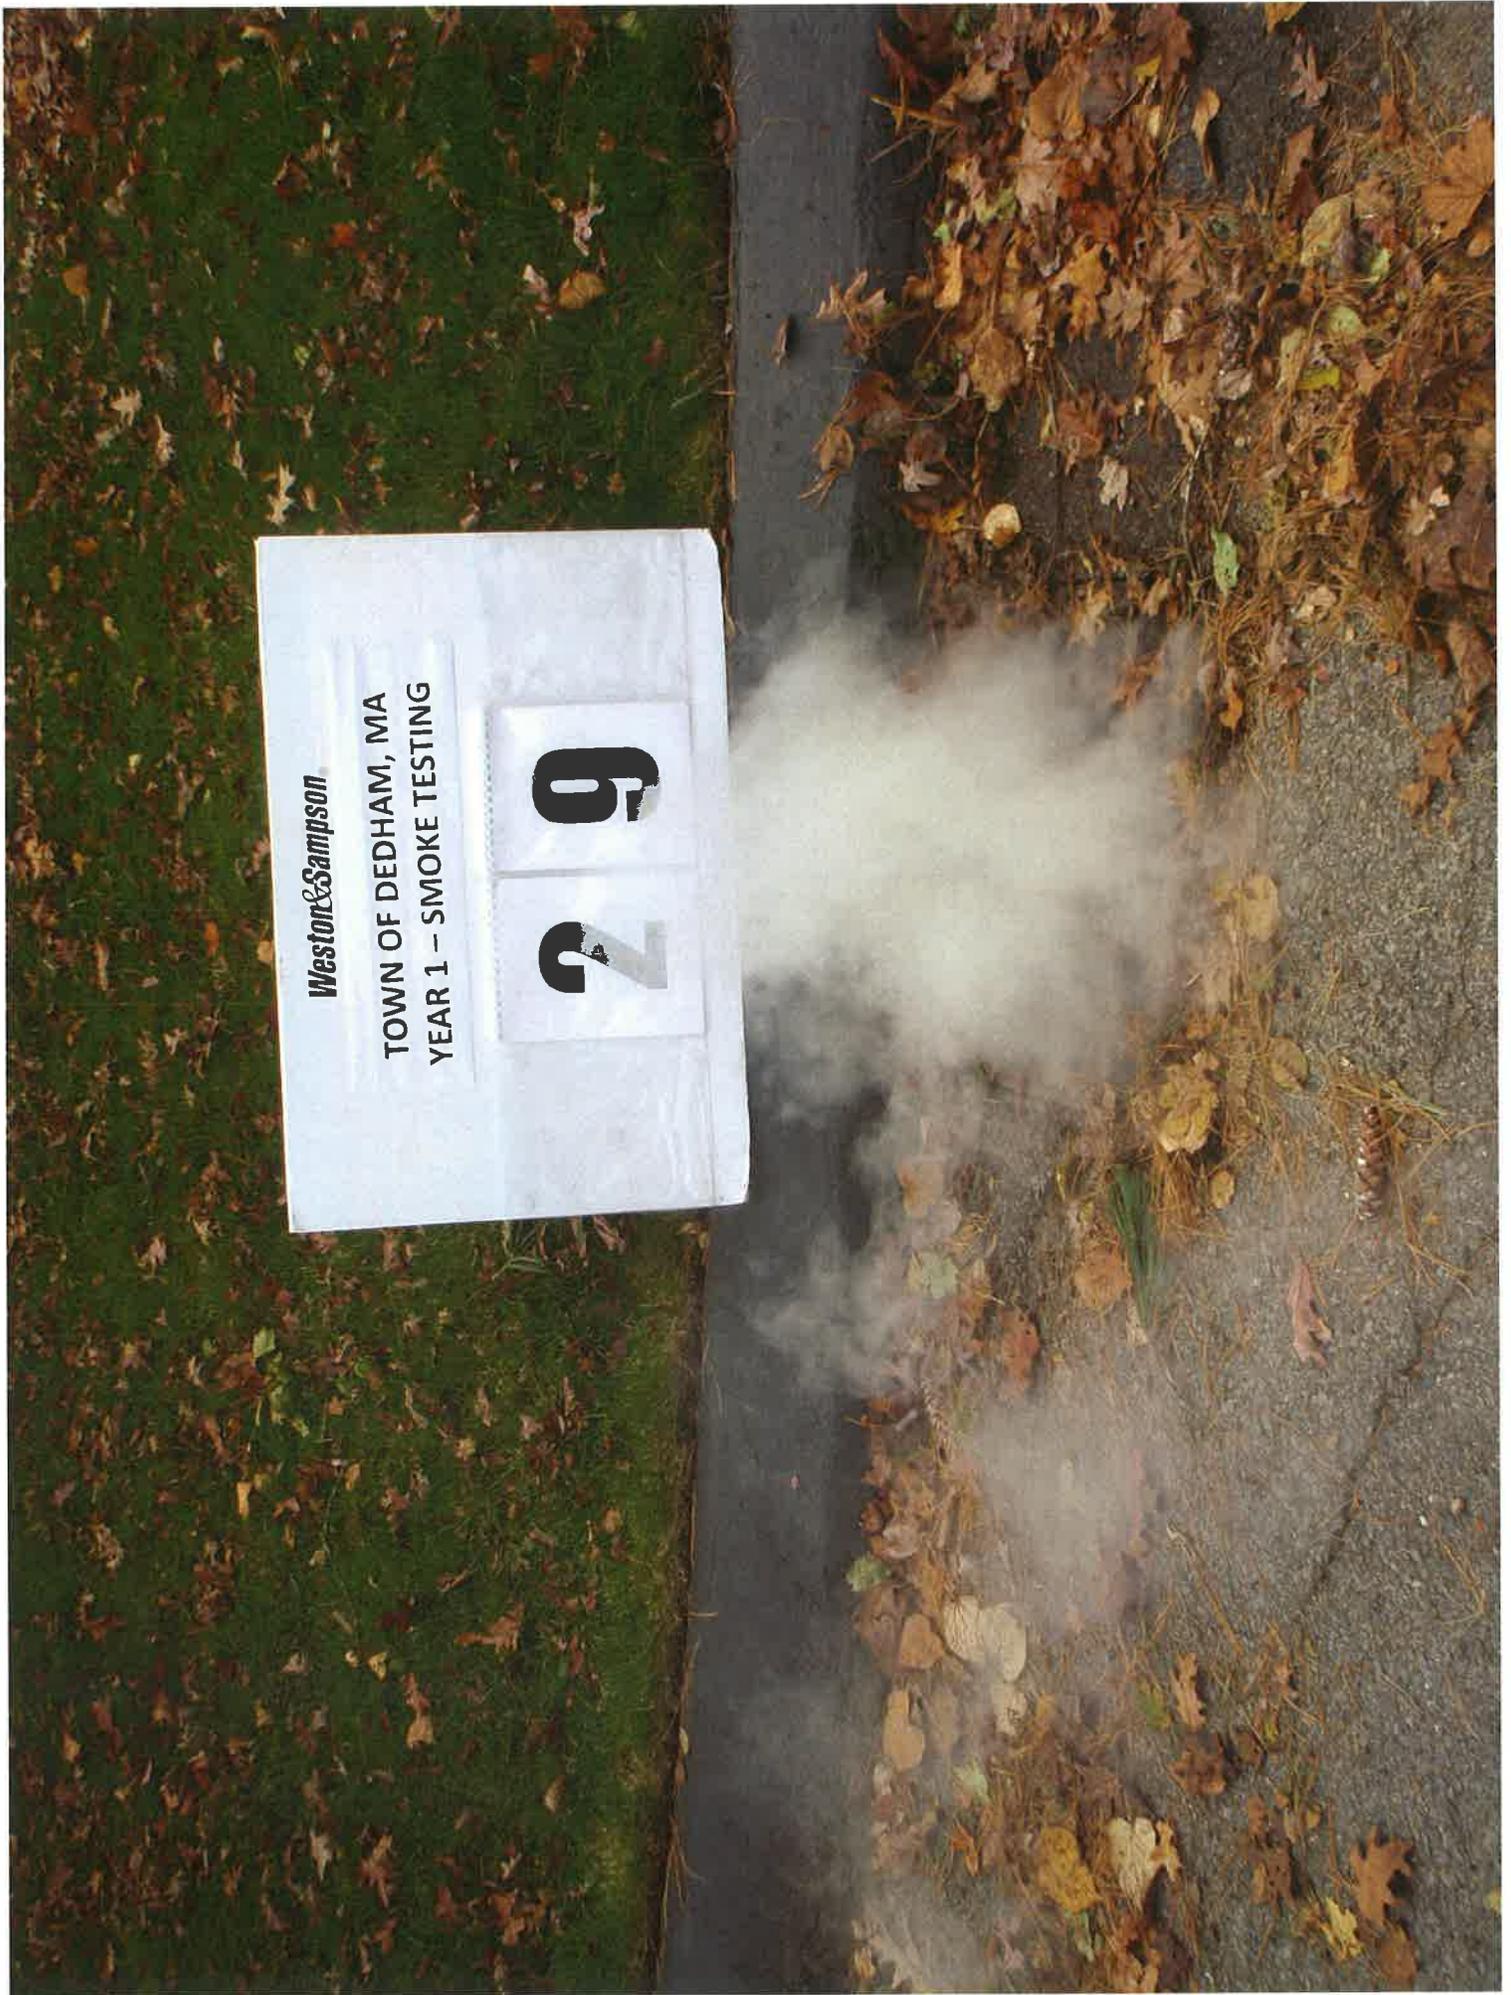
DEFECT: 28 thru 29

DEFECT	DESCRIPTION	Drainage Area (ft <sup>2</sup> )	Surface Type	Severity			Picture No.(s)
				Major	Mod	Minor	
28	Heavy Smoke from Catch Basin near house #100	4,020	Asphalt		x		102
29	Moderate Smoke from Catch Basin near house #105	4,800	Asphalt		x		103
