# **Report**

## **Town of Dedham, MA**

### **2012 Inflow Investigation**

February 2013

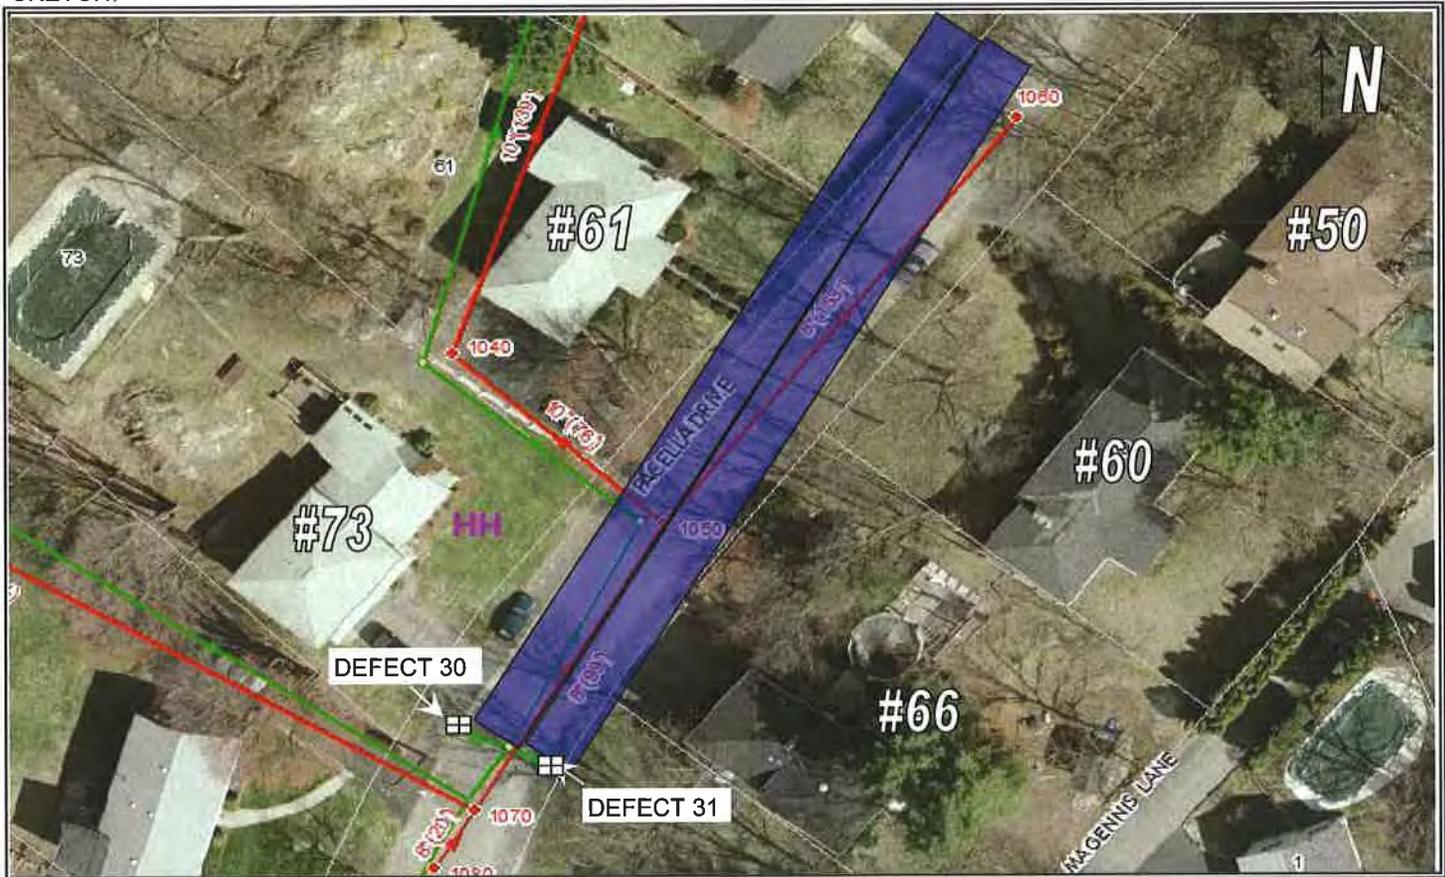
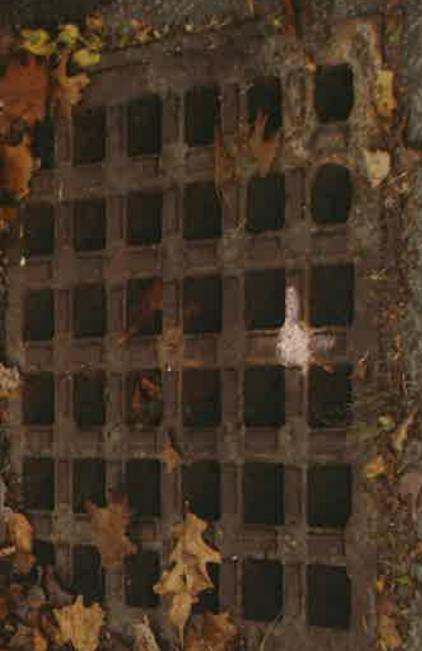
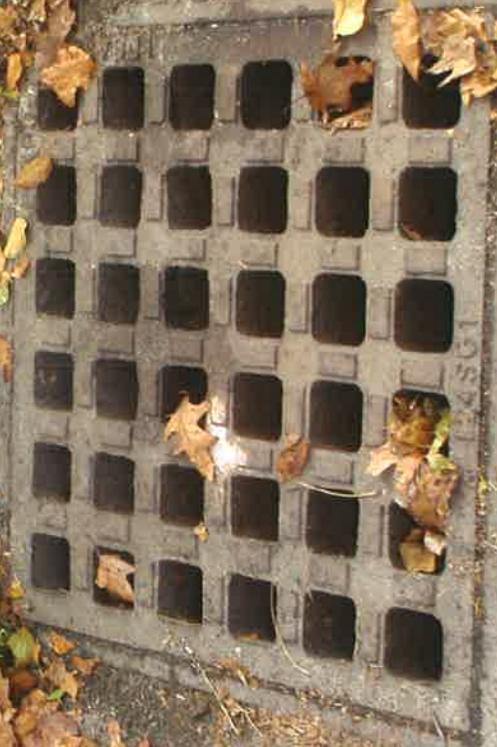
DEFECT: 30 thru 31

DEFECT	DESCRIPTION	Drainage Area (ft <sup>2</sup> )	Surface Type	Severity			Picture No.(s)
				Major	Mod	Minor	
30	Light Smoke form Catch Basin near house #73	3,000	Asphalt			x	104
31	Light Smoke form Catch Basin near house #66	3,000	Asphalt			x	105

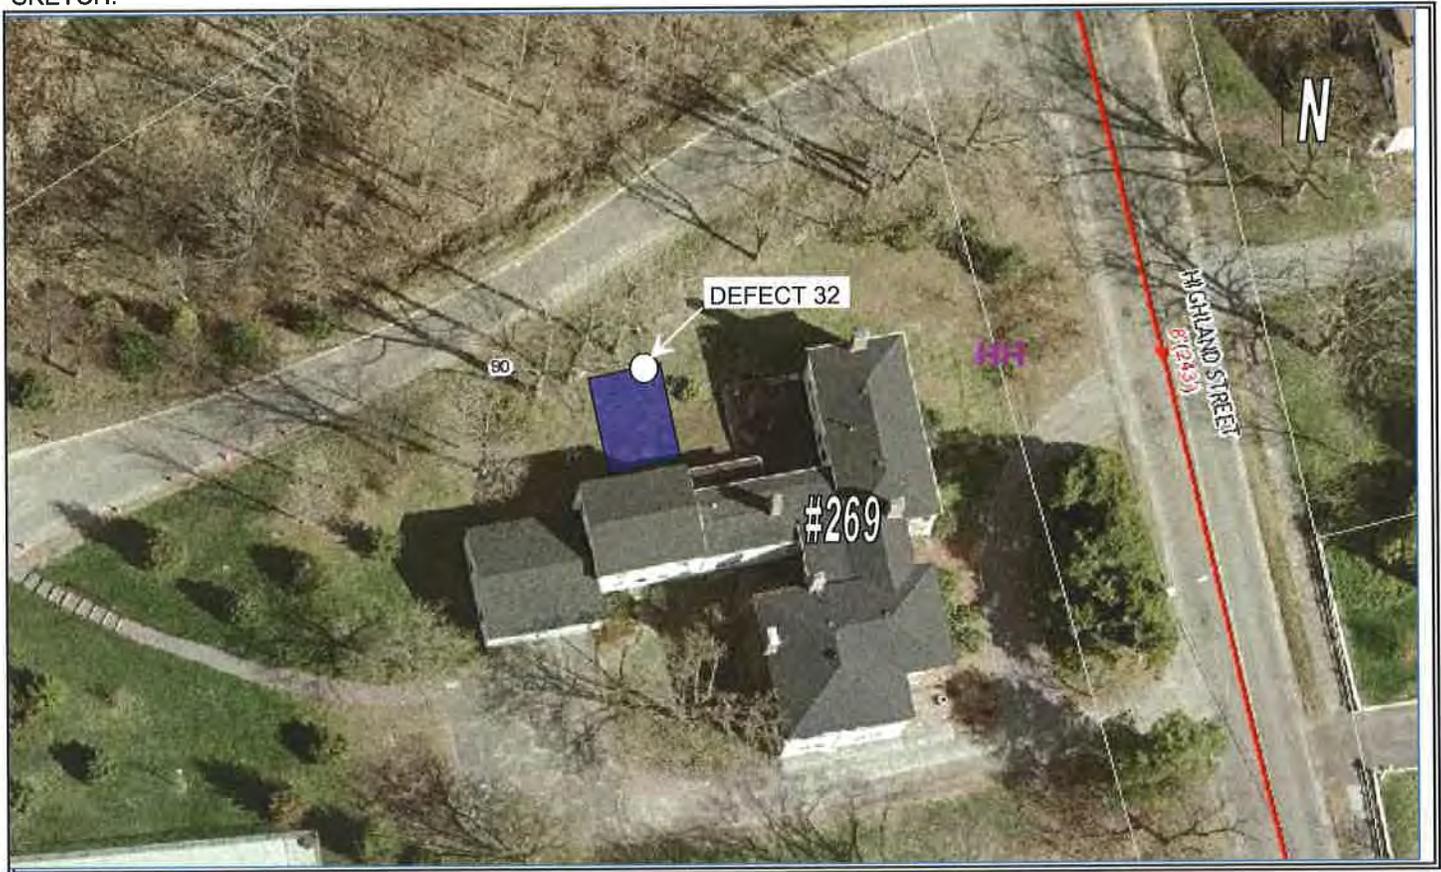
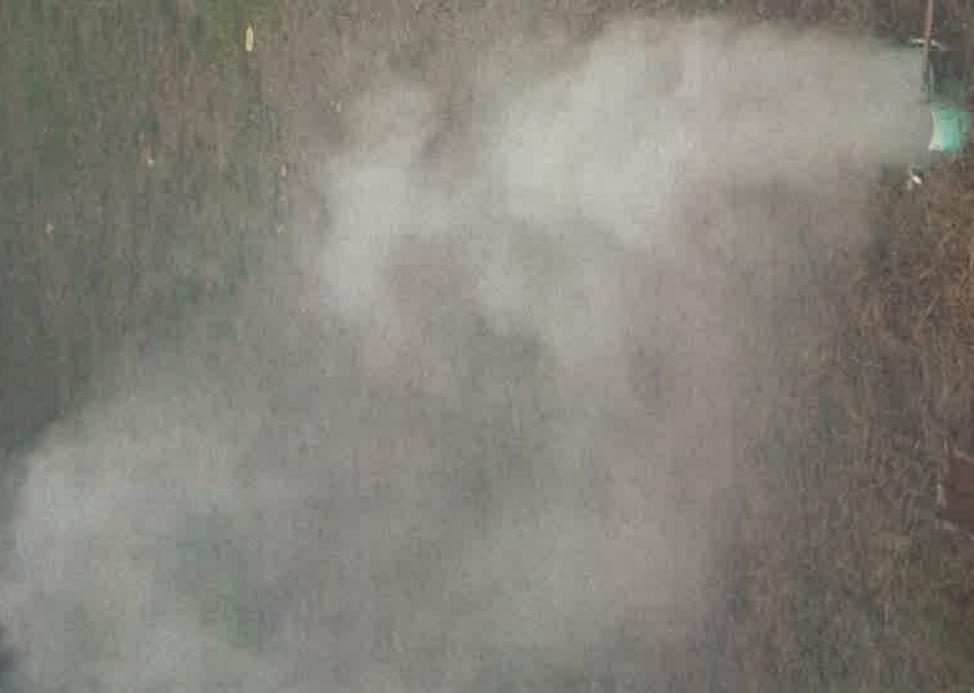
DEFECT: 32 thru 32

DEFECT	DESCRIPTION	Drainage Area (ft <sup>2</sup> )	Surface Type	Severity			Picture No.(s)
				Major	Mod	Minor	
32	Open Cleanout (at grade)	300	Grass		x		106-107

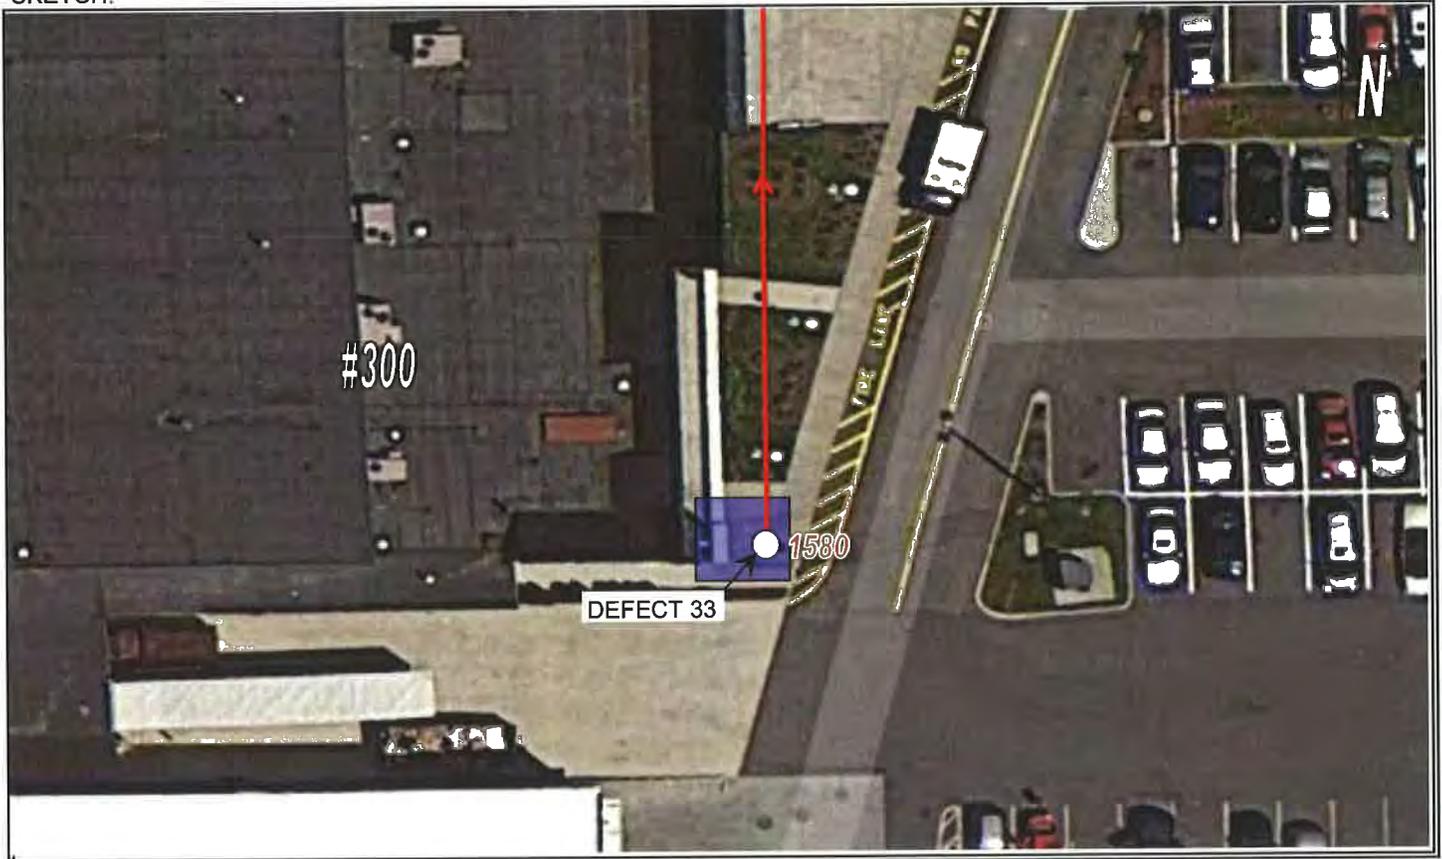
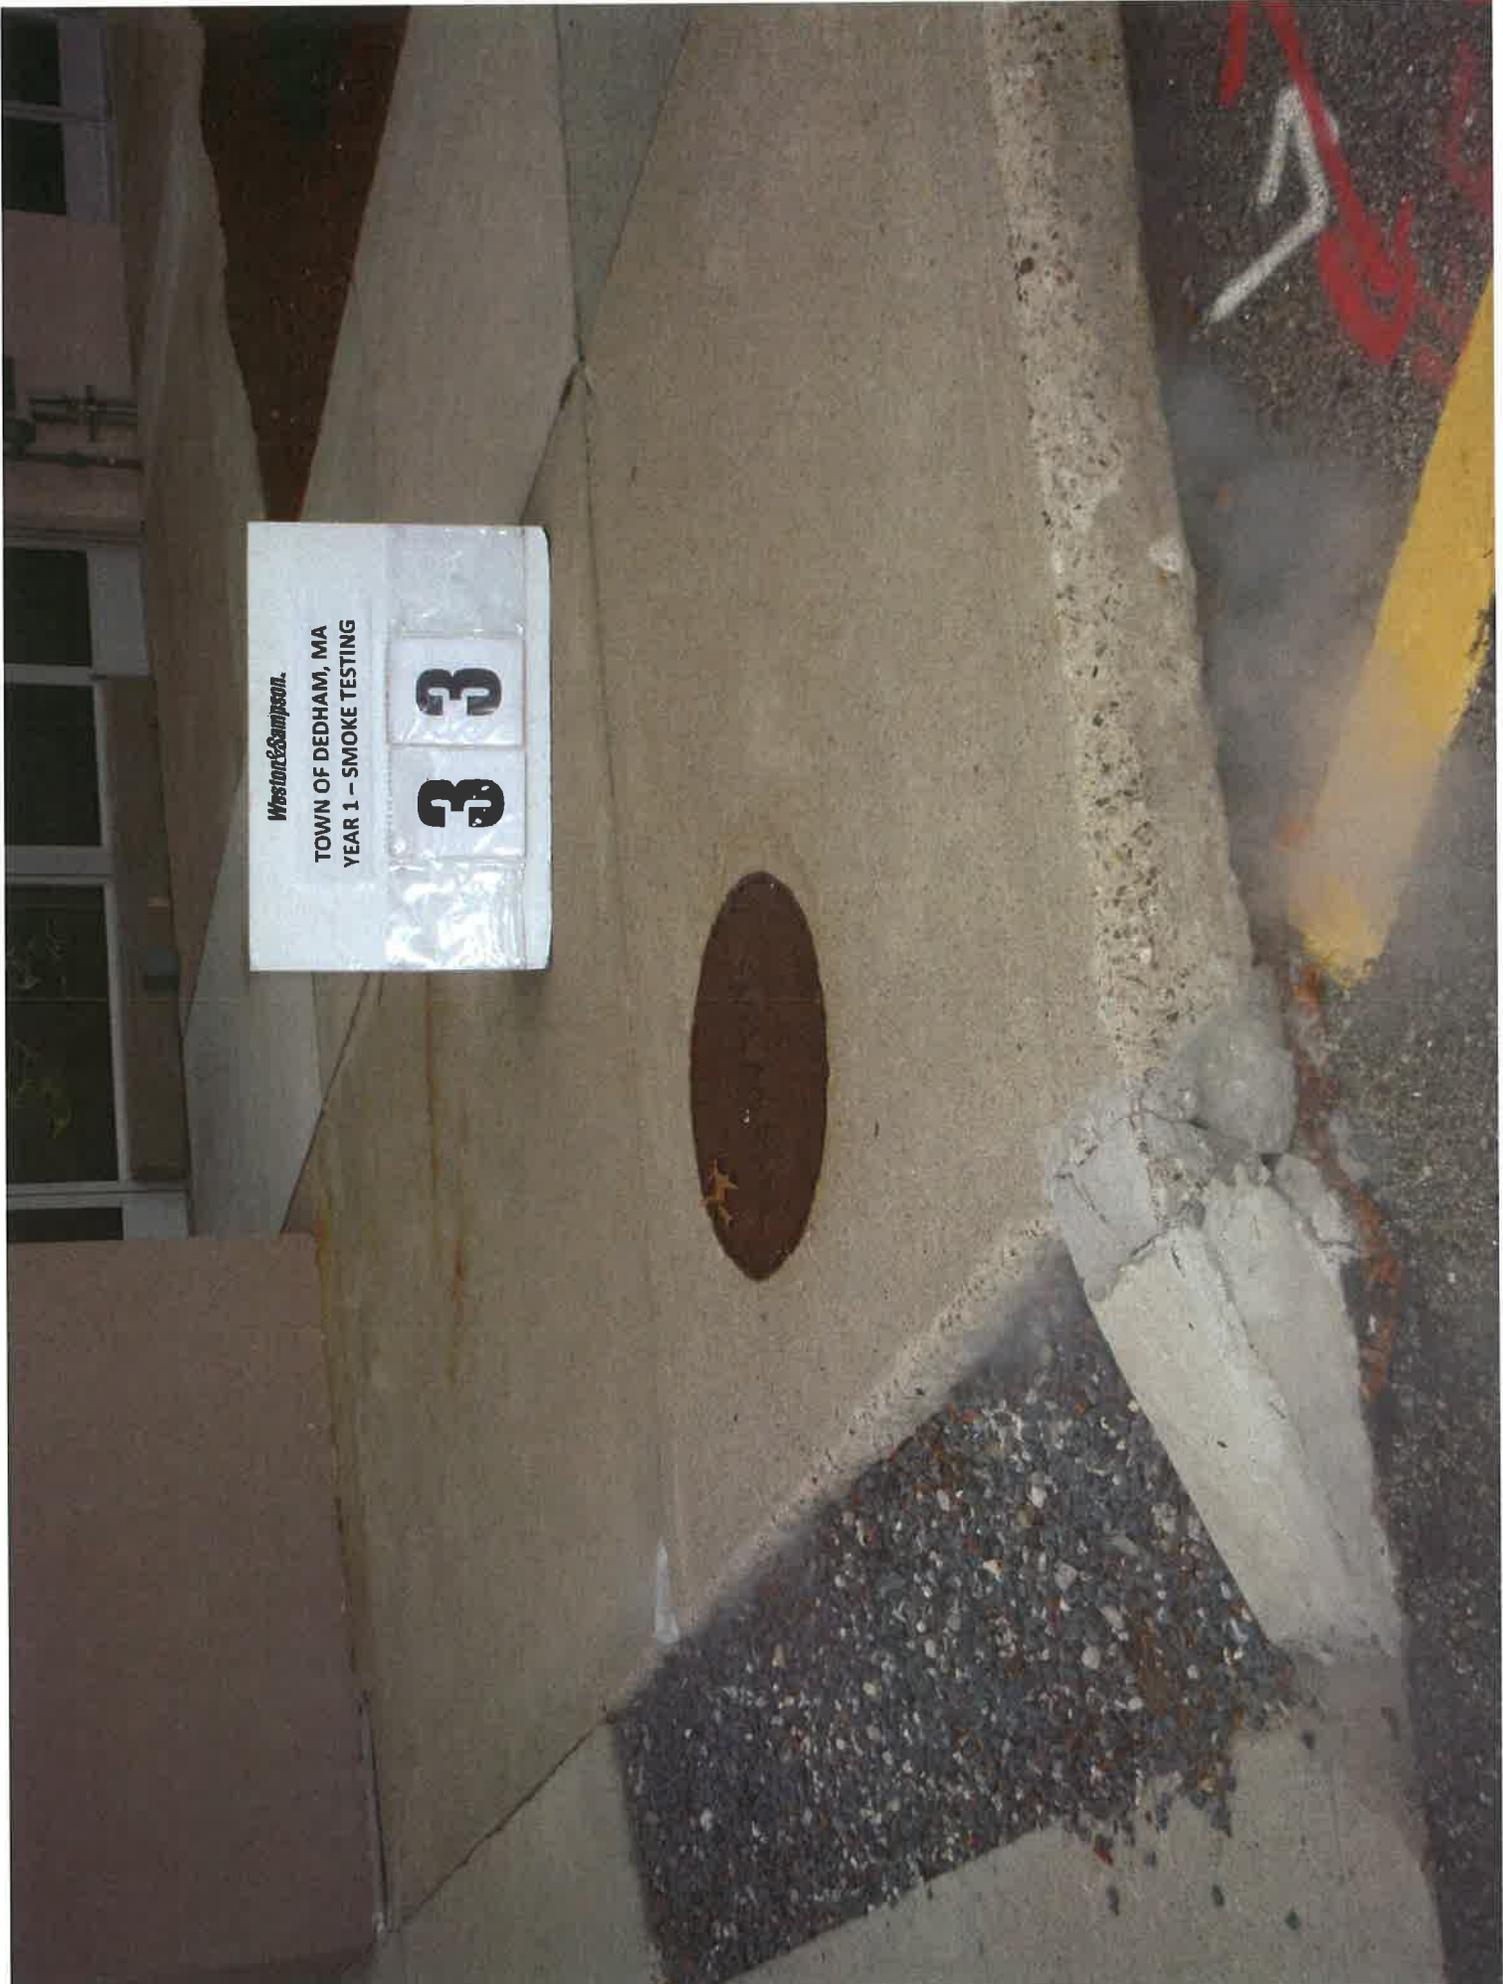
DEFECT: 33 thru 33

DEFECT	DESCRIPTION	Drainage Area (ft <sup>2</sup> )	Surface Type	Severity			Picture No.(s)
				Major	Mod	Minor	
33	Smoke from cracks in sidewalk and pavement around SMH	225	Concrete			x	111

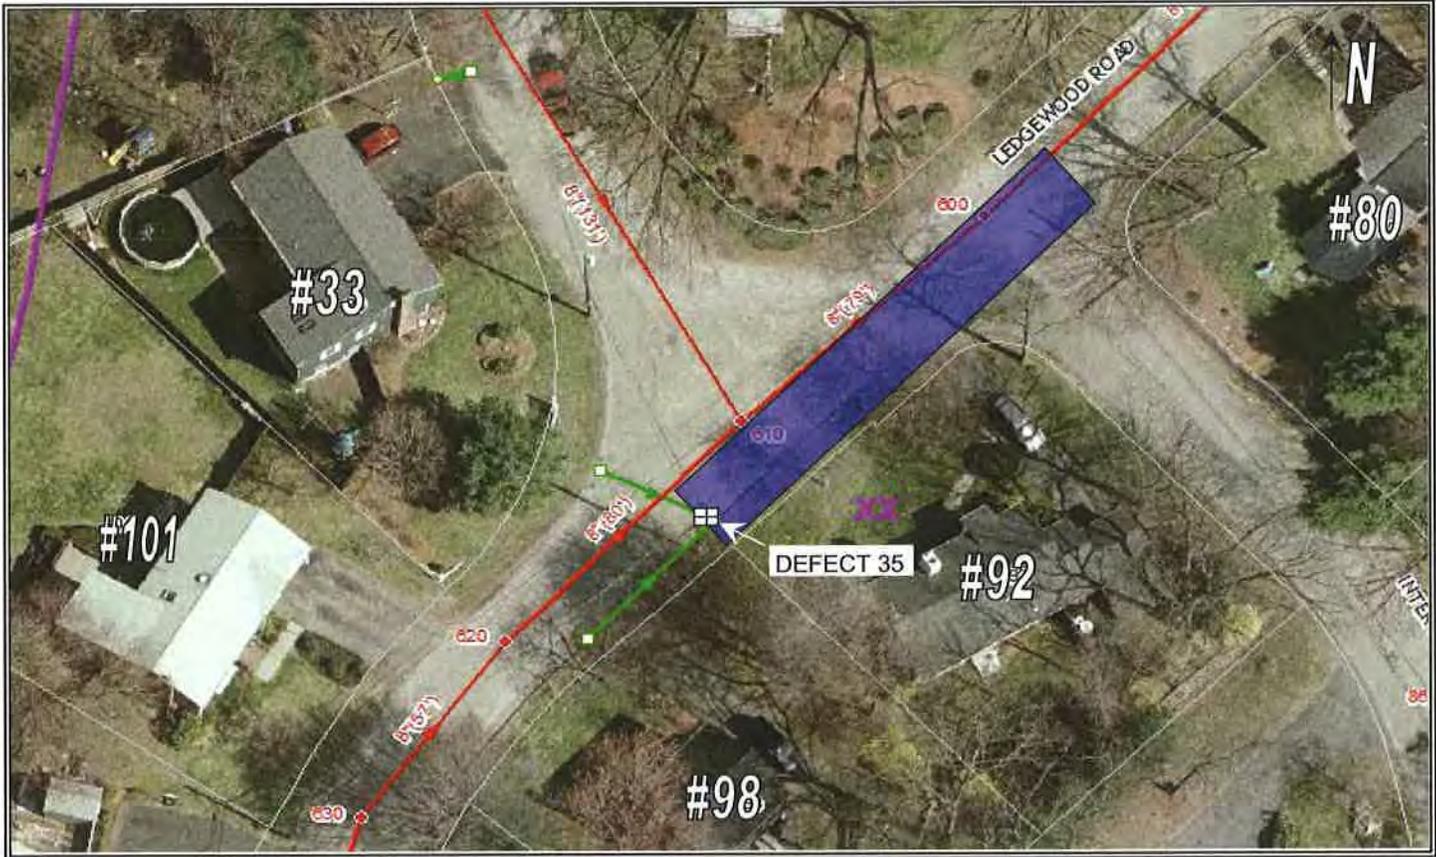
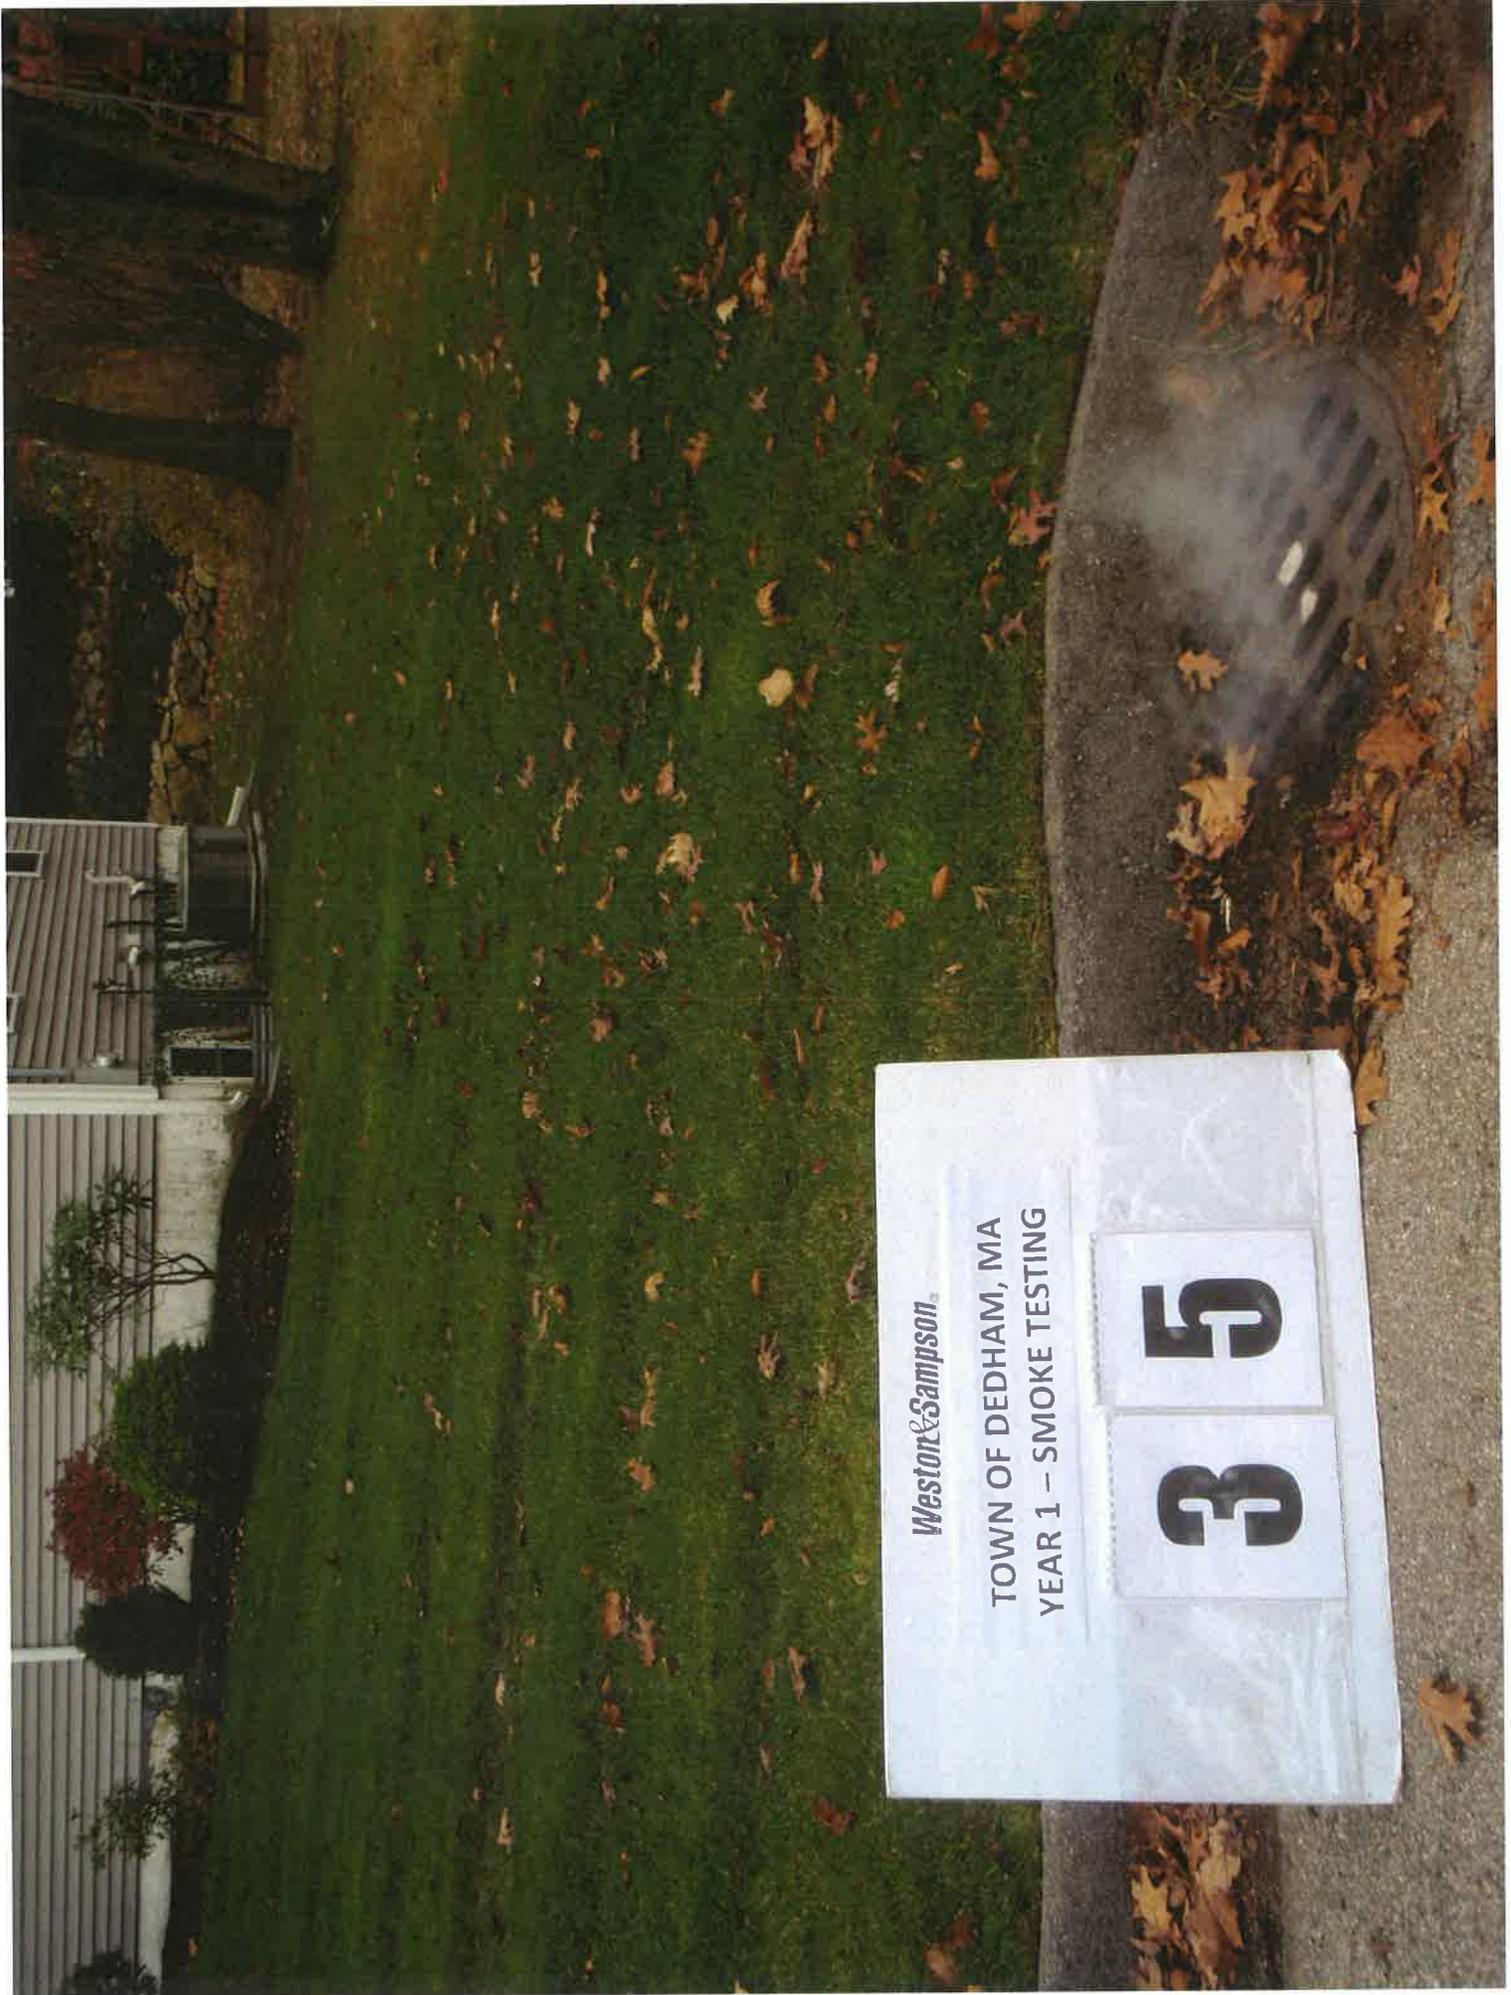
DEFECT: 35 thru 35

DEFECT	DESCRIPTION	Drainage Area (ft <sup>2</sup> )	Surface Type	Severity			Picture No.(s)
				Major	Mod	Minor	
35	Moderate Smoke from Catch Basin near house #92	1,800	Asphalt		x

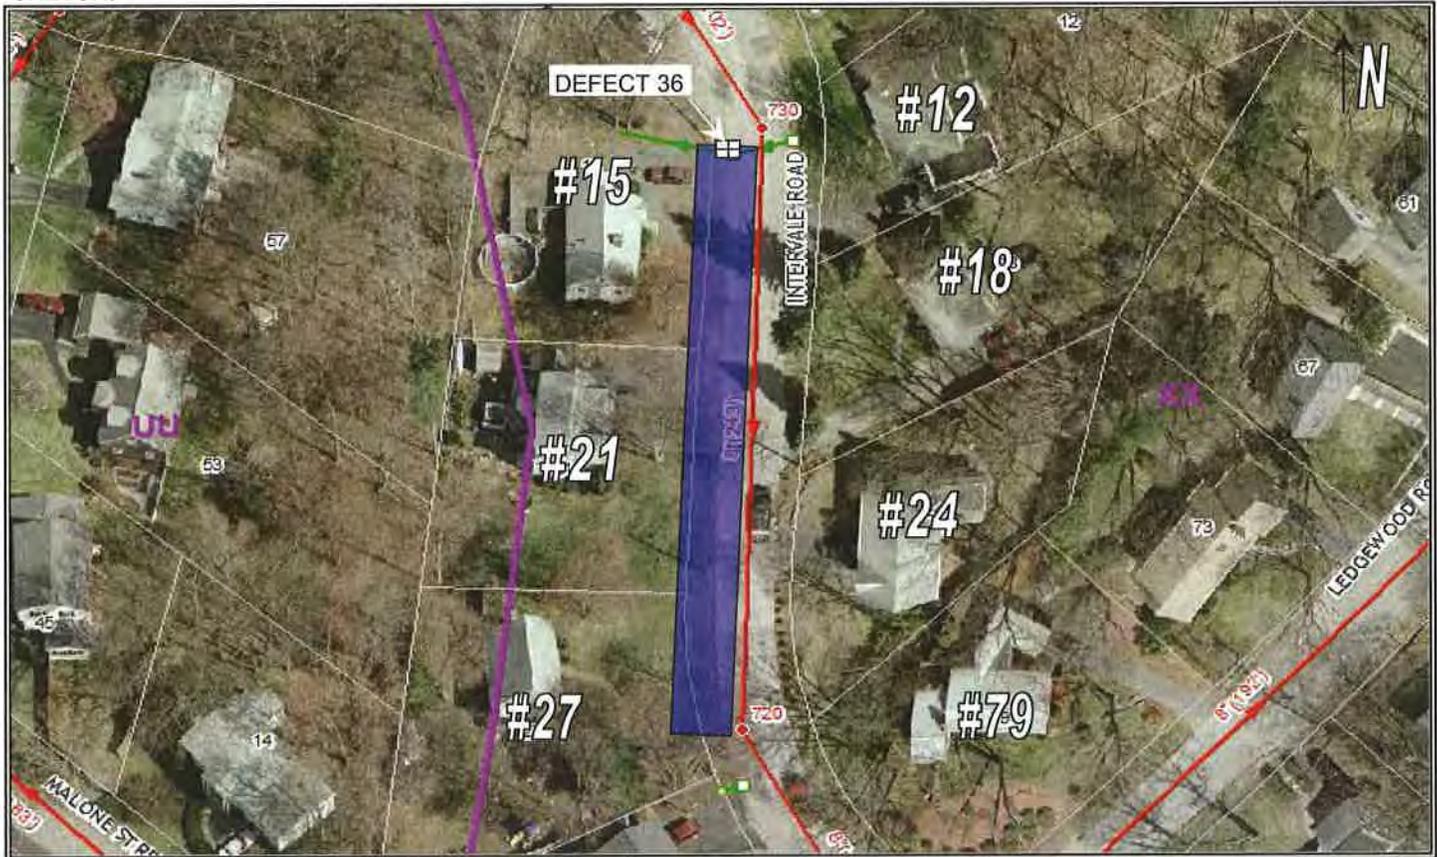
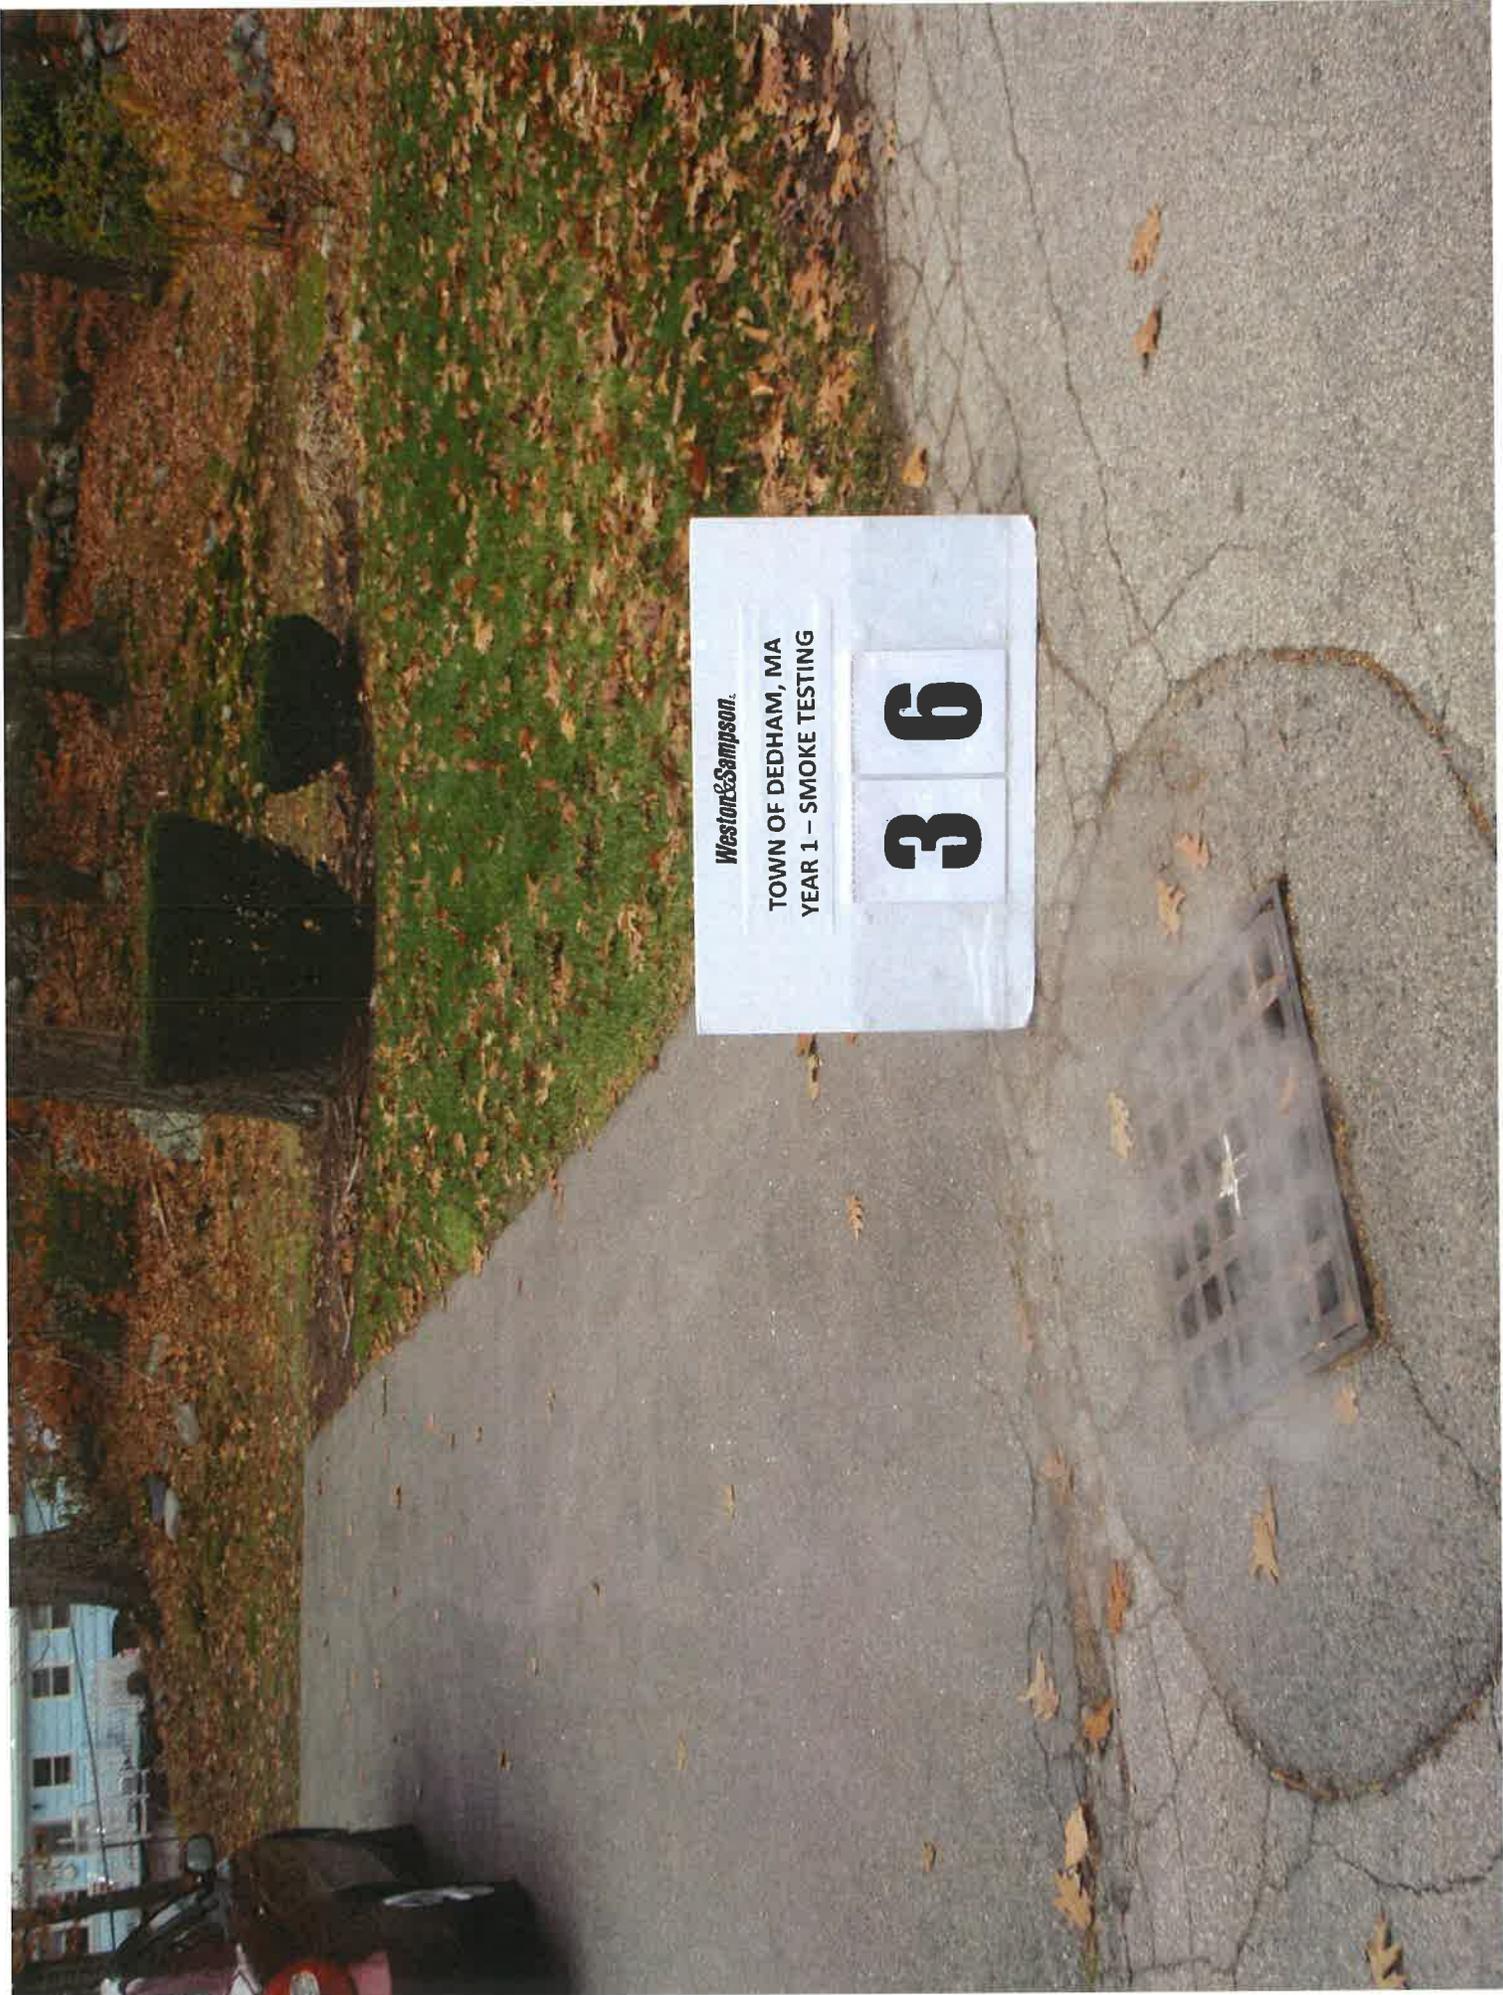
DEFECT: 36 thru 36

DEFECT	DESCRIPTION	Drainage Area (ft <sup>2</sup> )	Surface Type	Severity			Picture No.(s)
				Major	Mod	Minor	
36	Moderate Smoke from Catch Basin near house #15	2,916	Asphalt		x

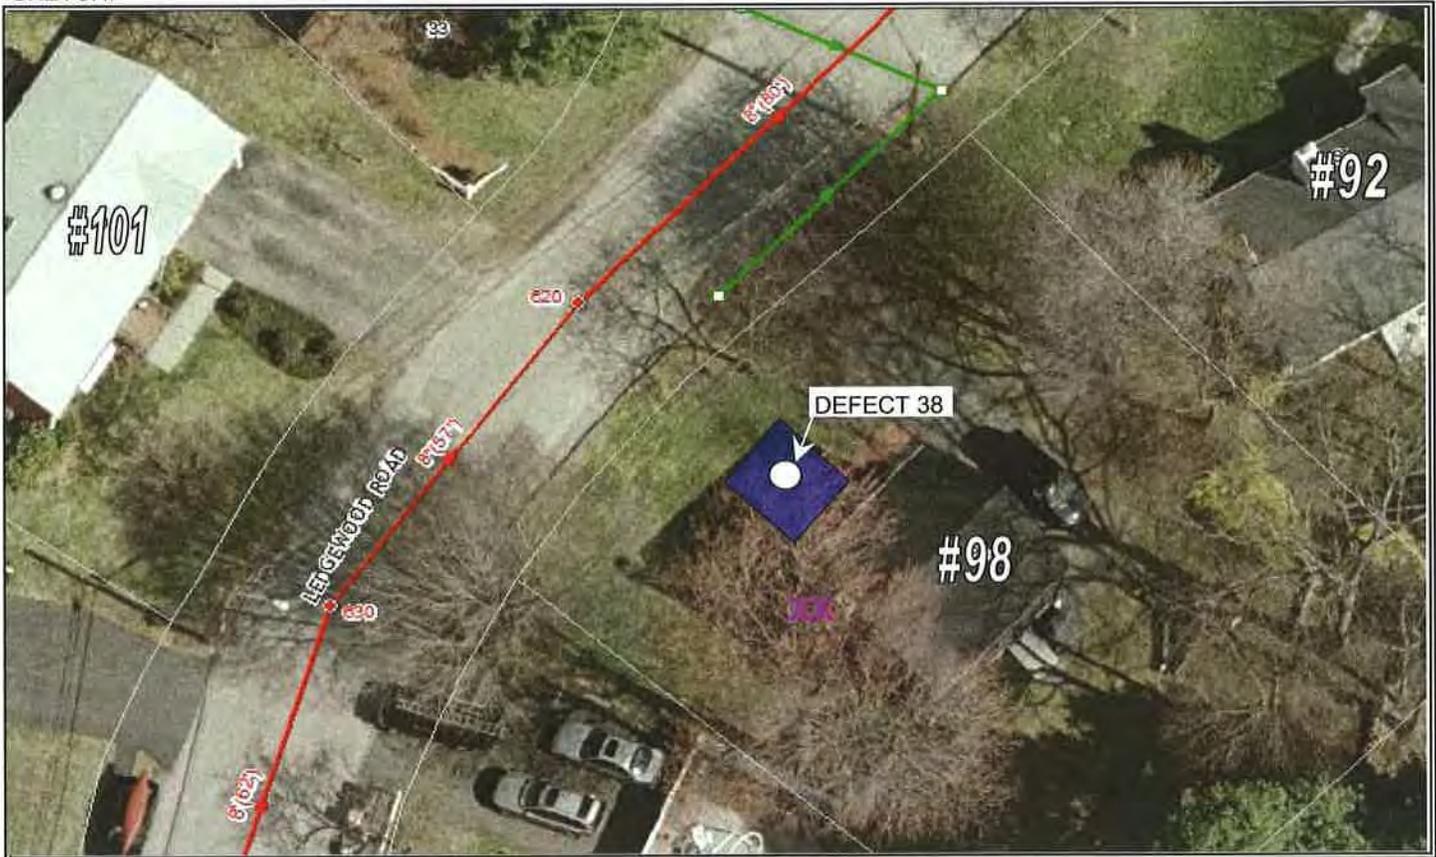
DEFECT: 38 thru 38

DEFECT	DESCRIPTION	Drainage Area (ft <sup>2</sup> )	Surface Type	Severity			Picture No.(s)
				Major	Mod	Minor	
38	Light Smoke rising from yard near house #98	100	Grass			x

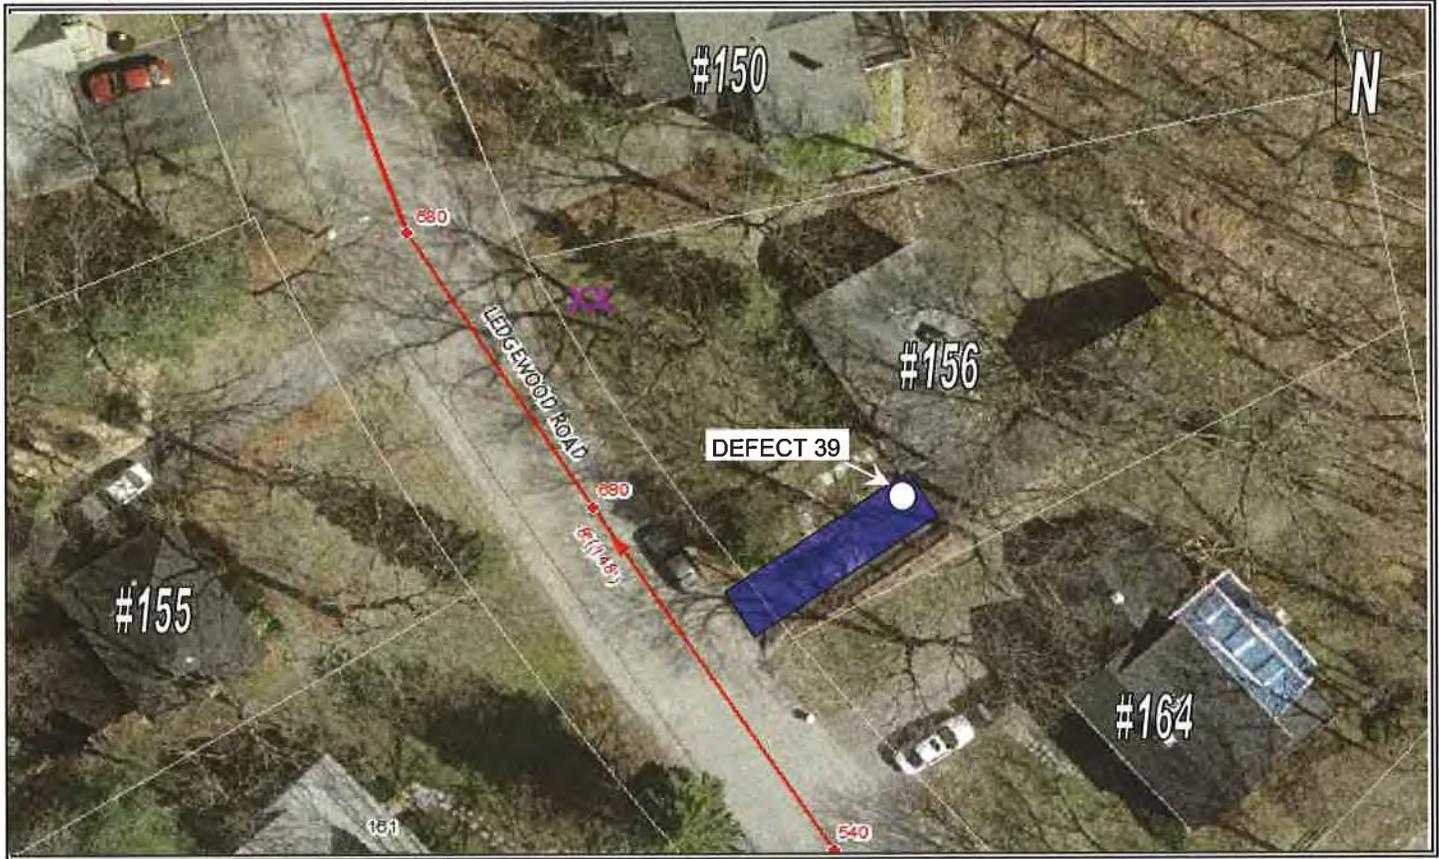
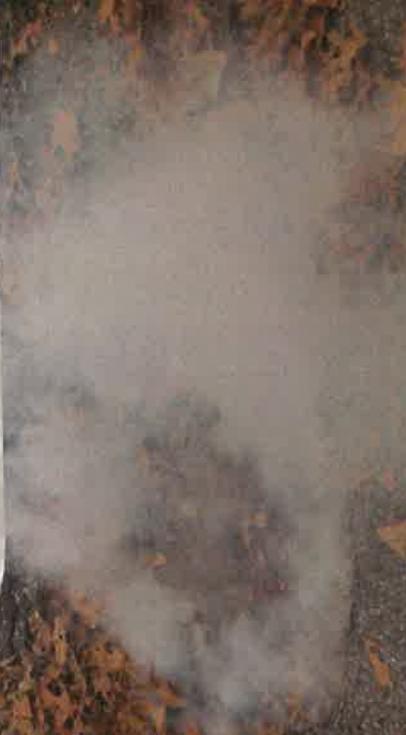
DEFECT: 39 thru 39

DEFECT	DESCRIPTION	Drainage Area (ft <sup>2</sup> )	Surface Type	Severity			Picture No.(s)
				Major	Mod	Minor	
39	Moderate Smoke from Service Manhole near house #156	540	Ashault		x
