# **Report**

## **Town of Dedham, MA**

### **2012 Inflow Investigation**

February 2013

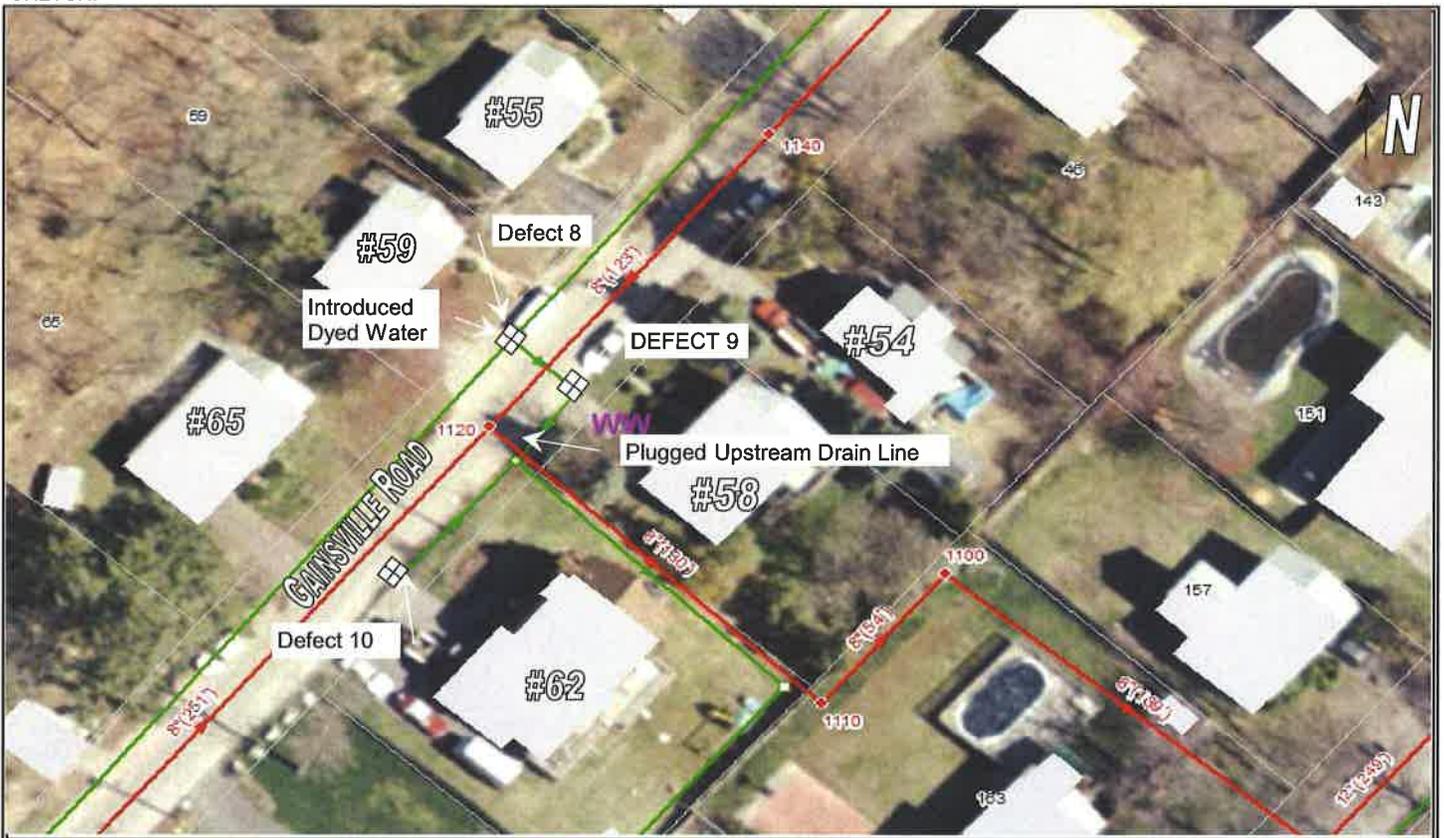
**Description of test:** Upon plugging and flooding of drain lines, dyed water was observed in MH 1120. Television inspection from MH 1120 towards MH 1140 identified dyed water incoming from the pipe connection at MH 1120 and mainline joints. Television inspection from MH 1120 towards MH 1110 identified similar defects as well. Defects 8 through 10 are associated with this indirect source. Total infiltration rates for these defects are approximately 2.0 gpm.

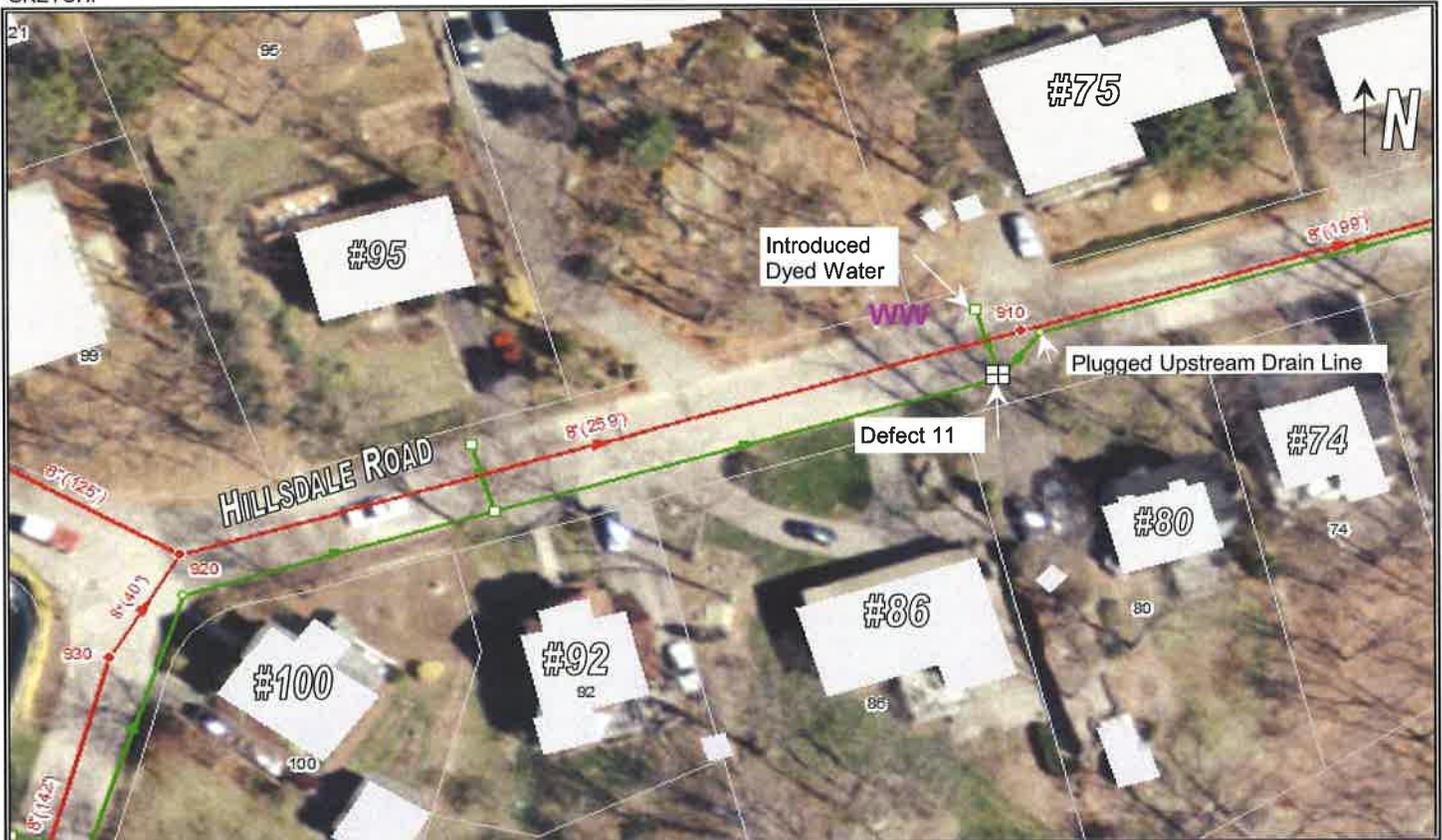
ENGINEER: Weston & Sampson  
 OWNER: Town of Dedham  
 PROJECT: Fall 2012 Smoke Testing  
 LOCATION: Hillsdale Road

**Description of test:** Upon plugging and flooding drain lines, no dyed water was observed in any of the surrounding sewer manholes. Sewer manhole 910 is missing some mortar from brick chimney section. The drain manhole located next to sewer MH 910 is constructed of concrete block with little mortar visible. Due to the close proximity of these manholes and opening in the manhole walls, smoke most likely traveled between these manholes, causing smoke to exit from the nearby catch basin (defect 11).

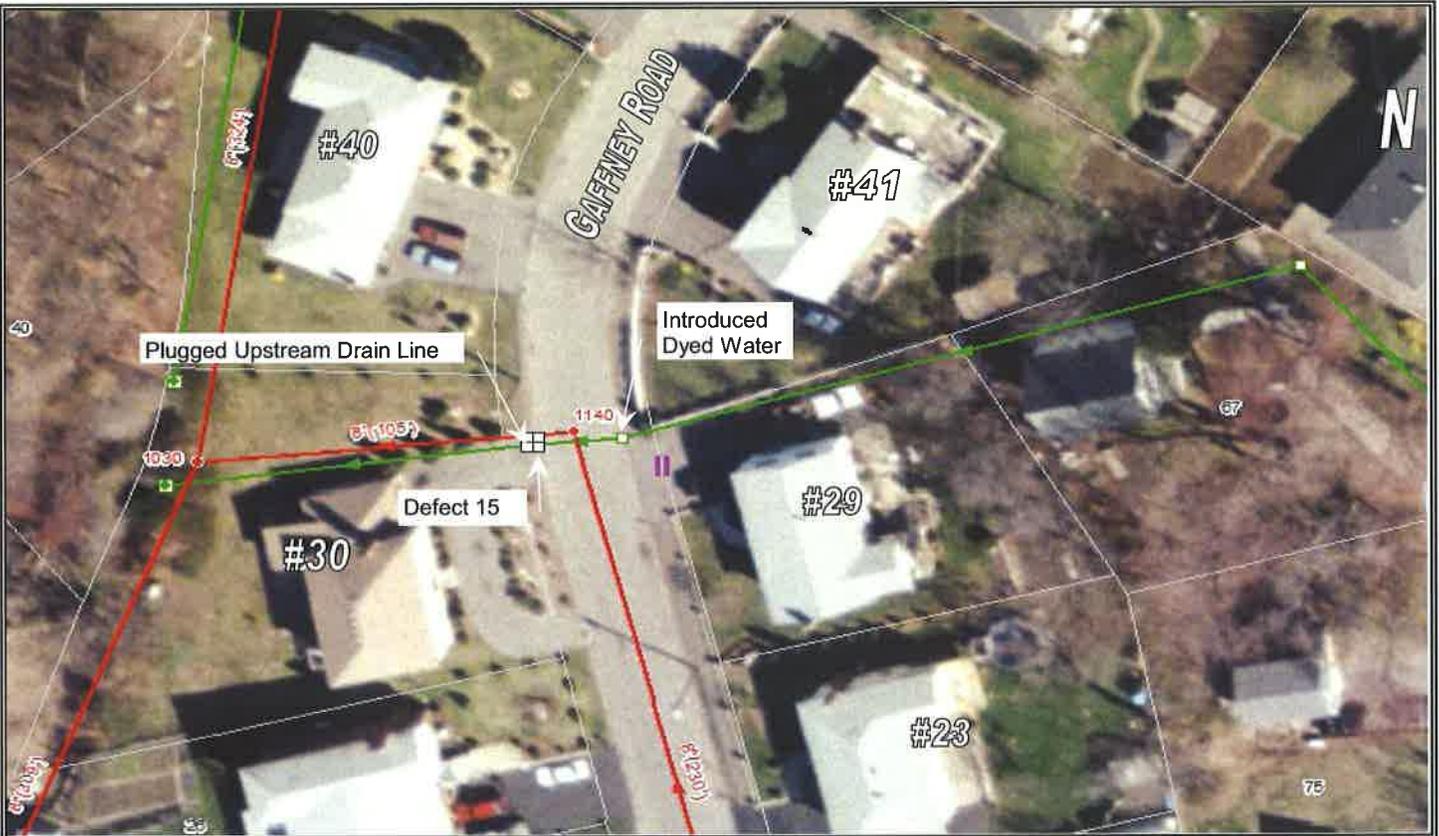
ENGINEER: Weston & Sampson  
 OWNER: Town of Dedham  
 PROJECT: Fall 2012 Smoke Testing  
 LOCATION: Gaffney Road

**Description of test:** Upon plugging and flooding drain lines, surrounding sewer structures were inspected for dyed water. No dyed water was observed in any of the inspected sewer manholes.

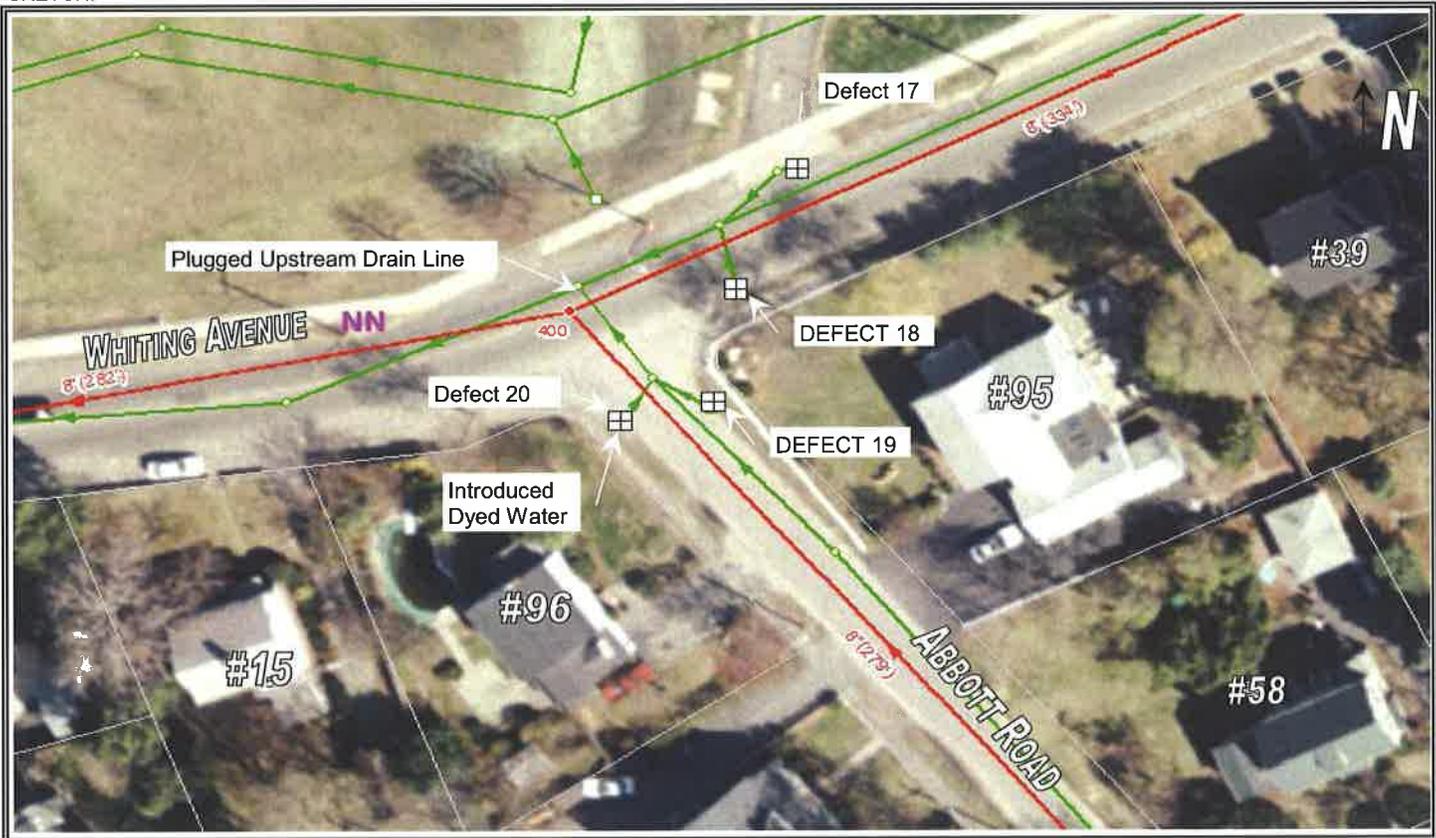
ENGINEER: Weston & Sampson  
 OWNER: Town of Dedham  
 PROJECT: Fall 2012 Smoke Testing  
 LOCATION: Whiting Avenue & Abbott Road

**Description of test:** Upon plugging and flooding drain lines, no dyed water was observed in any of the surrounding sewer manholes. Sewer line on Whiting Avenue was lined from manhole-to-manhole after completion of the smoke testing. The source for defects 17 through 20 were most likely rehabilitated through the installation of the manhole-to-manhole liner.

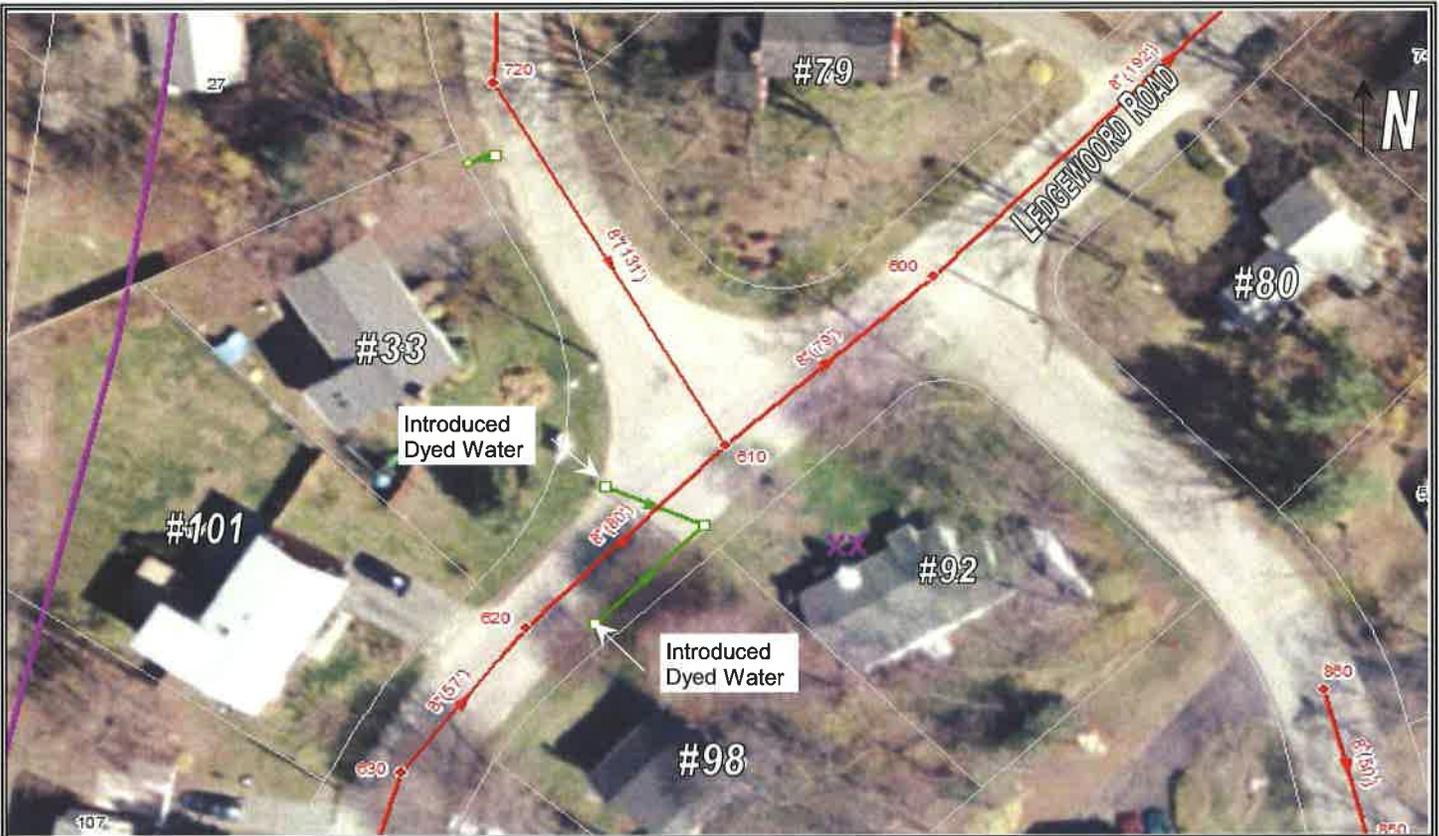
ENGINEER: Weston & Sampson  
 OWNER: Town of Dedham  
 PROJECT: Fall 2012 Smoke Testing  
 LOCATION: Ledgewood Road

**Description of test:** The catch basins on Ledgewood Road connect and drain to the ground. Upon flooding of the drain system with dyed water, surrounding sewer structures were inspected and no dyed water was observed.

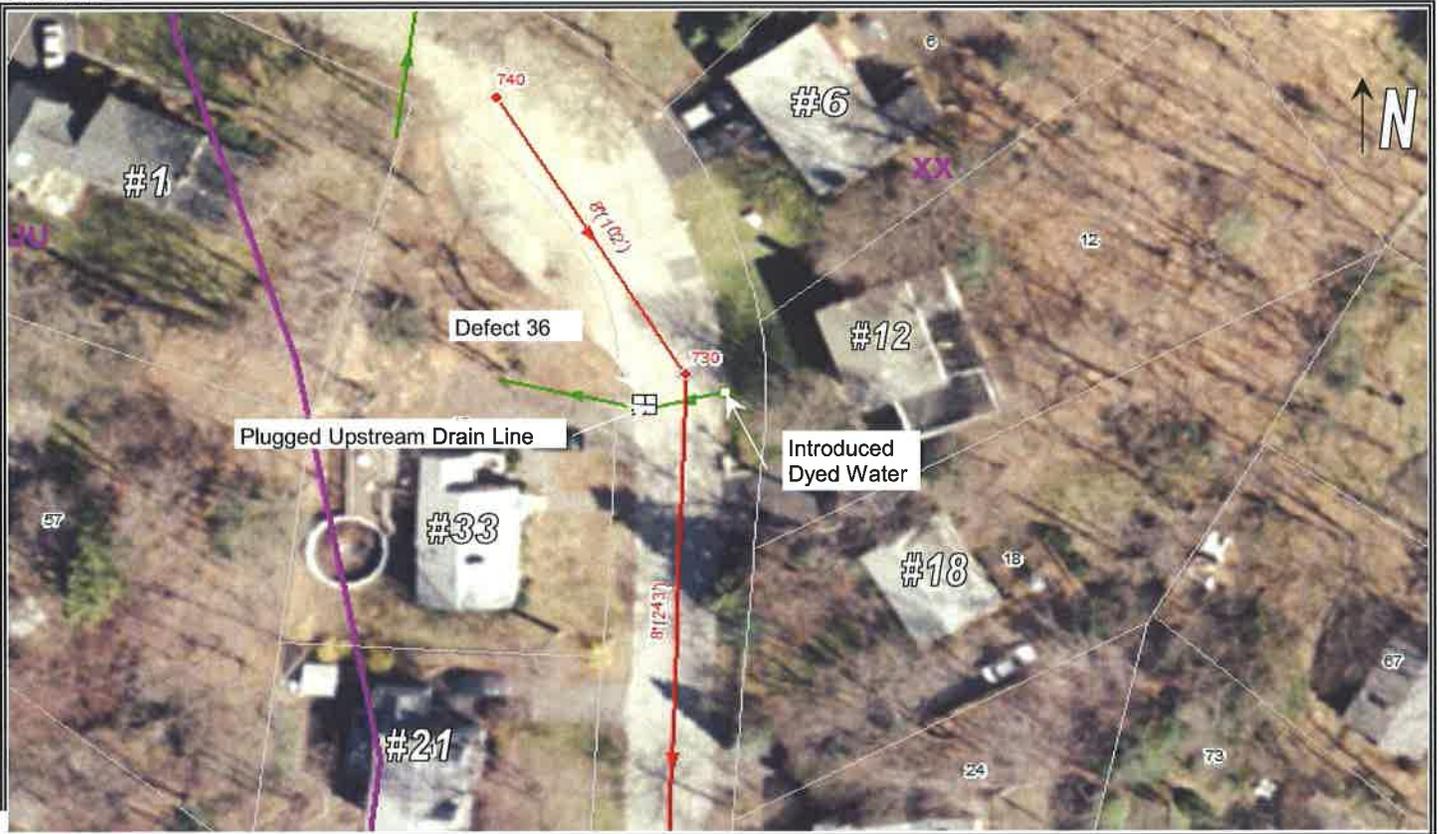
ENGINEER: Weston & Sampson  
 OWNER: Town of Dedham  
 PROJECT: Fall 2012 Smoke Testing  
 LOCATION: Intervale Road

**Description of test:** Upon plugging and flooding of the drain with dyed water, surrounding sewer structures were inspected. No dyed water was observed in the sewer.

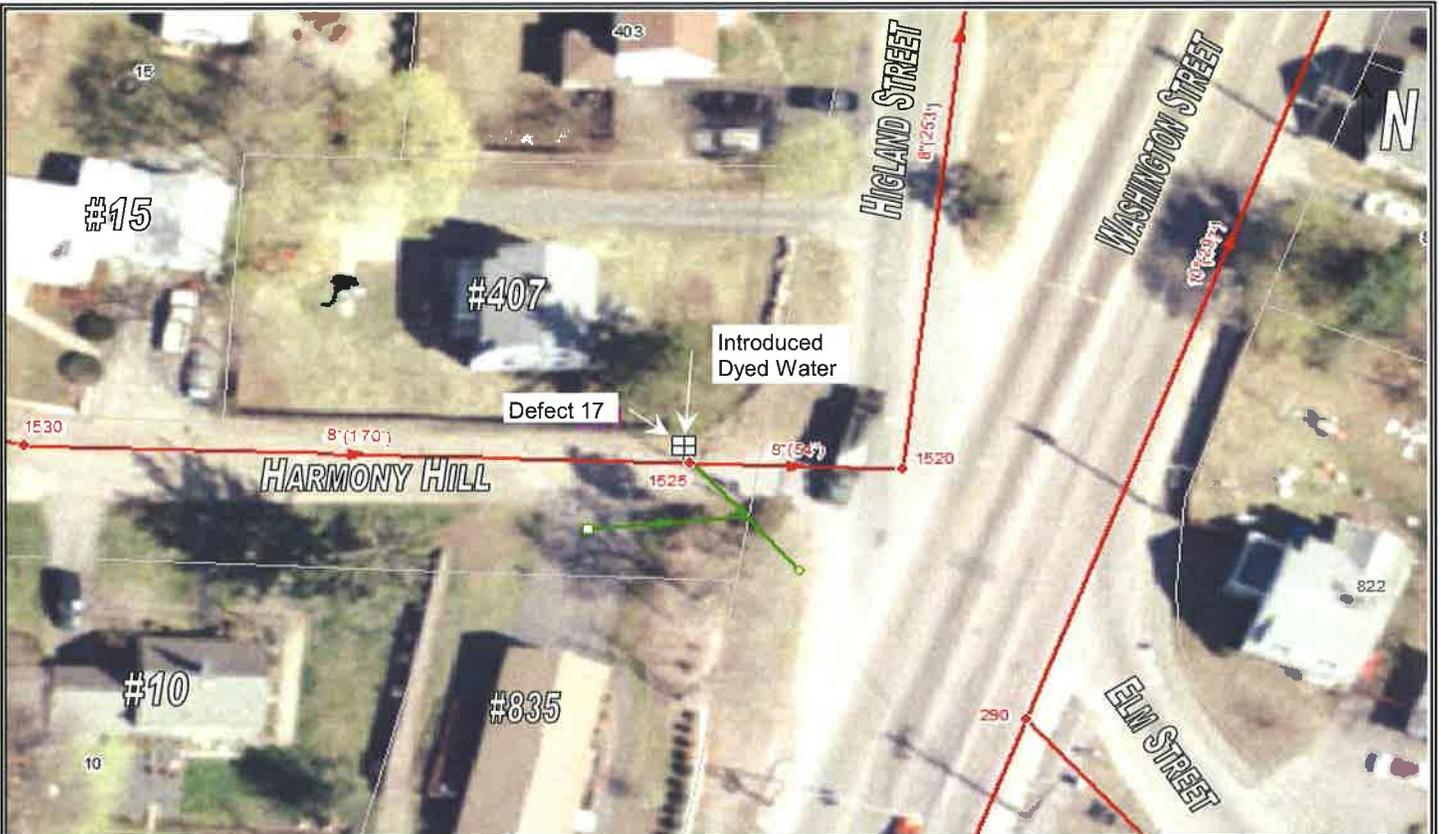
ENGINEER: Weston & Sampson  
 OWNER: Town of Dedham  
 PROJECT: Fall 2012 Smoke Testing  
 LOCATION: Harmony Hill

**Description of test:** Dyed water was introduced to the catch basin near house #407 (defect 17). This catch basin flows to a drain manhole near Washington Street that did not appear to have an outgoing line. Upon flooding of this drain line, sewer manhole 1520 was inspected and showed no signs of dyed water in the sewer flow.

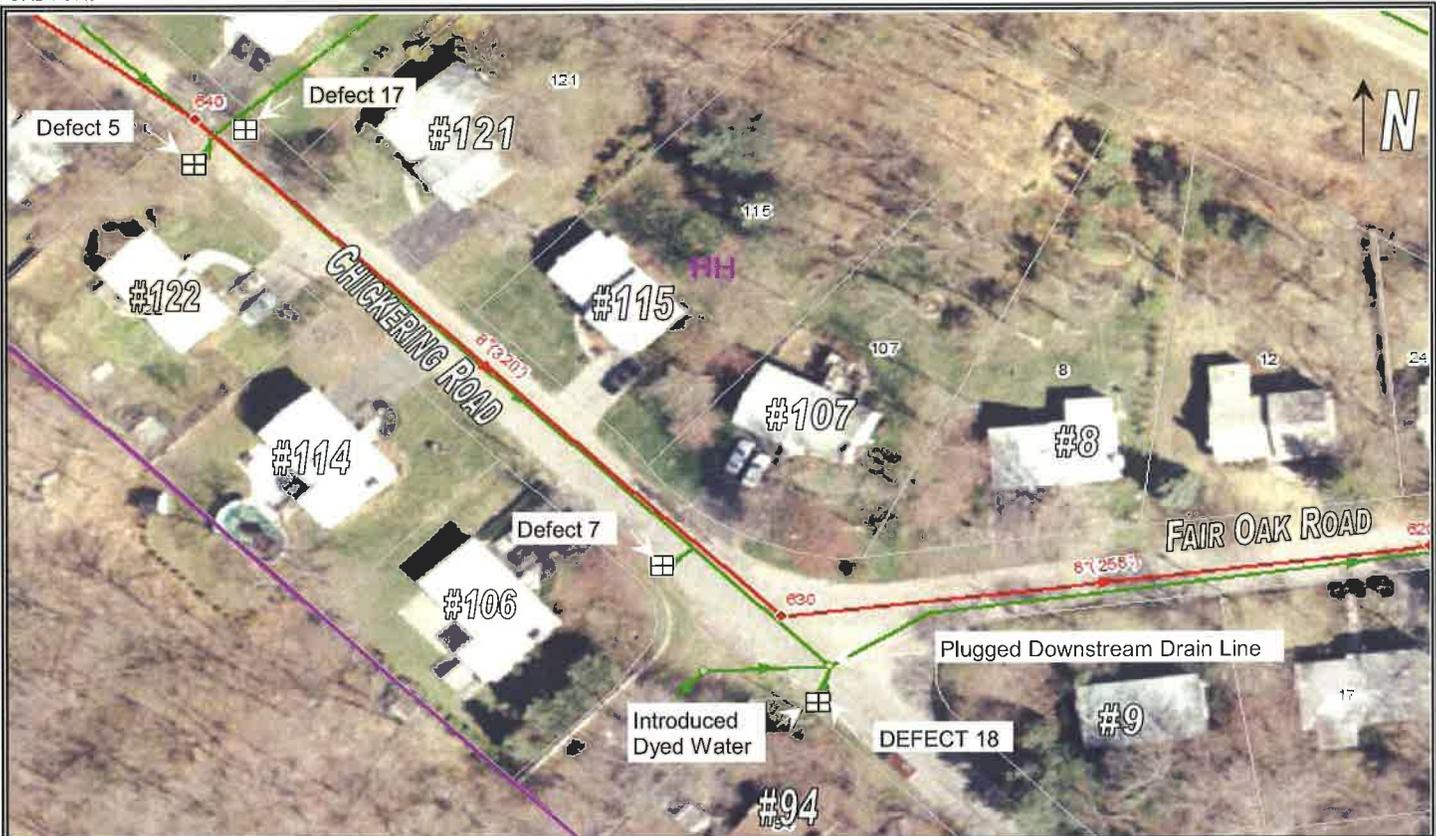
ENGINEER: Weston & Sampson  
 OWNER: Town of Dedham  
 PROJECT: Fall 2012 Smoke Testing  
 LOCATION: Chickering Road

**Description of test:** Upon plugging and flooding of drain lines, dyed water was observed in MH 630 incoming from what appears to be a service connection to house #94. Television inspection of this 6-inch line identified dyed water infiltrating from a joint approximately 25 feet upstream of MH 630 at a rate of 0.5 gpm. This source is associated to defects 23 through 26.

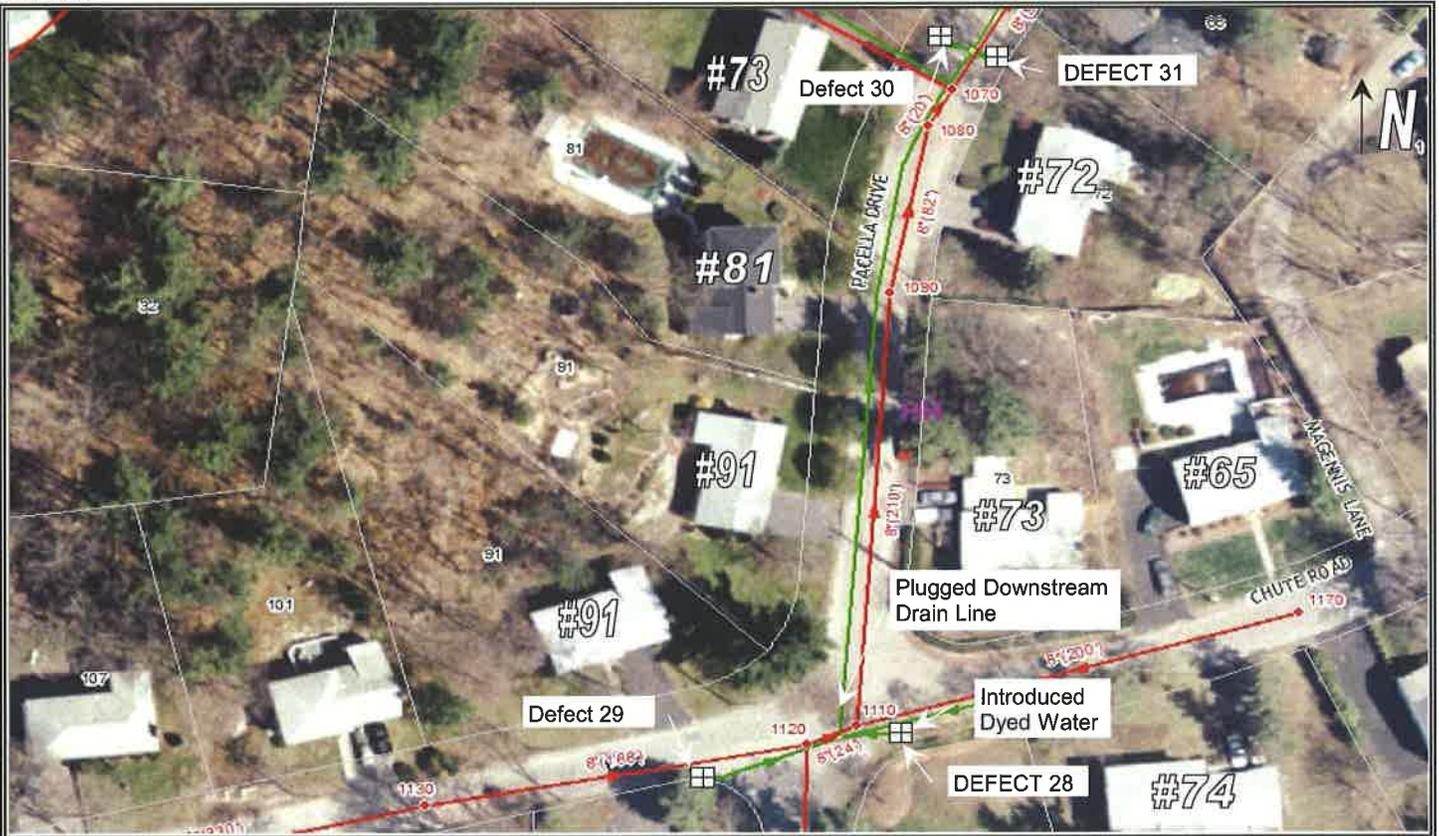
ENGINEER: Weston & Sampson  
 OWNER: Town of Dedham  
 PROJECT: Fall 2012 Smoke Testing  
 LOCATION: Pacella Drive & Chute Road

**Description of test:** Upon plugging and flooding of drain lines, dyed water was observed in MH 1110 incoming from the manhole walls. The sewer manhole is constructed of concrete block, with little mortar between blocks. Dyed water from the nearby catch basin lateral (defect 28) was infiltrating to the sewer manhole at a rate of 2.0 gpm.
