**Dedham Public Library**  
**43 Church Street**  
**Dedham, MA 02026**  
**781-751-9284**  
**Dr. Mary Ann Tricarico, Director**

**Planning for the Future**  
**Strategic Plan for FY13 to FY17**

**Approved by Board of Trustees September 18, 2012**

## DEDHAM PUBLIC LIBRARY MAIN BRANCH – ACCESS / CODE SURVEY PHOTOS + NOTES

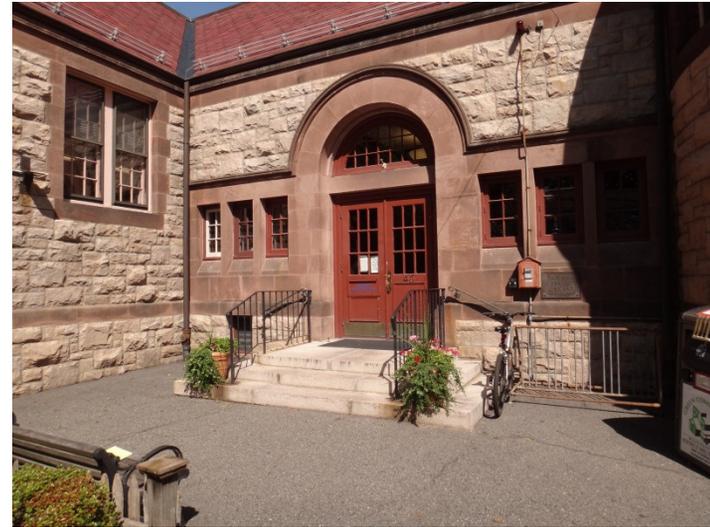
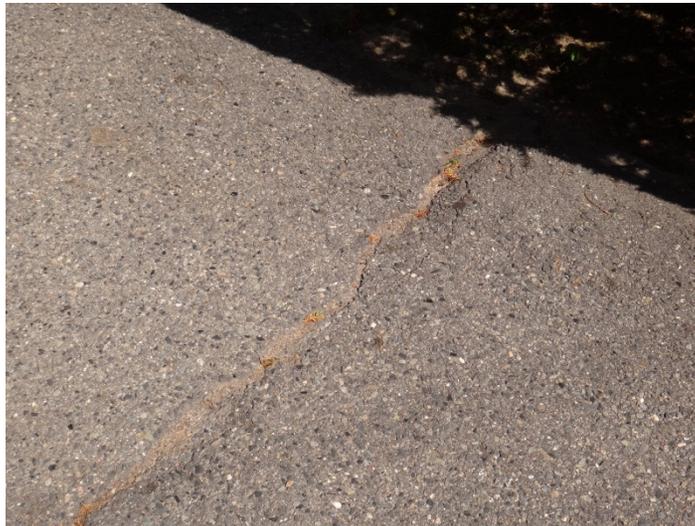
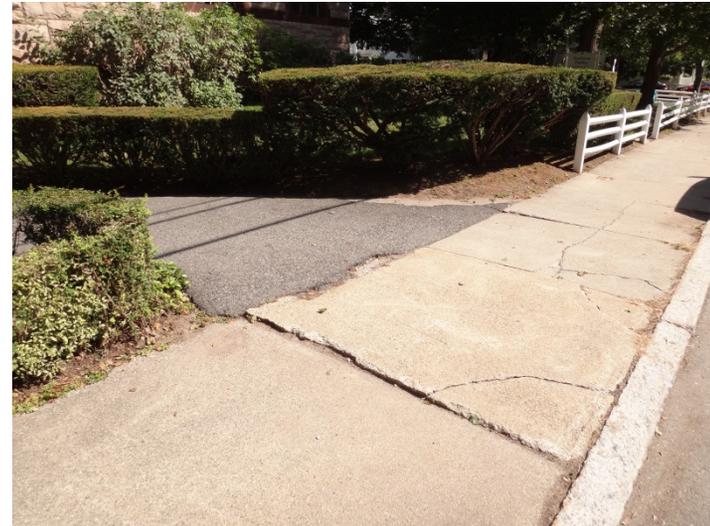
**Issue (s):** Fire alarm device not accessible due to bike rack; door opening force; no signage directing users to accessible entrance; surface conditions – cracks.

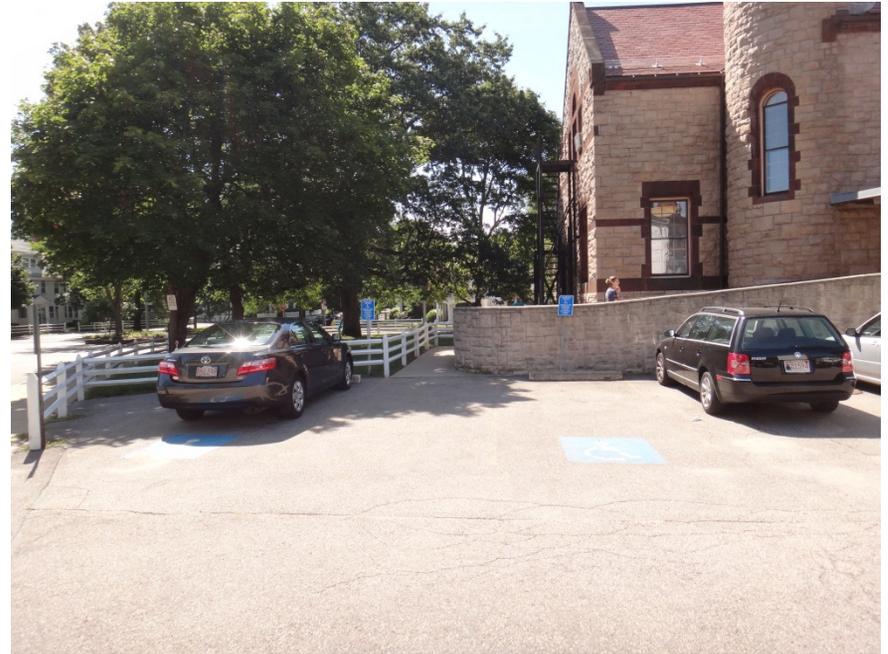
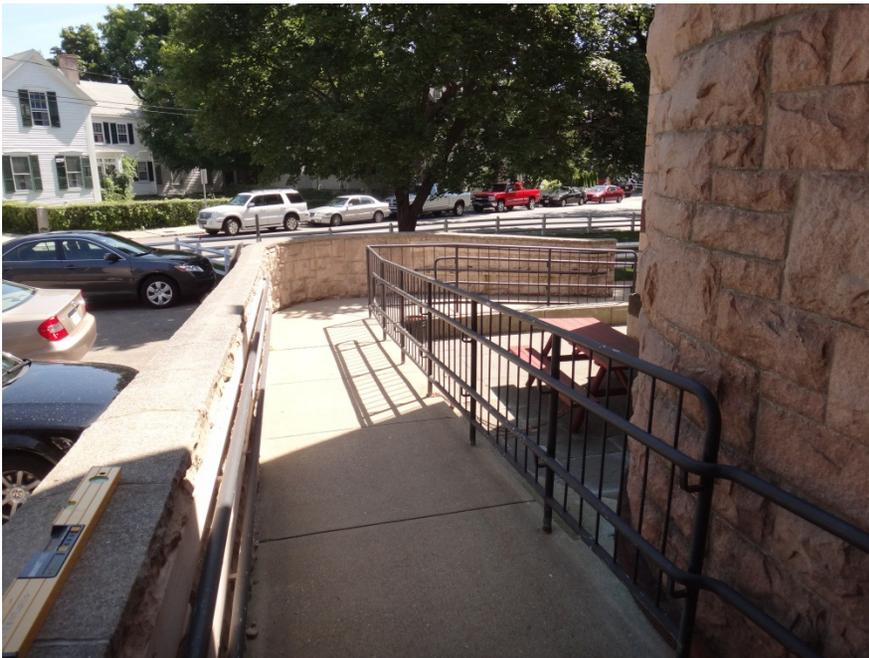
### PHOTO No. 7 (left)

**Issue (s):** Surface conditions – cracking present; parking lot striping and access aisle is faded – inadequate contrast; NO “van” accessible signage provided at left parking space.

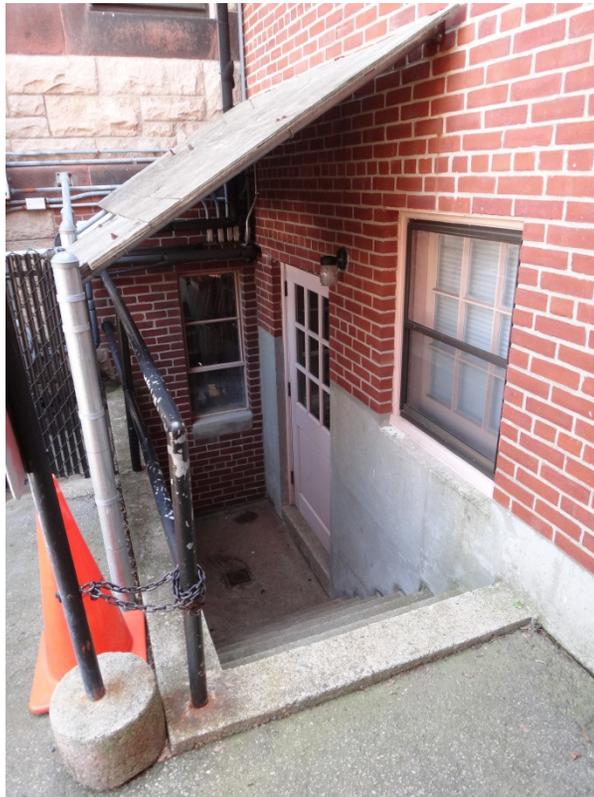
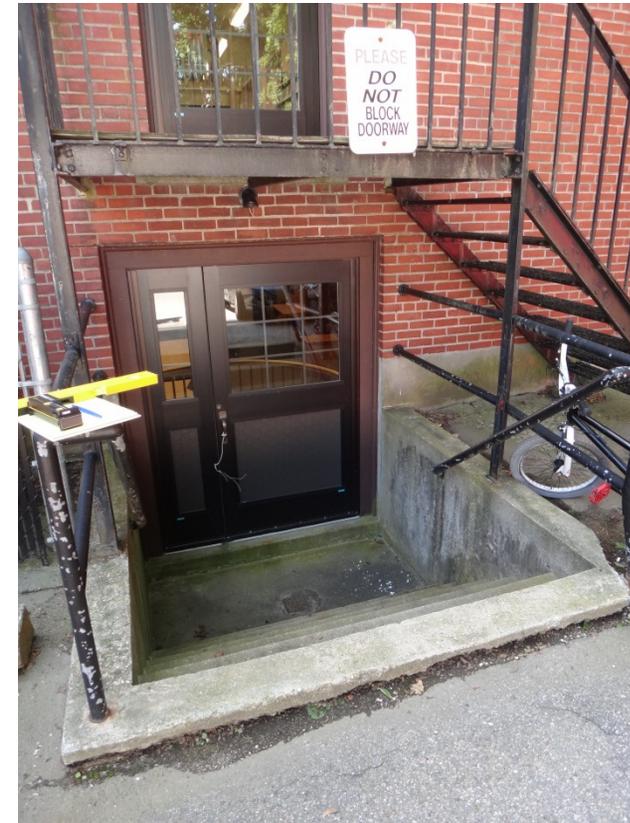
**PHOTO No. 11** (left)

**Issue (s):** No Code compliant handrails present, surface conditions.

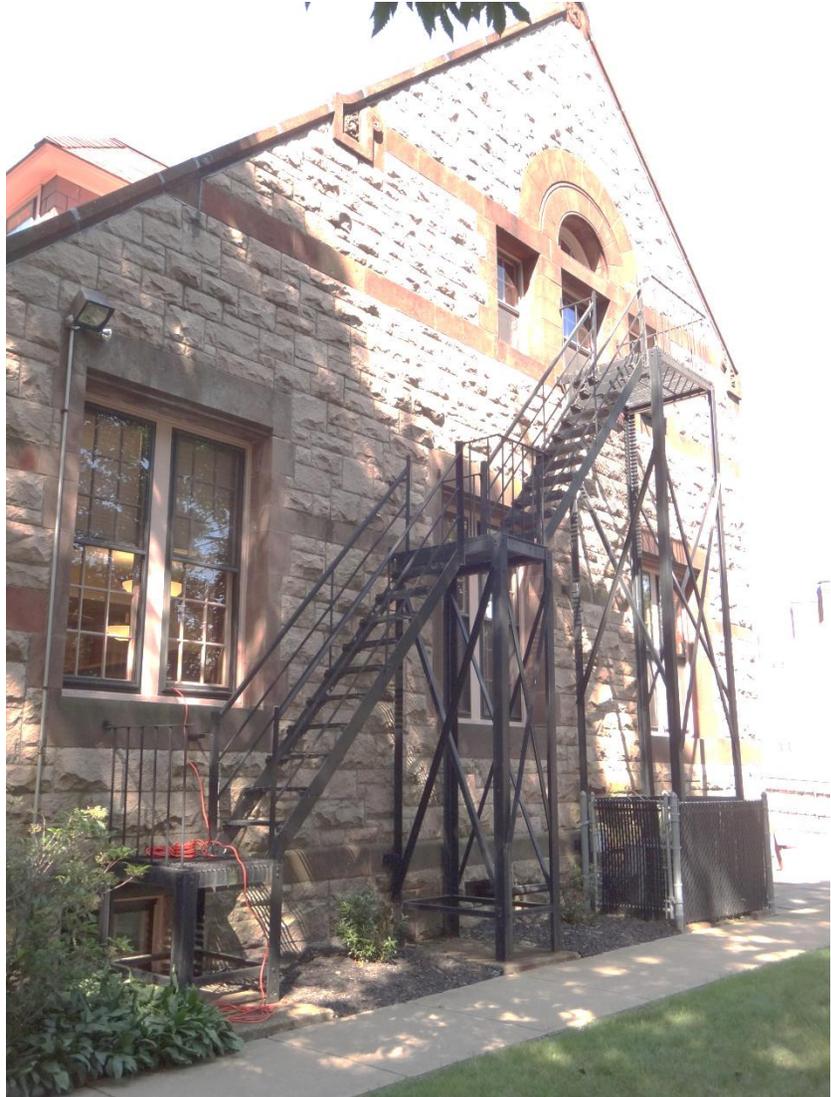
### PHOTO No. 13 (right)

Exterior fire escape stair terminates at a landing with no steps or ladder connecting to pathways at grade.

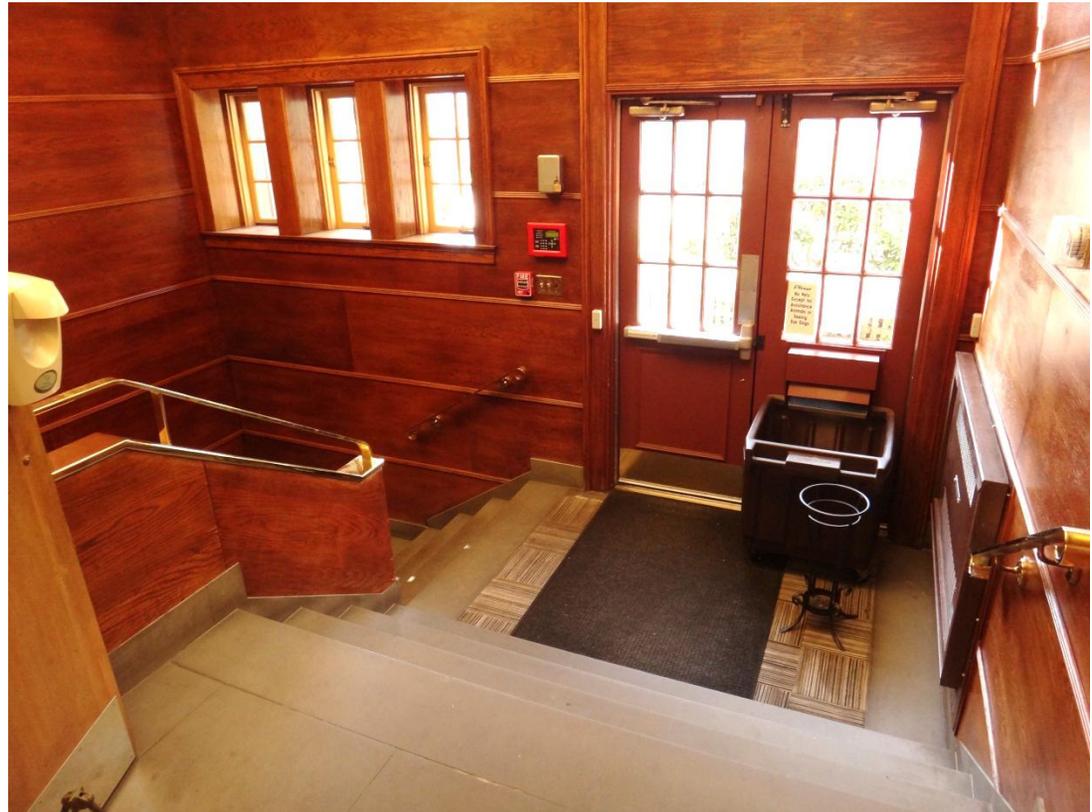
**PHOTO No. 14** (top / bottom)

Fire alarm pull too close to top tread at landing – hazardous. Alarm control panel is mounted at 61" AFF and not on an accessible route.

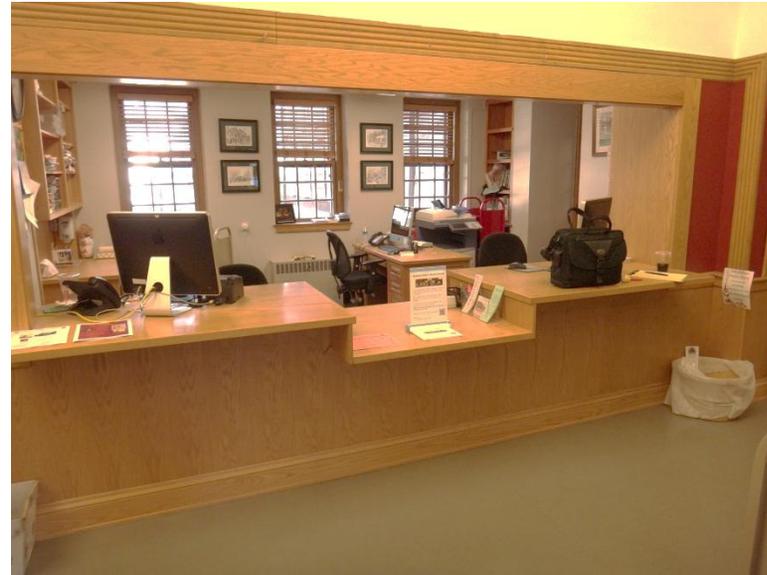
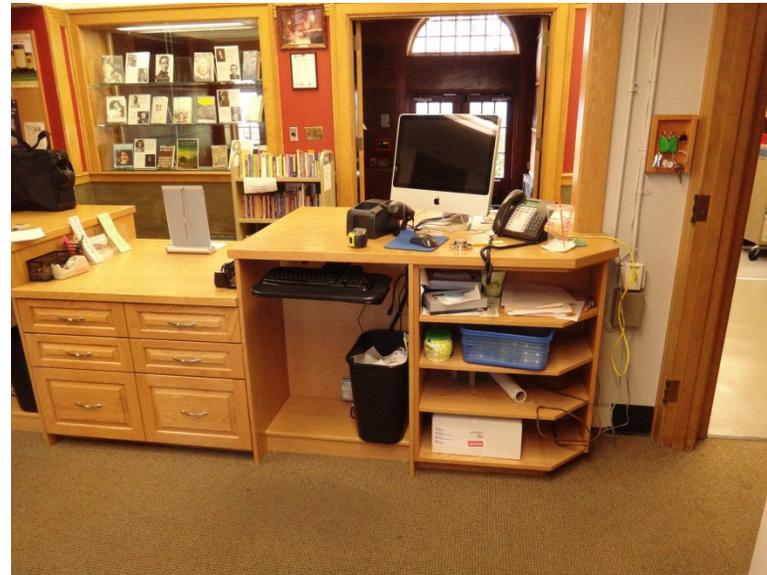
**PHOTO No. 16** (right/ left)

Inadequate door clearances into office areas (less than 32" clear min).

Computer stations have counter heights greater than 34" AFF. Built in cabinets would need to be re-designed to provided an accessible workstation for employees.

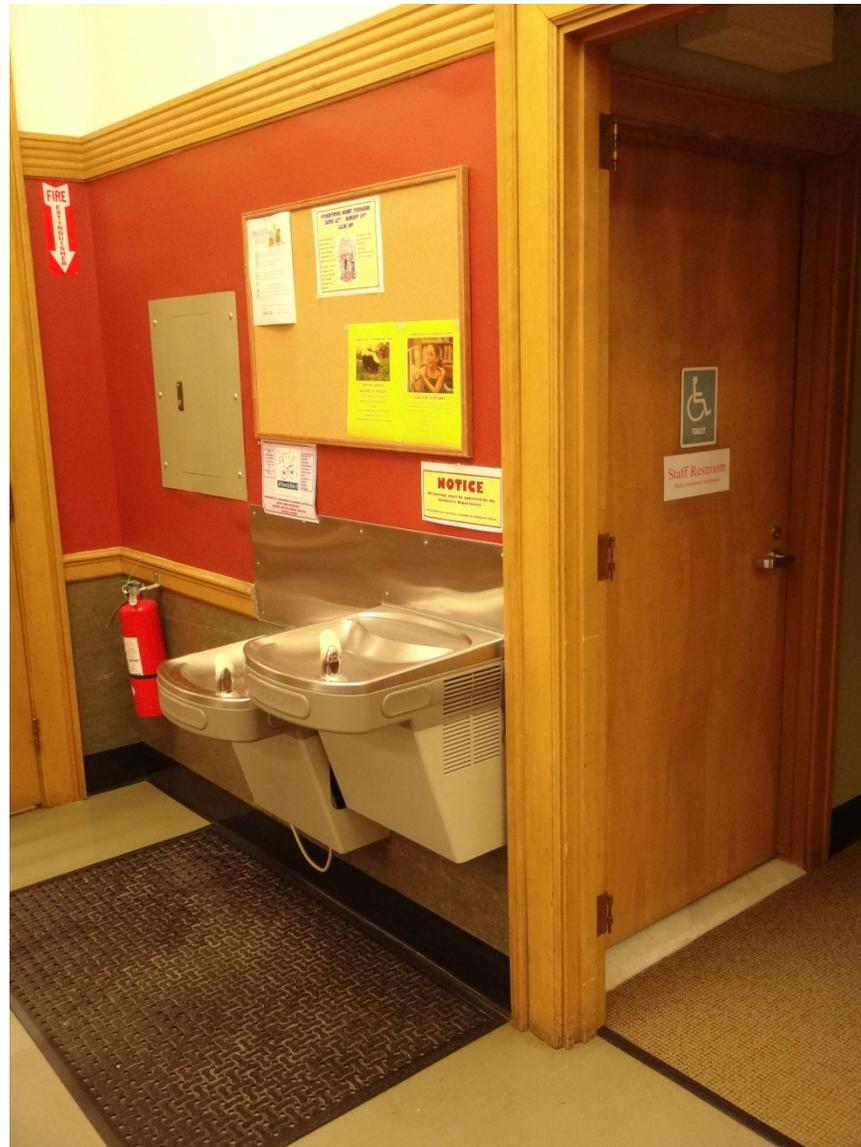
### PHOTO No. 18 (right)

Fire extinguisher is located behind door that conflicts with egress; does not provide adequate clearance per ADA and 521 CMR.

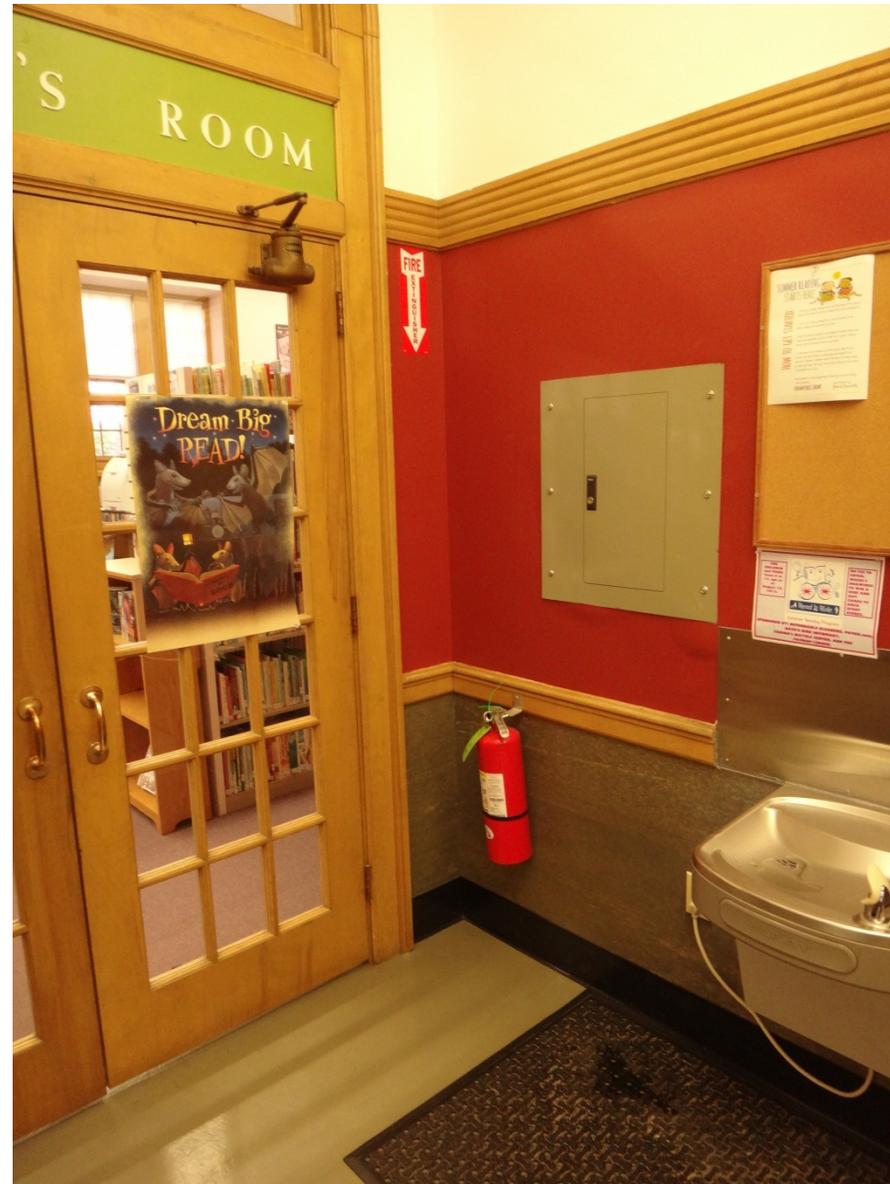
### PHOTO No. 19 (right)

FE is mounted at 32” AFF to controls = OK.

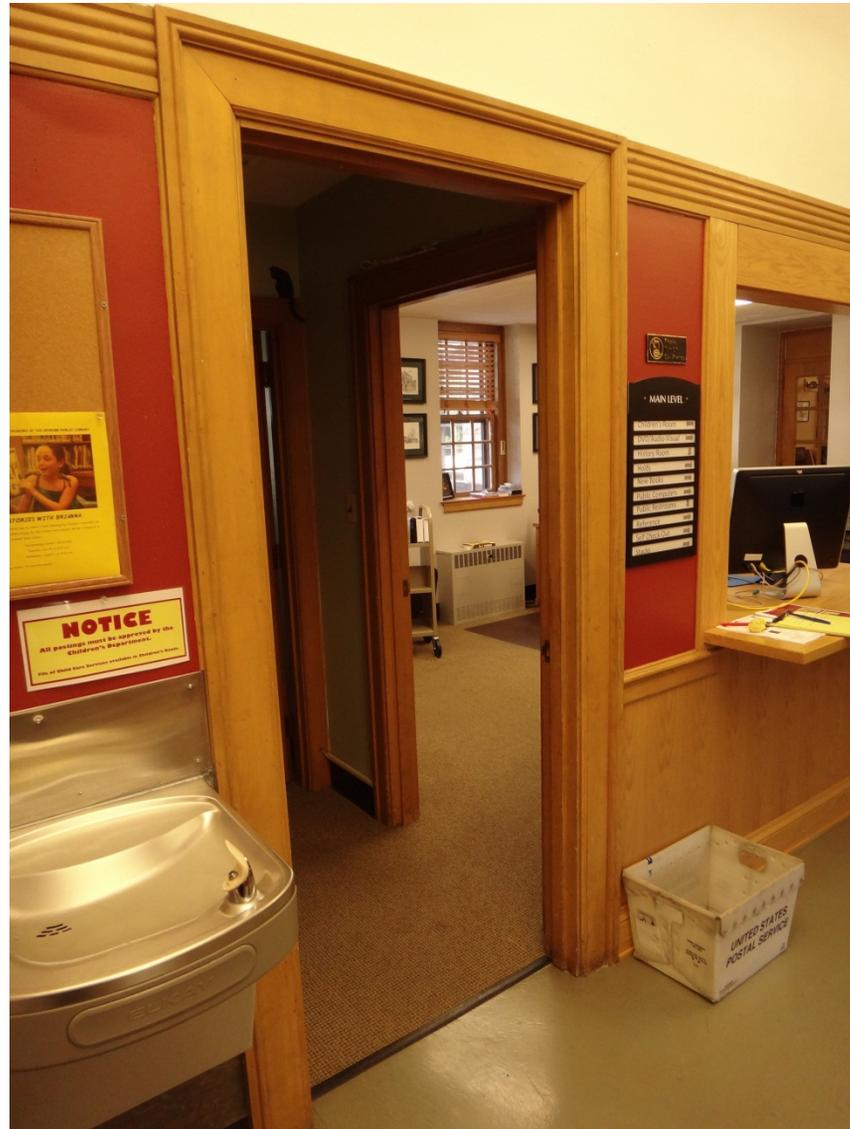
**PHOTO No. 20** (right)

Cased opening is less than 32” clear – door has been removed but hinges remain with pins that could pose a hazard.

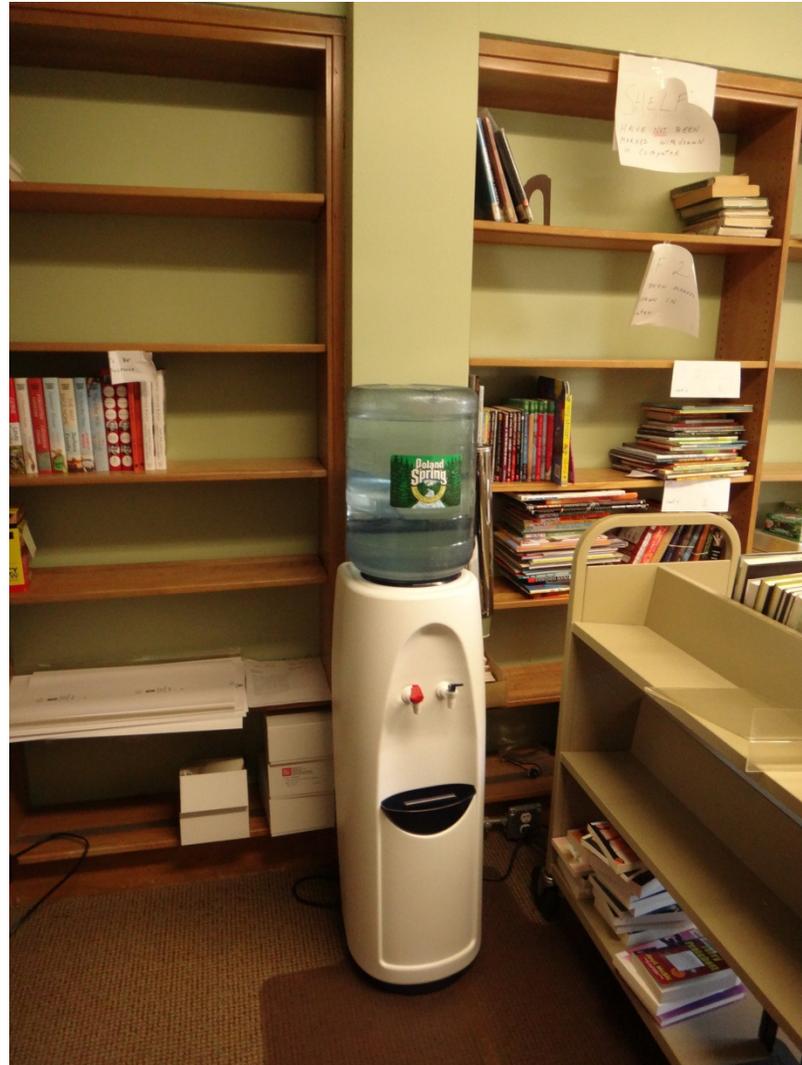
**PHOTO No.** 22 (top), 23 (bottom)

Desks = OK

Water cooler – control heights 19"-30" = OK. Inadequate clearance to approach fixture due to stored carts. 30" clear front approach required for fixture, 48" clear side approach.

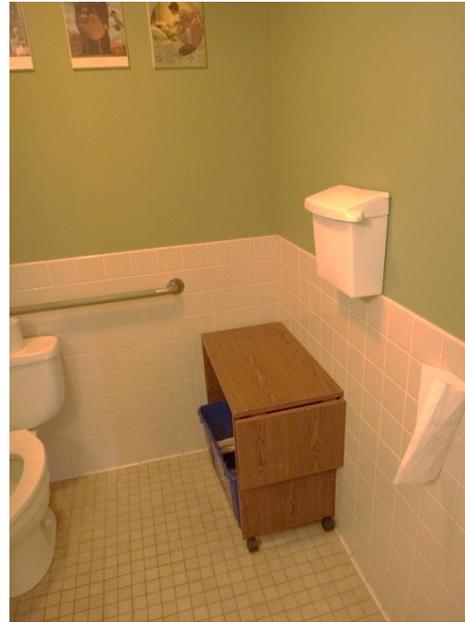
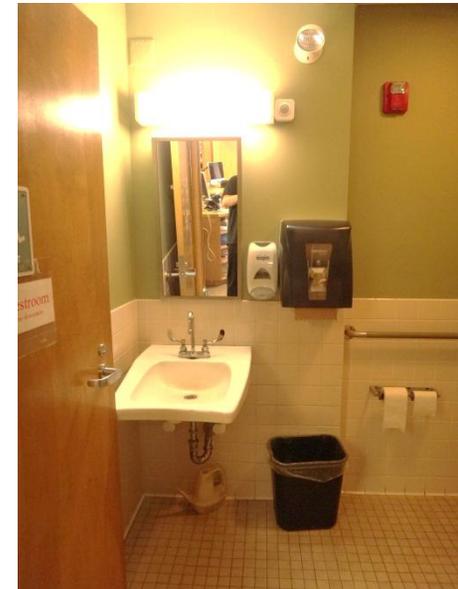
**PHOTO No.** 26 (top), 27 (bottom)

Mirror – mounted at 43" AFF > 40" max. per ADAAG and 521 CMR.

Sink – pipes do not have protective pipe wraps as required. Elongated sink and installed location do not allow required 30"x48" front approach clearance to the fixture.

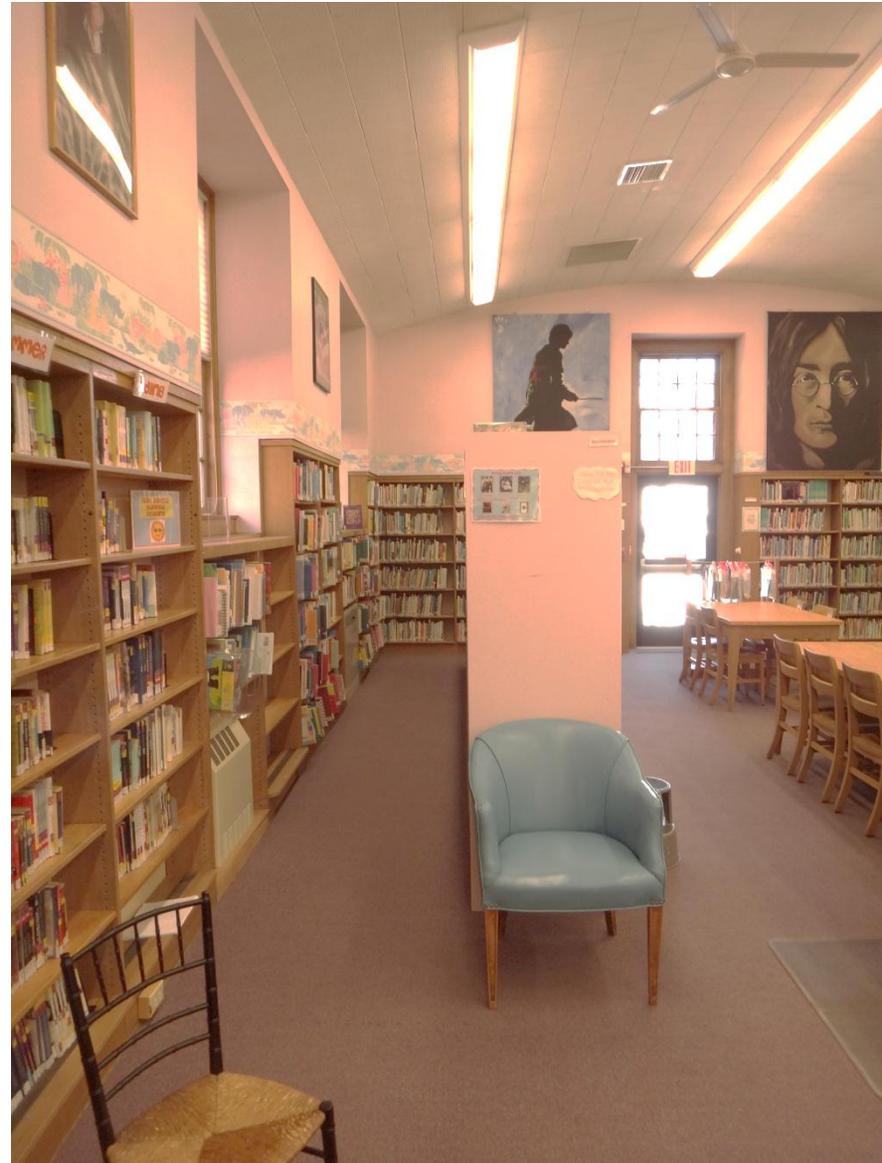
**PHOTO No.** 29 (top), 30 (bottom)

The express check out desk does not have adequate front or side clearances, is at a table with knee clearance less than 27" min. required and is adjacent to the double doors that access back to the lobby and function as a primary egress.

Secondary egress – provided to the exterior. Exit sign, fire alarm pull, and audible / visual alarms present. NOT accessible.

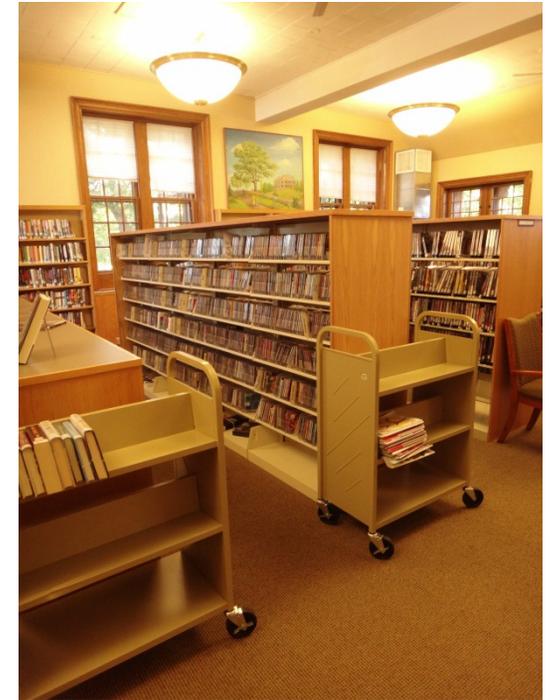
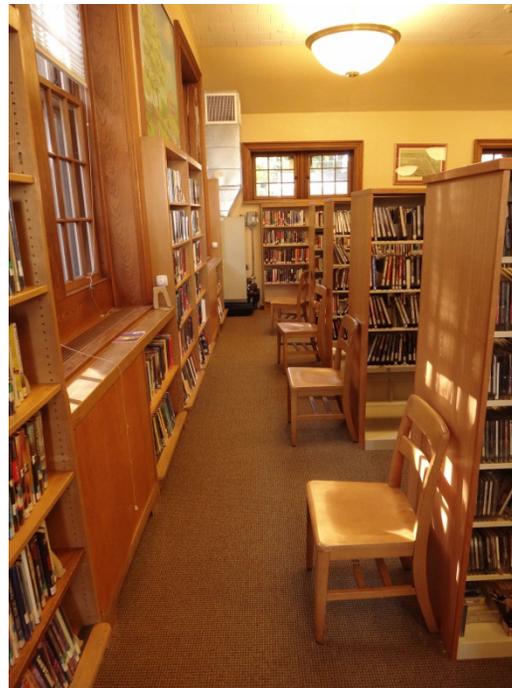
**PHOTO No.** 33 (top), 34 (bottom)

### **Issue (s):**

Accessible routes at stacks in Reading room – Moveable chairs reduce accessible route to less than 36" clear width. Placement of moveable carts and equipment also reduce clear width at accessible routes and reduce access aisle widths to book stacks to less than 36" min. clear required.

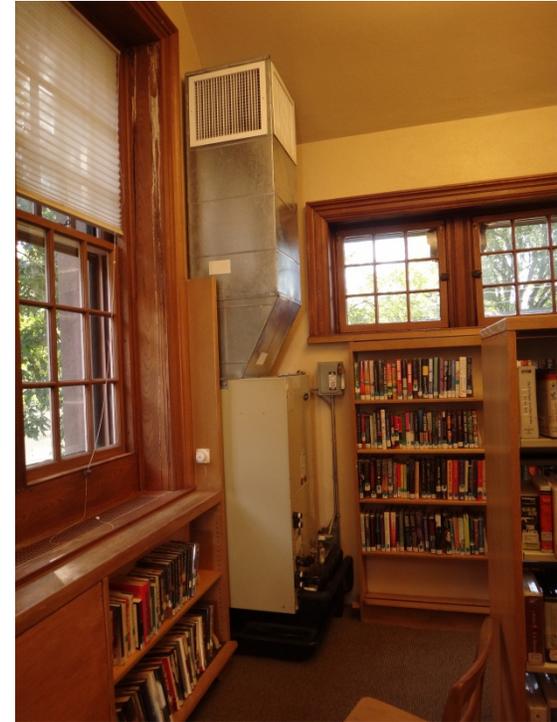
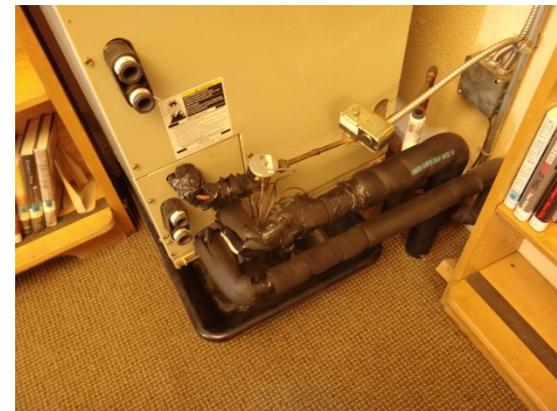
### PHOTO No. 35 (right)

Upon further research, this is a residential HVAC unit and not intended for commercial applications.

Under IBC 2009, Table 508.2.5 this equipment is required to be housed in a 1-hour fire resistant rated room.

12. Double doors should be replaced with single doors, proper panic hardware, and the ability to maintain smoke tight zones throughout the building
13. HVAC equipment located in public areas is unenclosed and in code violation

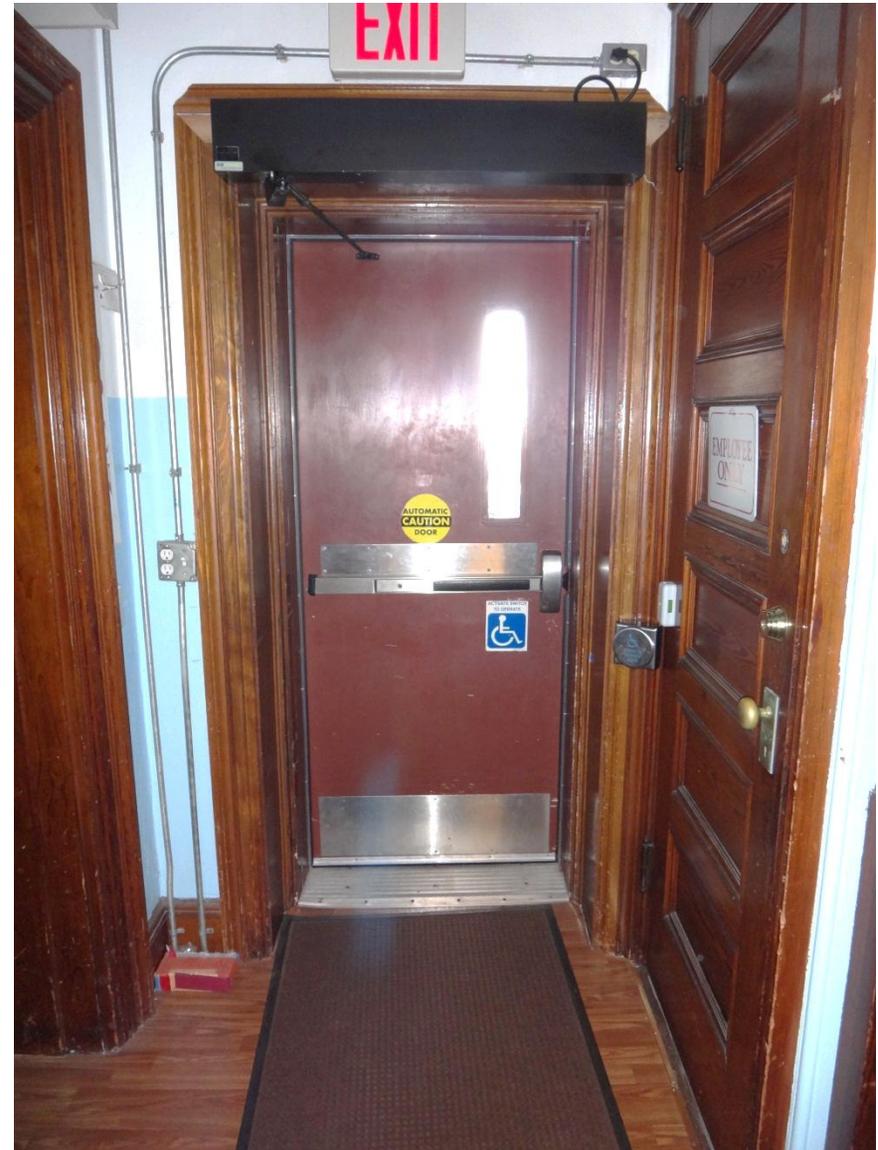
**PHOTO No. 36** (right)

Door to Reading room – the existing door is a double-action door but does not provide adequate push side clearance on the corridor side of the door into the Reading Room. The door is not properly fire rated.

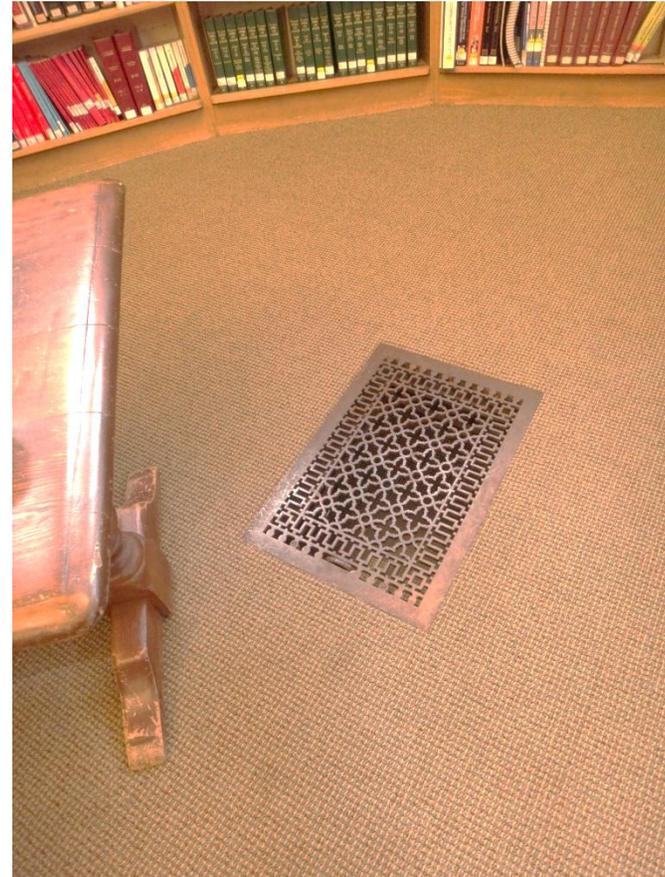
**PHOTO No.** 37 (top), 38 (bottom right); 39 (bottom left)

Floor diffuser grilles – HVAC – the existing floor grille diffusers in the Reading Room have openings that exceed  $\frac{1}{2}$ " x  $\frac{1}{2}$ " based on the ornate, diverse openings of the grates. As present, the grates could pose a hazard.

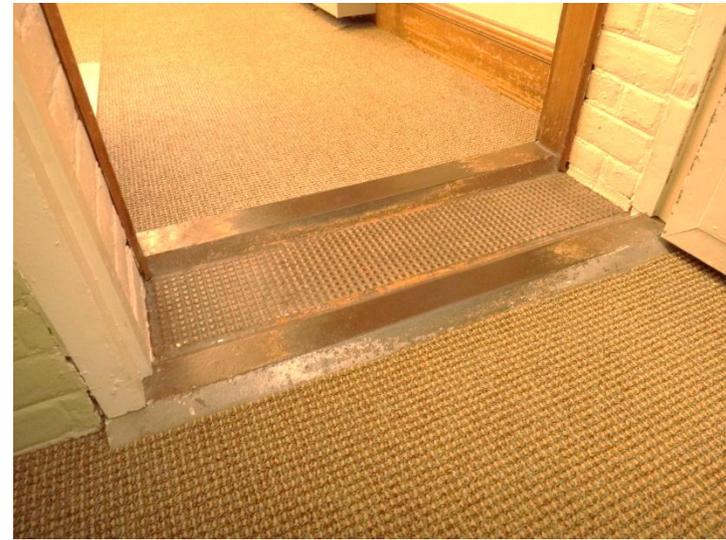
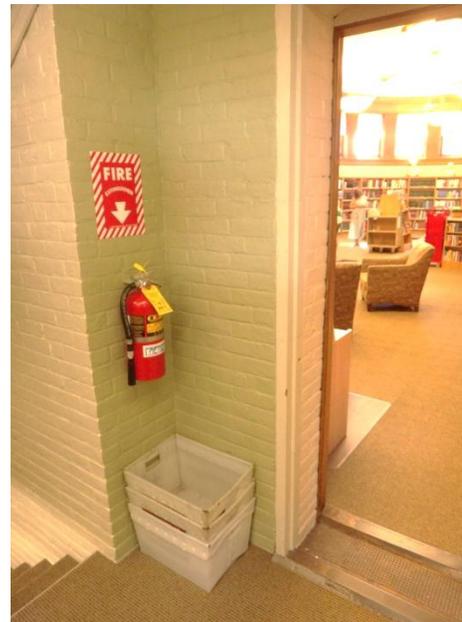
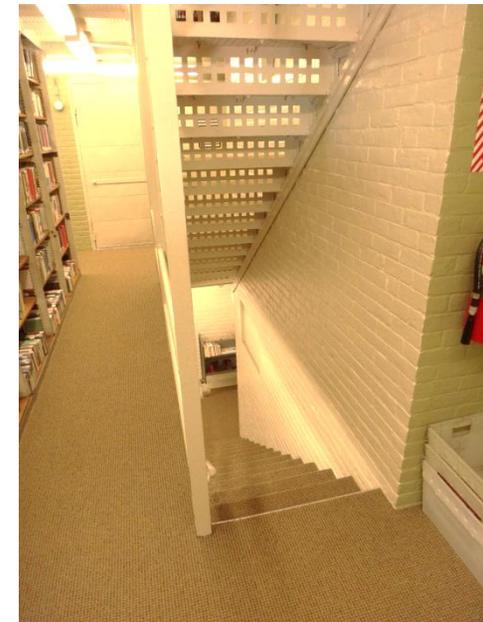
**PHOTO No.** 40 (top left), 41 (top right); 42 (bottom)

Stairs – railings – stairs are only 31” clear < 48” clear required under 780 CMR. Handrails are provided one side only at a height of 30.5” AFF < 24”-38” range required. There are no guardrails present at landings, rails are 31.5” AFF < 42” AFF min. HAZARD.

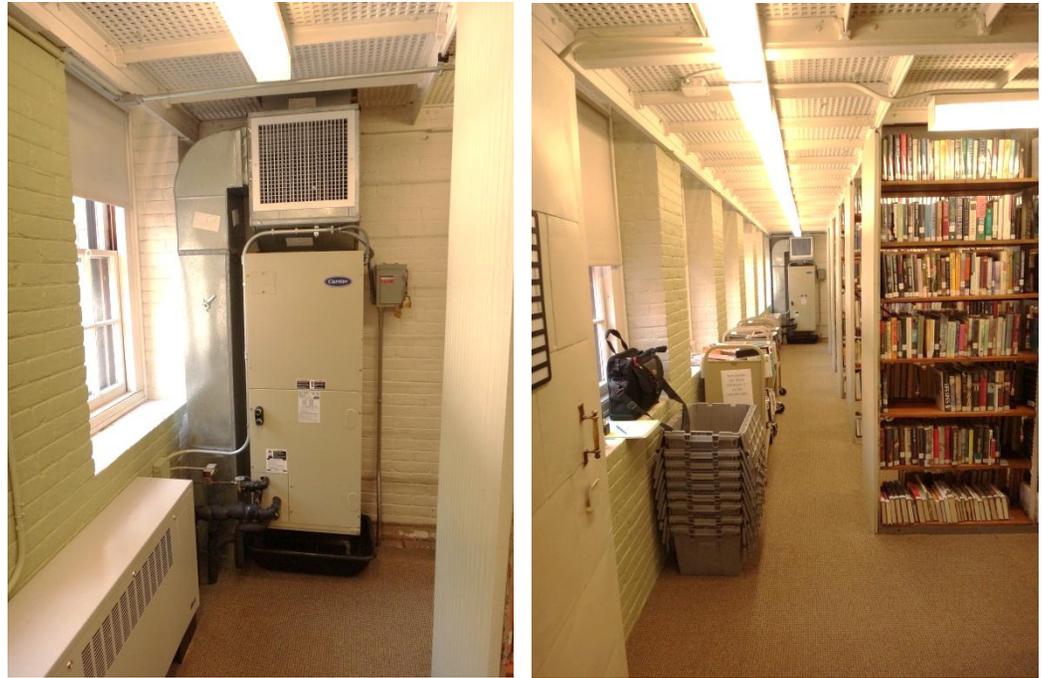
**PHOTO No.** 43 (left), 44 (right);

Access aisles – first floor aisles at left side are impacted by stored bins, boxes, and equipment. These items need to be relocated to provide min. 36” aisles.

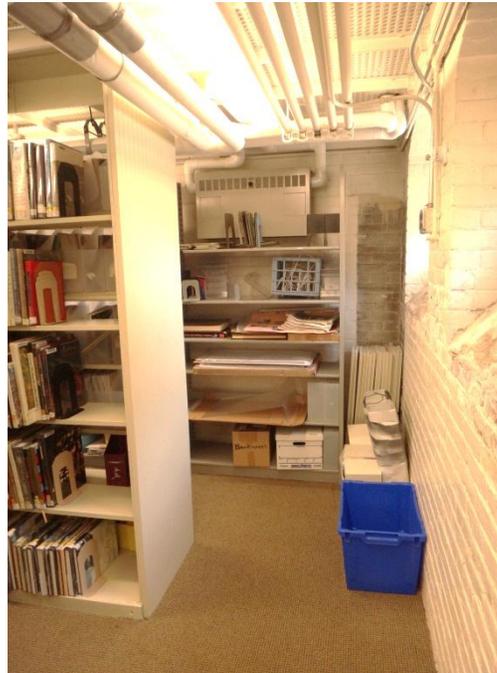
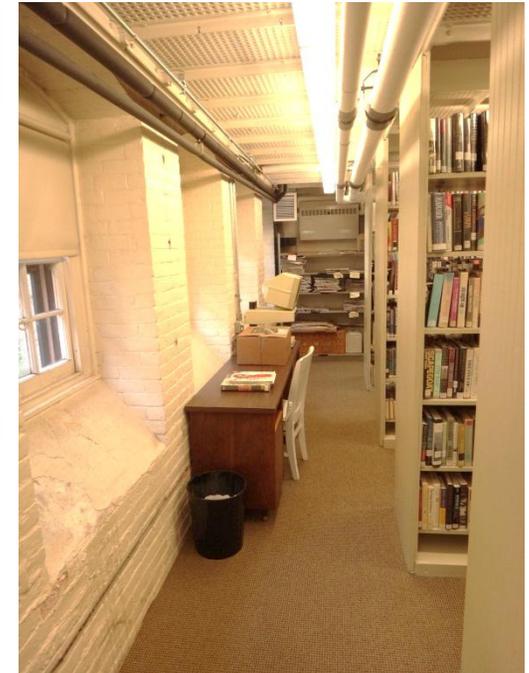
**PHOTO No.** 45 (left), 46 (right);

HAZARD – the basement level does NOT have a second means of egress.

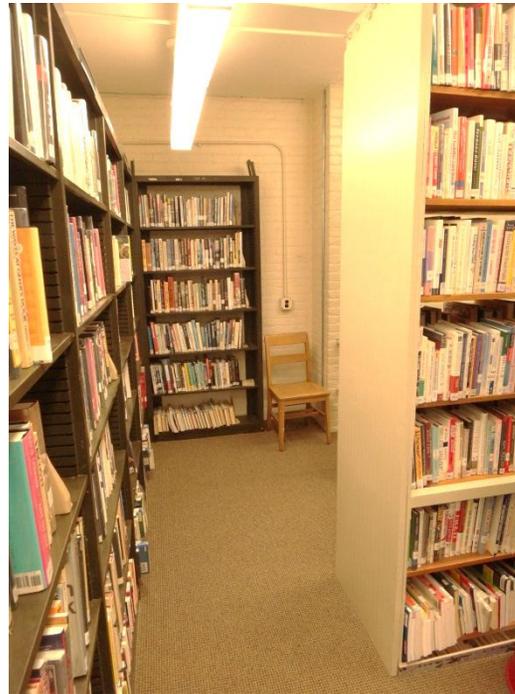
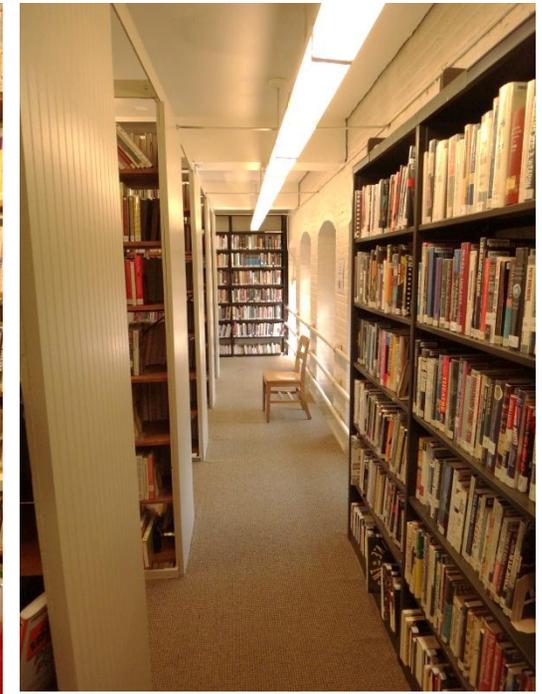
**PHOTO No.** 47 (left), 48(right);

HAZARD – the second floor level does NOT have a second means of egress.

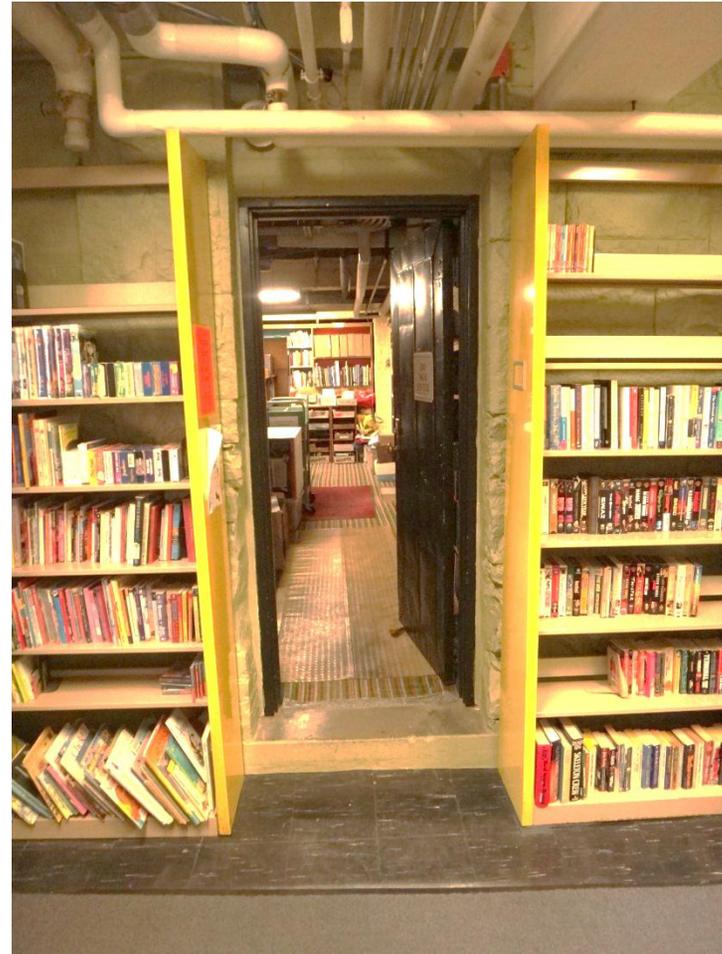
**PHOTO No.** 50 (left), 51 (right)

Door hardware – door knobs are present at landing door (levers required) and door is held open – not providing rating at stair enclosure. Exterior door has outdated panic hardware.

HAZARD – interior “step” up to exit door and “step” up into additional “for sale” area and facilities office are not uniform and do not have visual contrast.

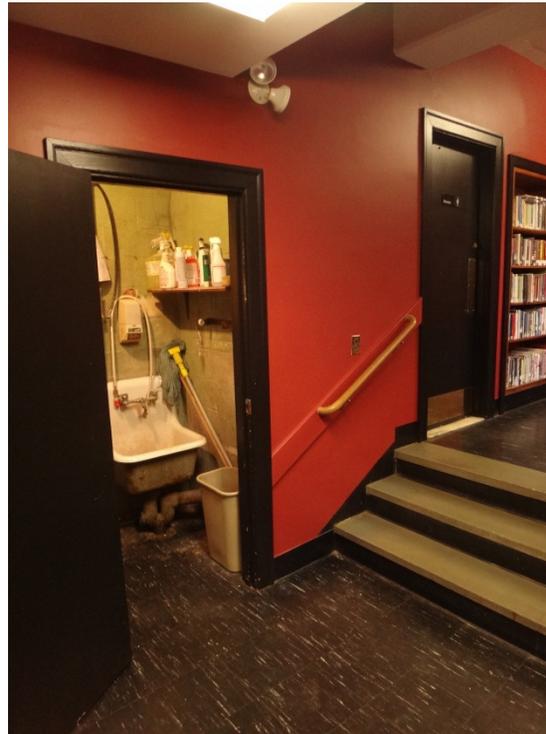
**PHOTO No.** 52(top), 53 (bottom)

Handrail – 37” AFF = OK for height. Handrail extensions are not provided as required by Code.

Exit sign – exit sign present for upper basement level egress but no arrow for egress up main lobby stairway.

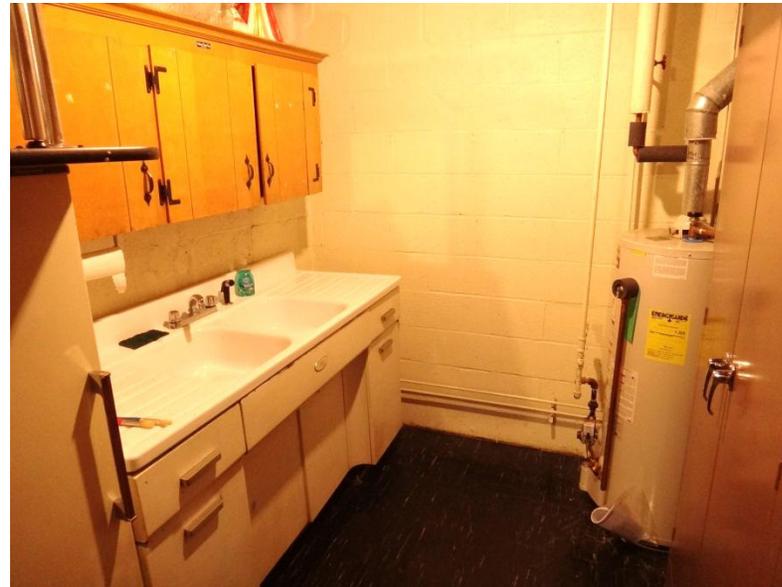
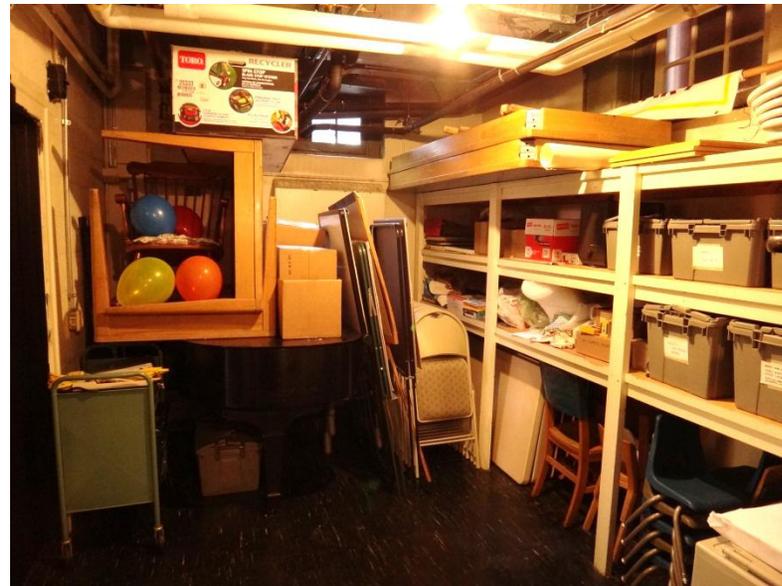
**PHOTO No.** 54 (left), 55 (right)

The storage and utility need to be separated  
from the kitchen use with proper fire  
resistant construction.

Door hardware – the existing doors have  
knob hardware, no closers, and would be  
required to have level handles, closers, and  
rated doors.

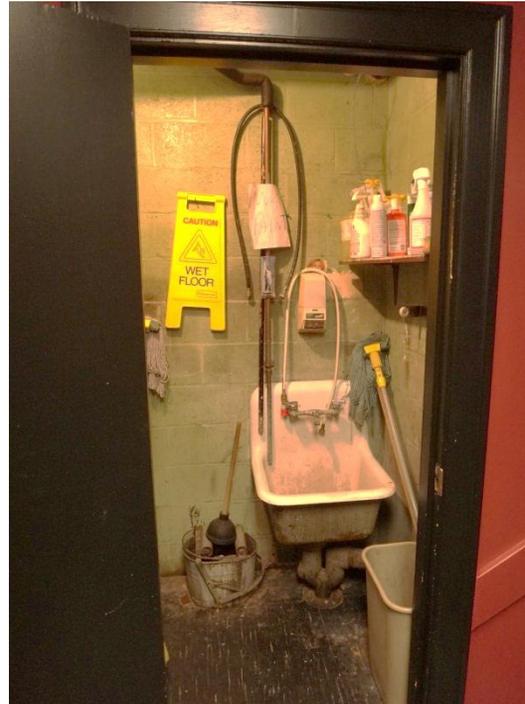
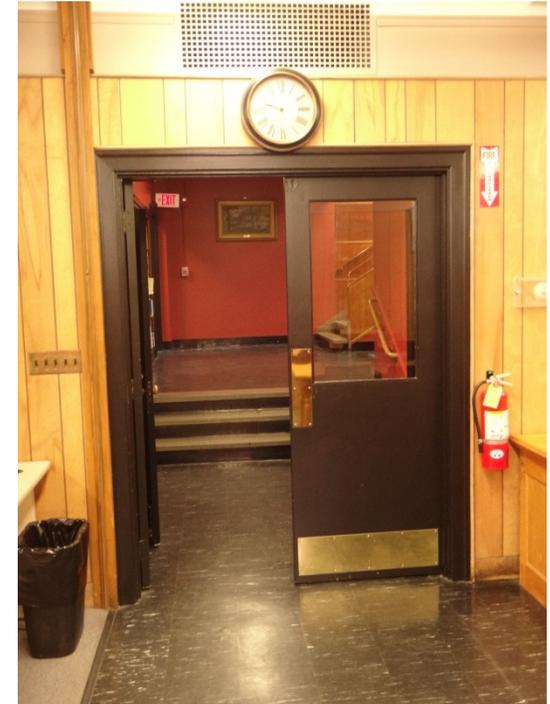
**PHOTO No.** 56 (left), 57 (right)

The pair of doors provide 30” clear each leaf < 32” clear required. The doors were observed to “stick” when kept closed (they were held open upon arrival) . The door opening force was 21 lbs when the door sticks / 10lbs when door does not stick (left when egressing); right leaf 12lbs opening force.

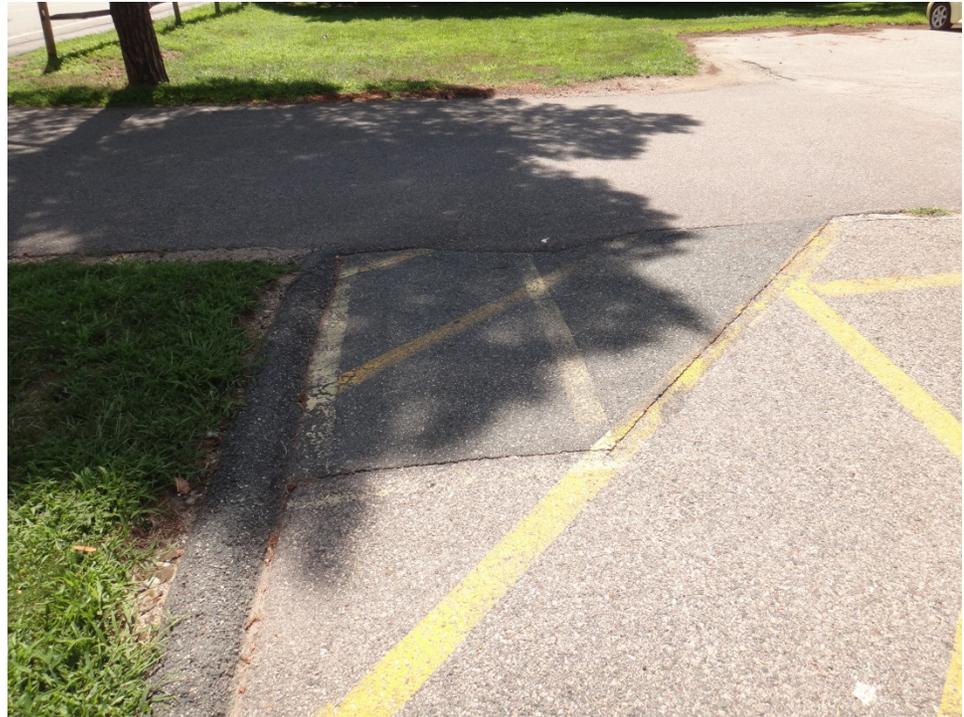
**PHOTO No. 5** (top), 6 (bottom )

Curb ramp has a slope of 9.3% with flared side of 14% > 8.3% and 10% flared side max. per ADAAG and 521 CMR.

Parking spaces in lot = 19 total spaces striped, (1) van accessible.

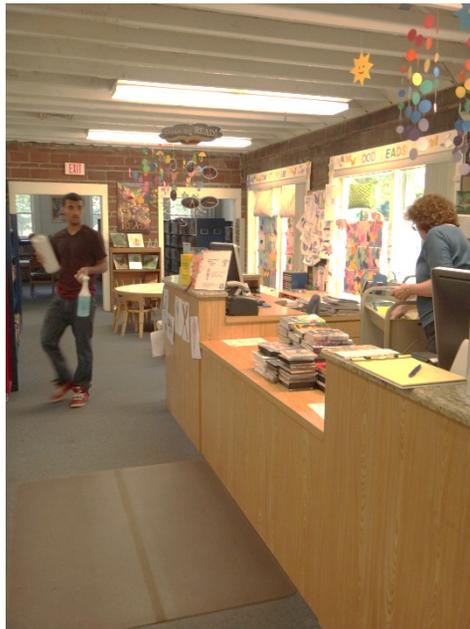
Existing circulation desk transaction counters are at 30" AFF with width greater than 36" = OK.  
Configuration allows for side approach of wheelchair user.
