**Dedham Public Library**  
**43 Church Street**  
**Dedham, MA 02026**  
**781-751-9284**  
**Dr. Mary Ann Tricarico, Director**

**Planning for the Future**  
**Strategic Plan for FY13 to FY17**

**Approved by Board of Trustees September 18, 2012**

## DEDHAM PUBLIC LIBRARY MAIN BRANCH – ACCESS / CODE SURVEY PHOTOS + NOTES

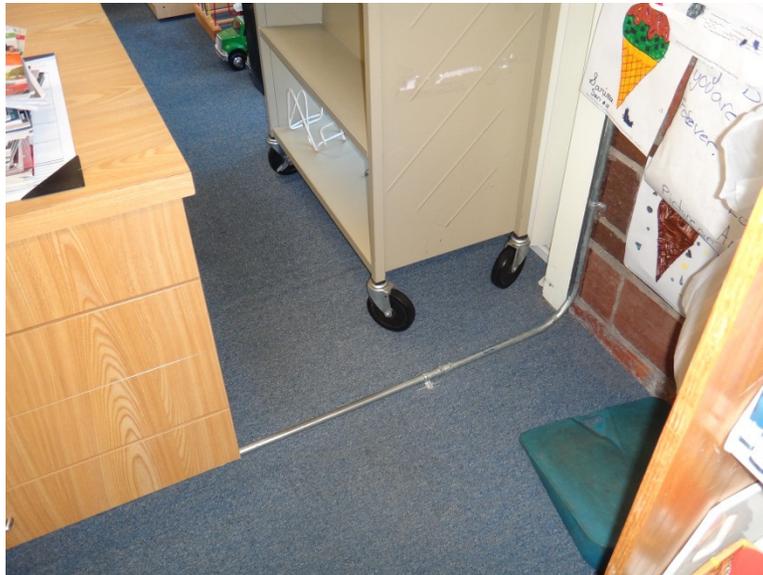
**PHOTO No.** 12 (right), 13 (bottom)

(photo 12) the self-checkout station has a counter at 39" AFF > 34" AFF max.; does not allow 30" front approach or 48" side approach do to location.

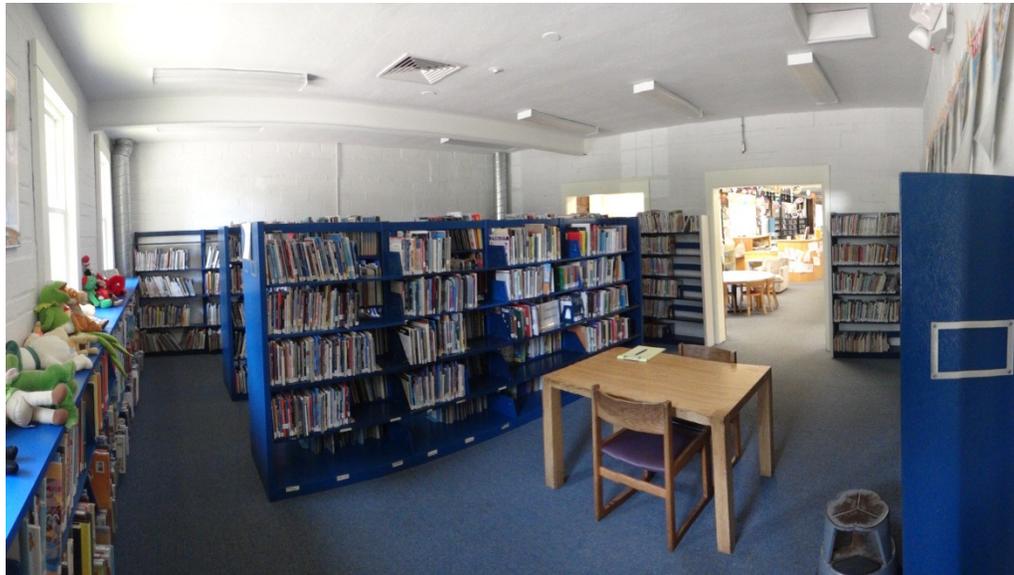
End Aisle was measured at 35 ½" < 36" min. required.

Existing furniture – 25" AFF knee clearance < 27" AFF min. required.

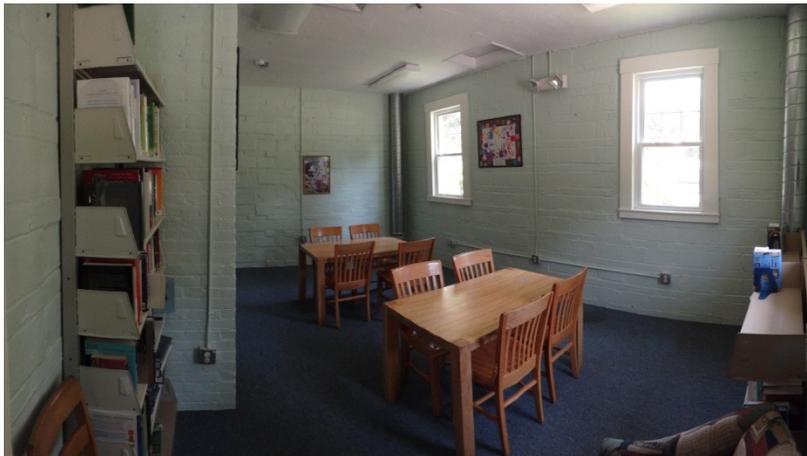
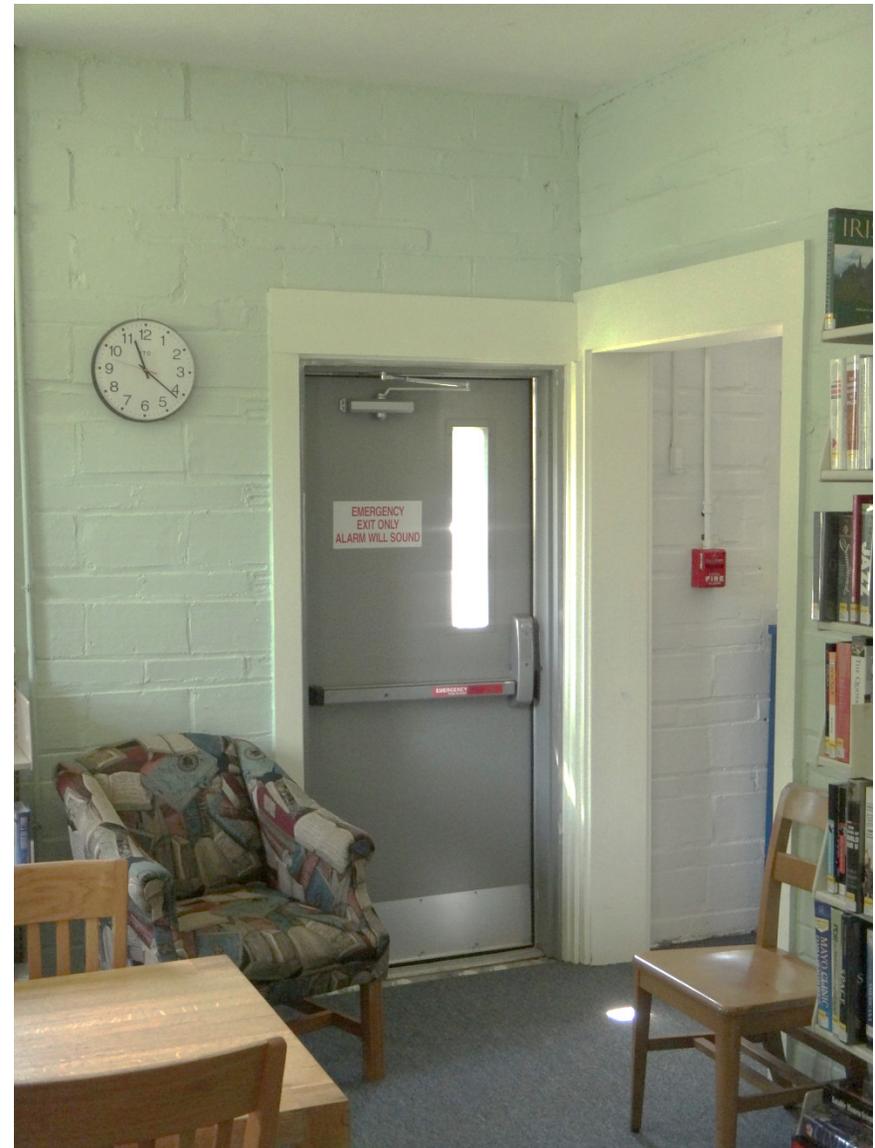
**PHOTO No.** 18 (top), 19 (bottom)

Stacks widths were measured at 35 ½" clear < 36" clear required.

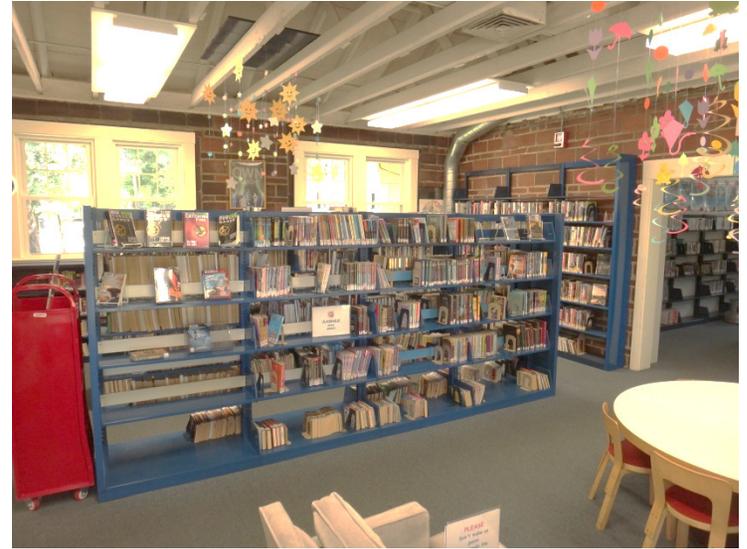
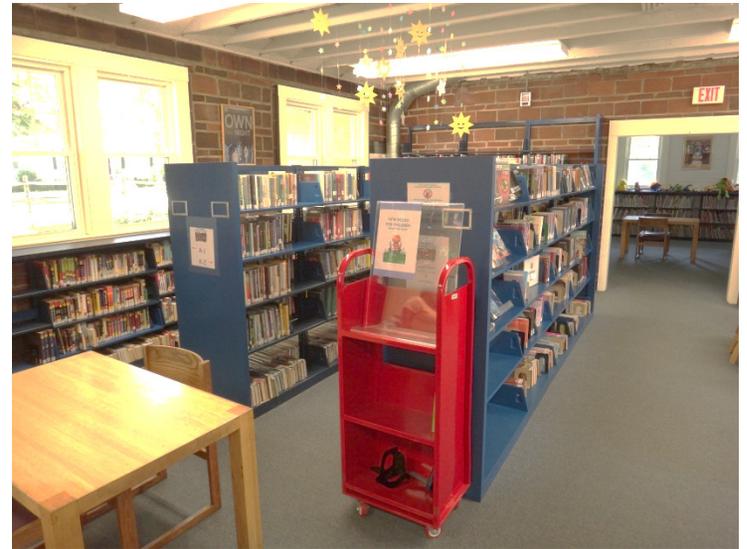
**PHOTO No.** 20 (right), 21 (bottom)

Stacks widths = OK

Computer Desks – 25" AFF knee clearance < 27" AFF min. required.

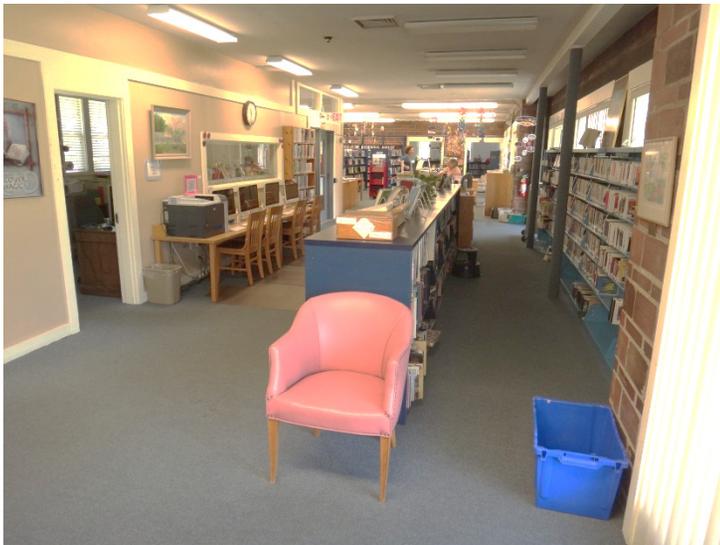
**PHOTO No.** 22 (right), 23 (bottom)

Clearances – inadequate pull side clearance at office door – furniture obstructions. Furniture needs to be reconfigured to allow min. 18” front approach to the door.

Maneuvering clearances – there may be inadequate maneuvering clearance within the room – 60” dia. Required.

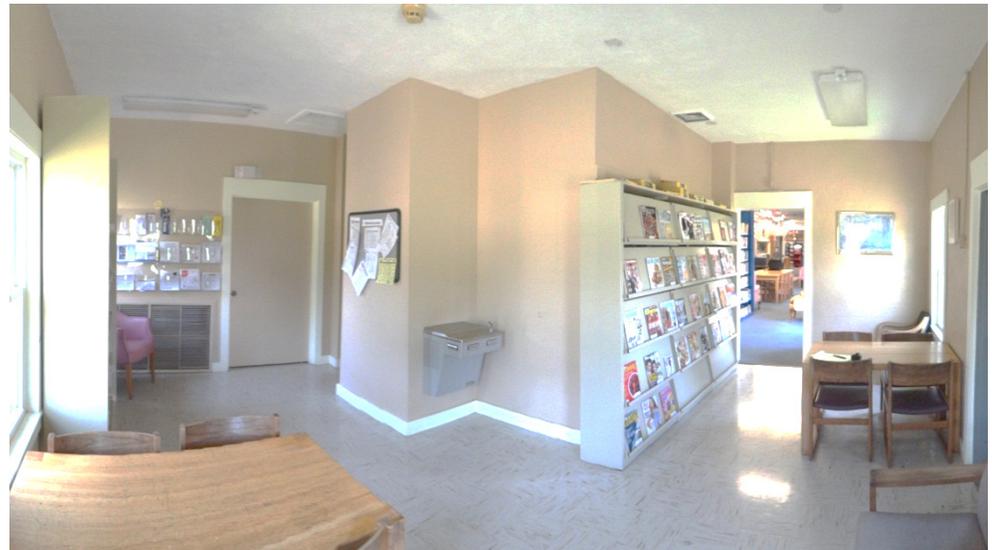
**PHOTO No.** 26 (top right), 27 (top left)

Fire Alarm pull – mounted at 52" AFF to control > 48" AFF max. required.

Door width – measured at 31" clear < 32" clear required; egress exits down a high step onto a grassed surface; not accessible.

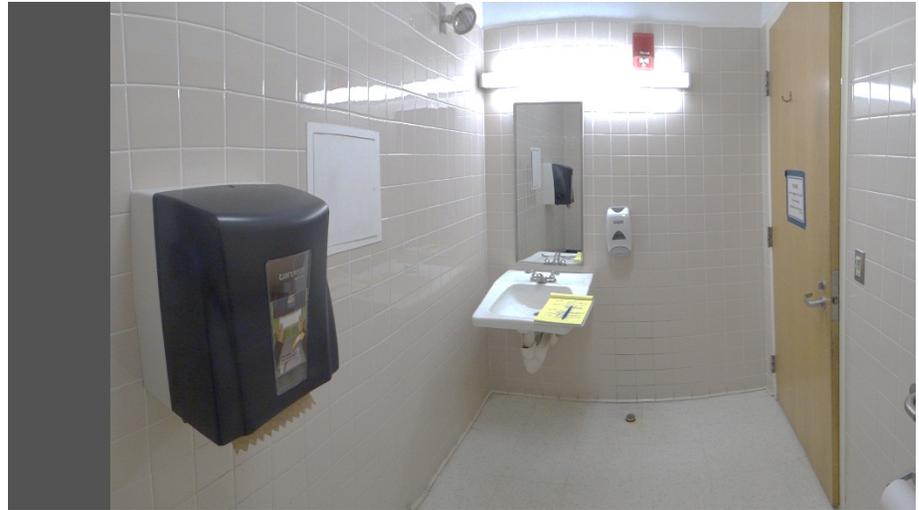
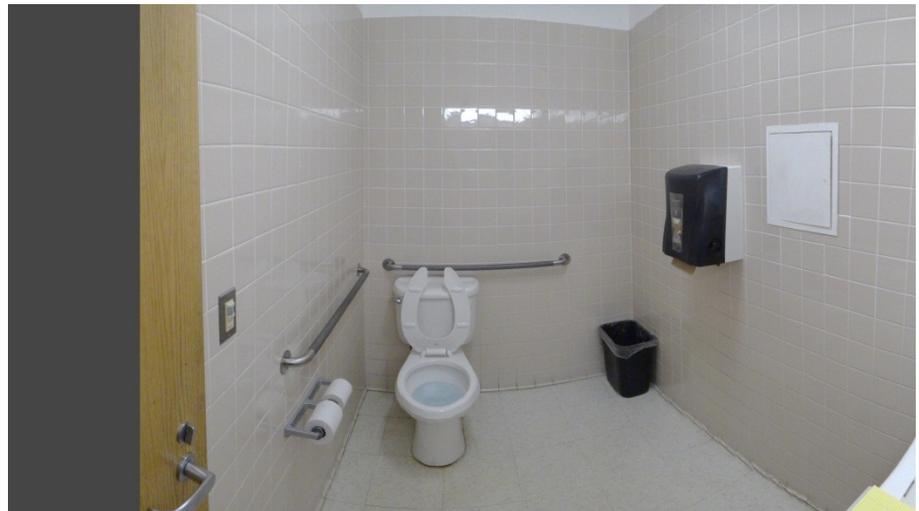
**PHOTO No.** 30 (top right), 31 (bottom)

Door hardware – the door does not have a closer though adequate 30"x48" maneuvering clearance exists to enter the room, but inadequate clearance to turn around and close the door behind.

Sink – pipes are wrapped but wrapping are in poor condition.

Coat hook – mounted at 69" AFF > 48" AFF max. required.

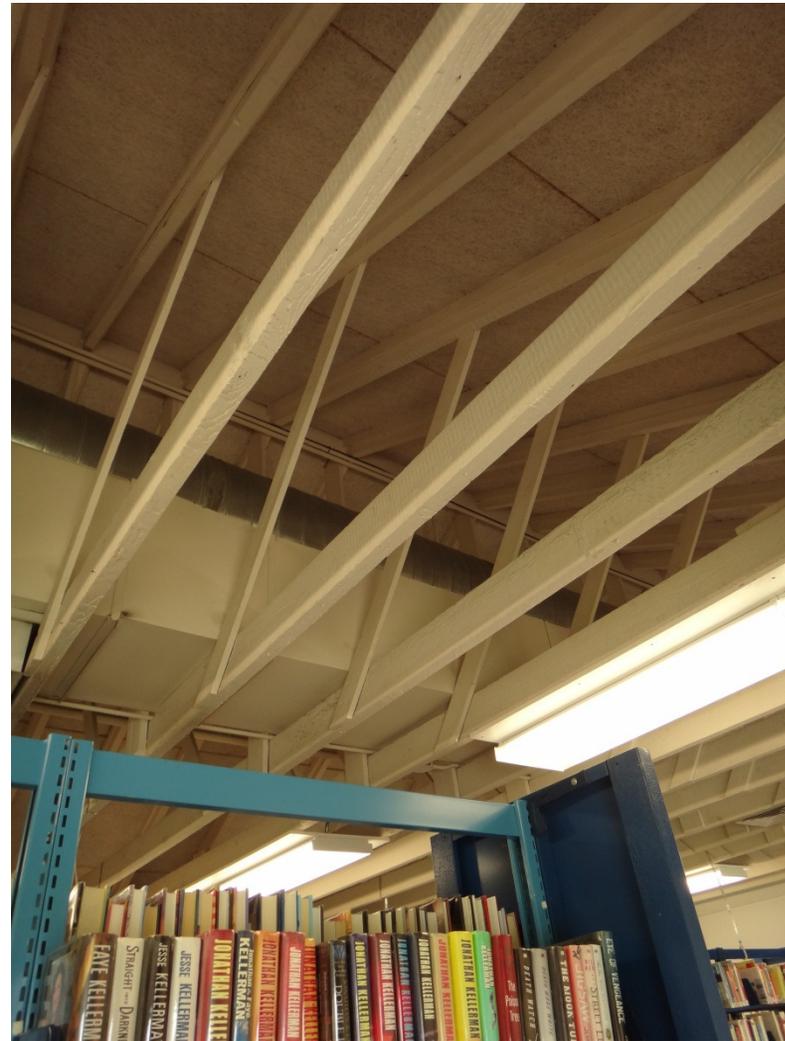
The primary concern is that an acoustical, fiber board material that has been installed previously does not provide adequate thermal insulation values.

7. Replace door hardware for compliance
8. Install approved automatic fire suppression system
9. Install portable fire extinguishers
10. For energy efficiency, remove existing fibrous acoustical material installed between trusses. Install at the underside of roof only, a closed-cell, spray-in foam insulation system, then install gypsum wallboard with acoustical plaster finish

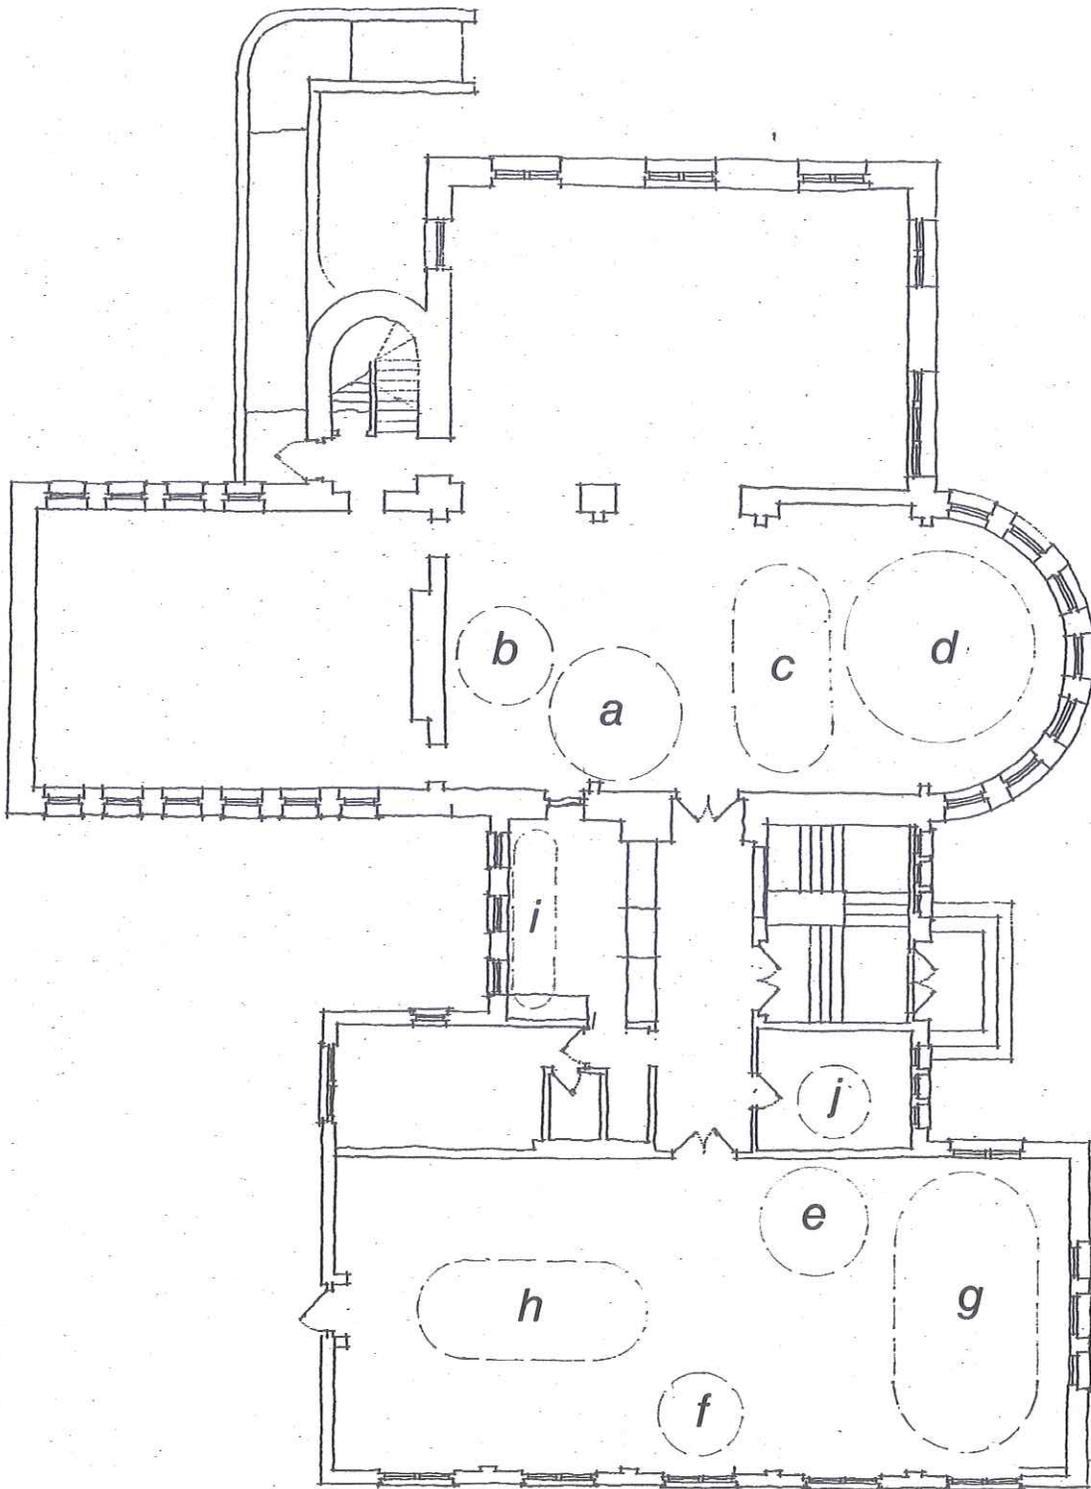
**PROPOSED NEW SPACE ORGANIZATION  
 DEDHAM PUBLIC LIBRARY / MAIN BRANCH / FIRST FLOOR PLAN  
 FIGURE # 6**

- a Reference Librarian / Public Printer / Self Check-out Station / Atlas
- b New books / will call books
- c Public Computer cluster
- d Periodical Reading Area
- e New 2 person work station
- f Seating area @ fireplace
- g Children's Activity Area
- h Large Group Activity Area
- i New linear workstation at Circulation Desk
- j New systems based desk

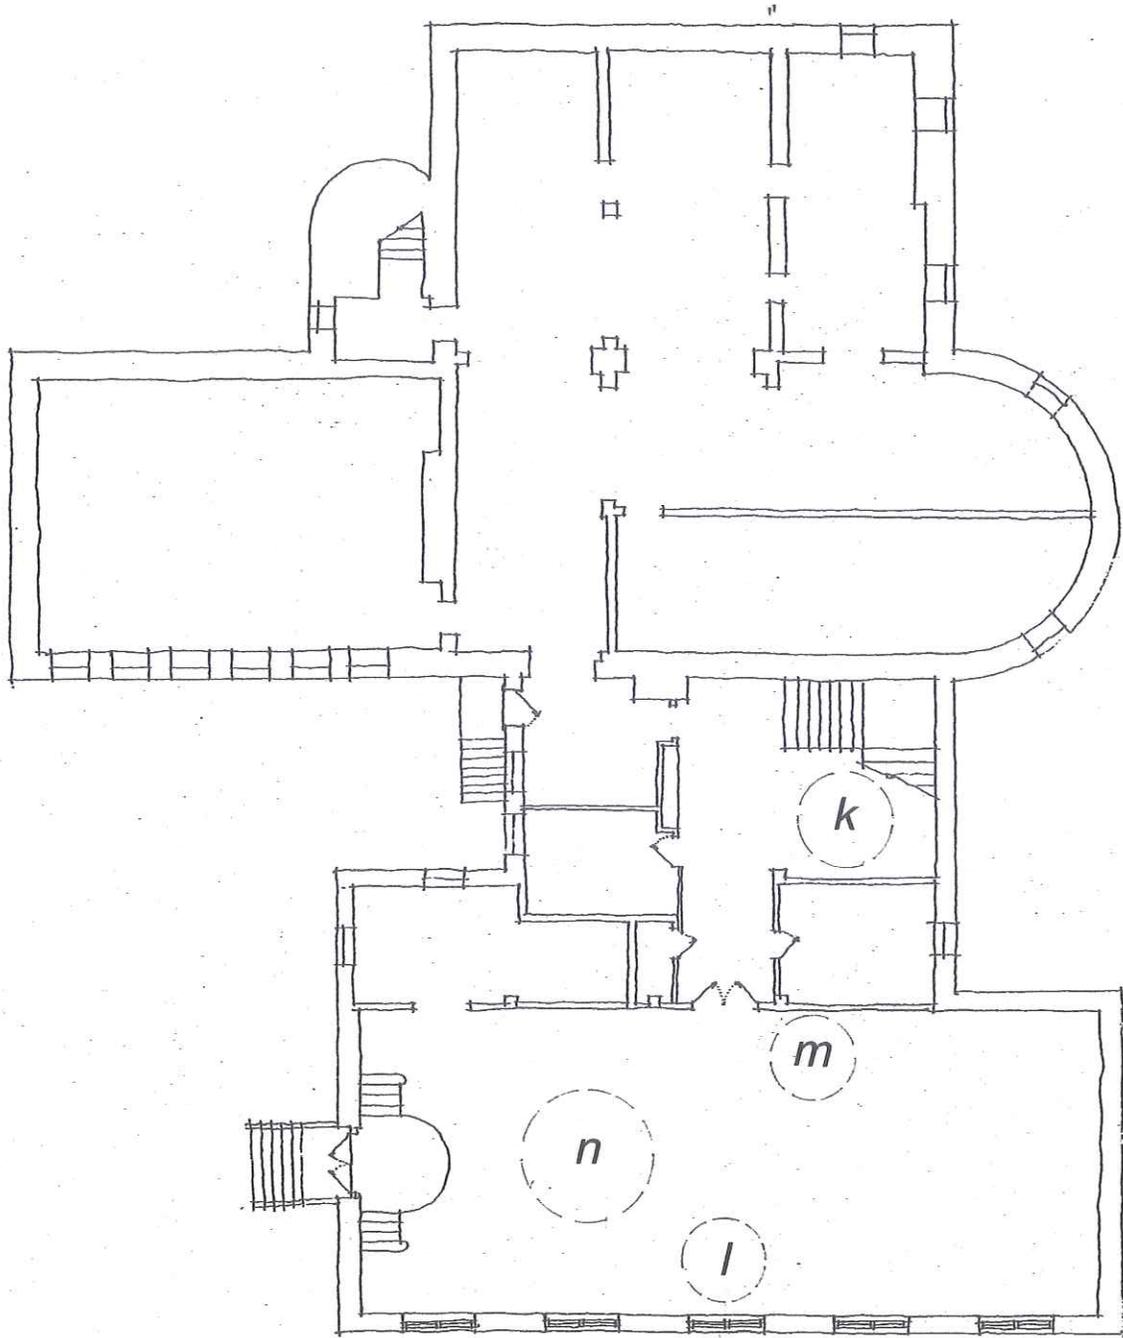
**PROPOSED NEW SPACE ORGANIZATION  
 DEDHAM PUBLIC LIBRARY / MAIN BRANCH / LOWER FLOOR PLAN  
 FIGURE # 7**

- k* Quiet reading niche
- l* Young Adult reading area
- m* Young Adult public computer cluster
- n* History Room stackable seating & folding tables

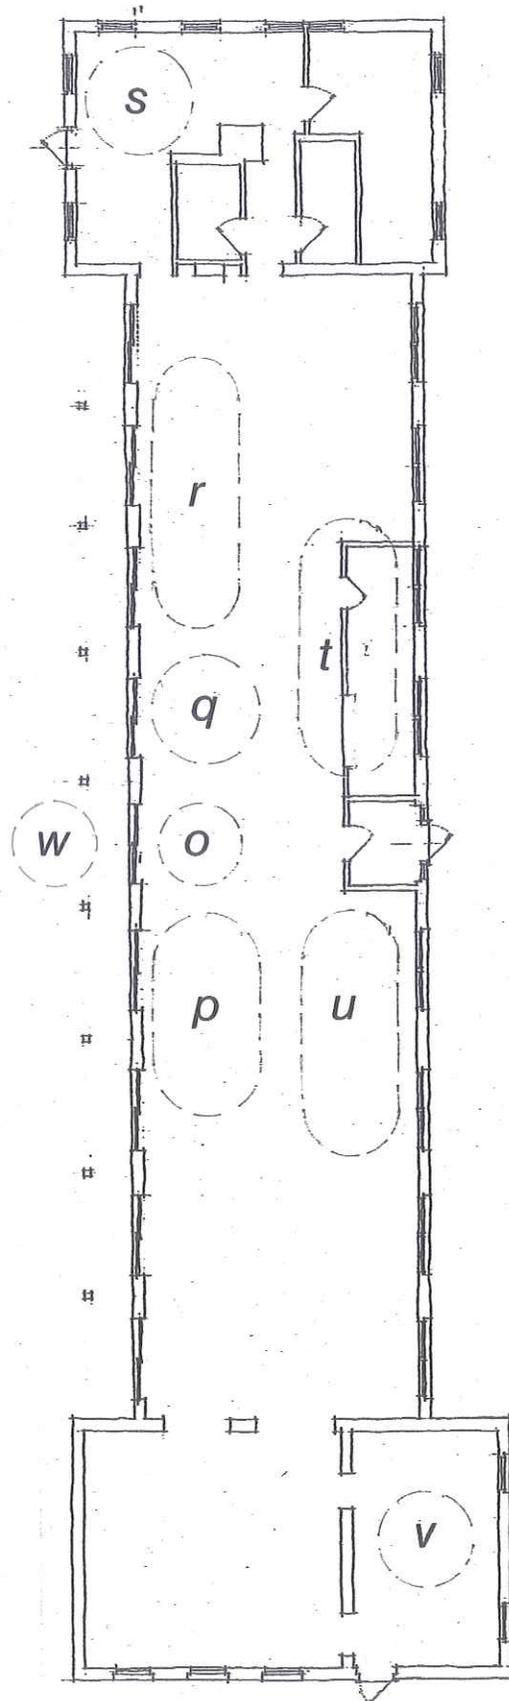
**PROPOSED NEW SPACE ORGANIZATION  
 DEDHAM PUBLIC LIBRARY / ENDICOTT BRANCH / FLOOR PLAN  
 FIGURE # 8**

- o* Small scaled lounge seating reading area
- p* Existing Circulation Station
- q* New Reference Librarian Station, public printer,
- r* Reading area, work tables, new books collection,
- s* Staff work room
- t* Public computer carrels
- u* Expanded Young Adult collection and work tables
- v* New Children's large activity Area tables
- w* Exterior flowering planting area
